## Annual Inspection

Winchester City Council

Meonwara PA (West Meon PC)

Inspection Ref: 2654716

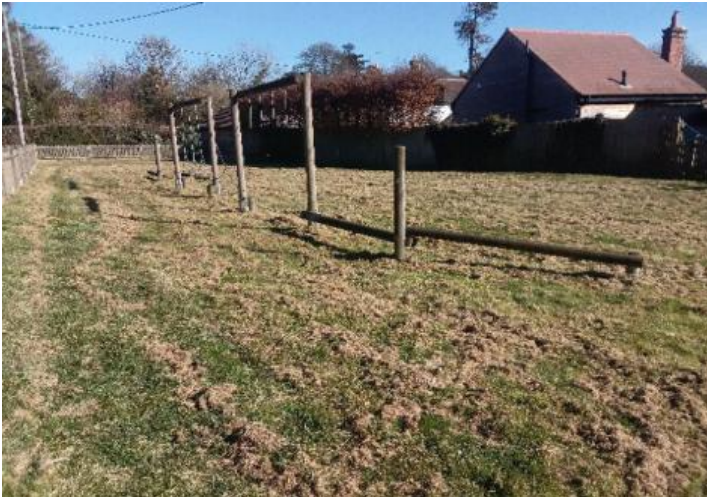
### 5 - Very Low Risk (Finding 1)

**Finding:** It is recommended that signage, with information including the site address, contact information for maintenance issues and emergency contact details are provided for the facility

**Action:** Provide in accordance with the recommendations

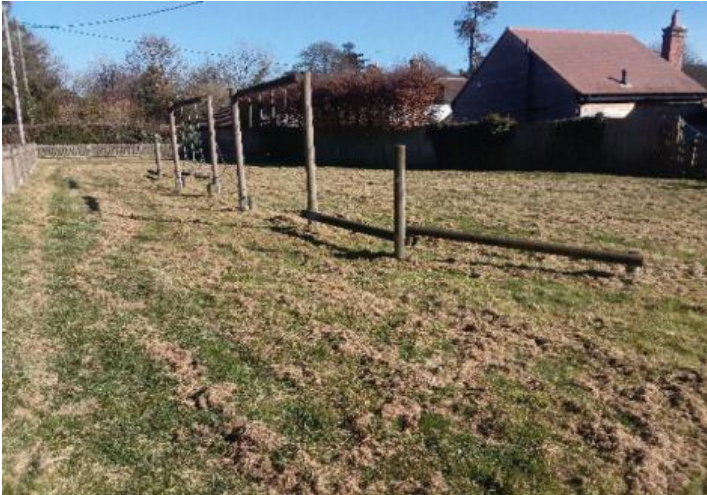
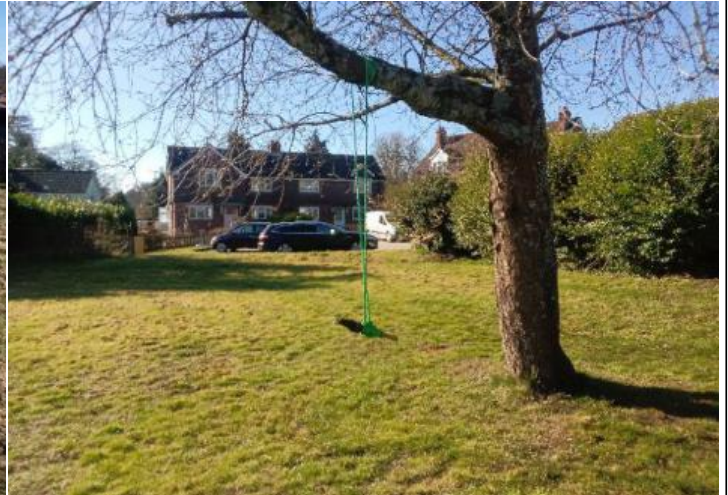
**!** 12 - Moderate Risk (Finding 2)

**Finding:** There is a self-made rope or tyre swing present. This type of construction is not recommended unless the trees / branches and connections have all been independently tested and checked by a competent person for sufficient structural stability, a suitable impact attenuating surface is provided on the seat itself and the surface underneath and a separately documented risk assessment and control measures are in place.

**Action:** Remove

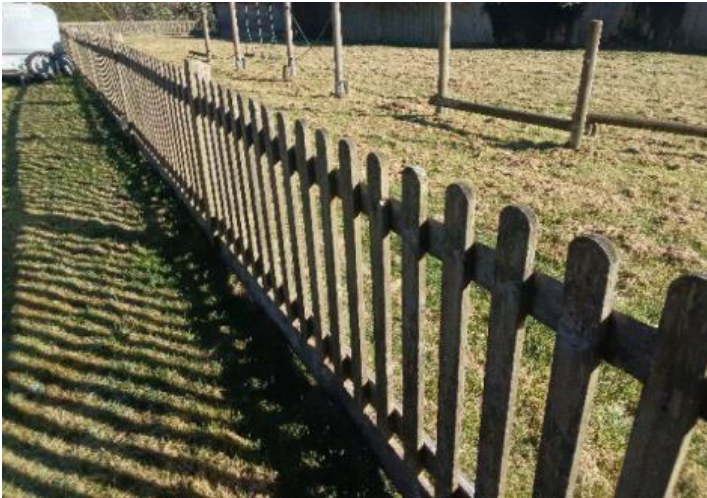
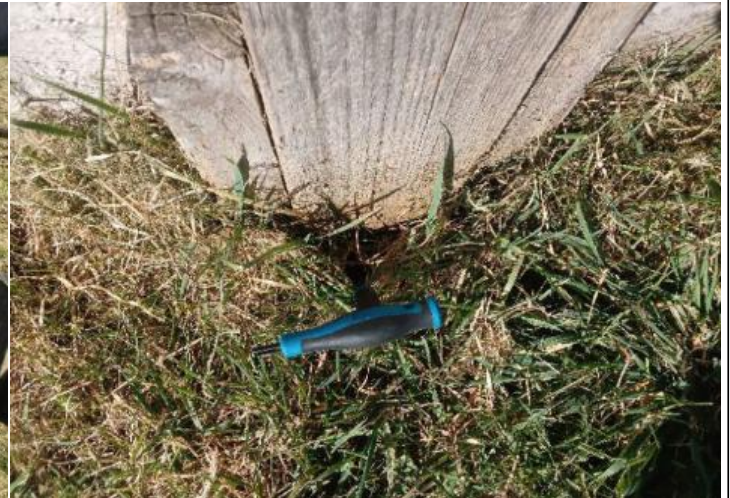
### 6 - Low Risk (Finding 1)

**Finding:** There is some evidence of rot in the timber

**Action:** Monitor for any further deterioration and replace as required

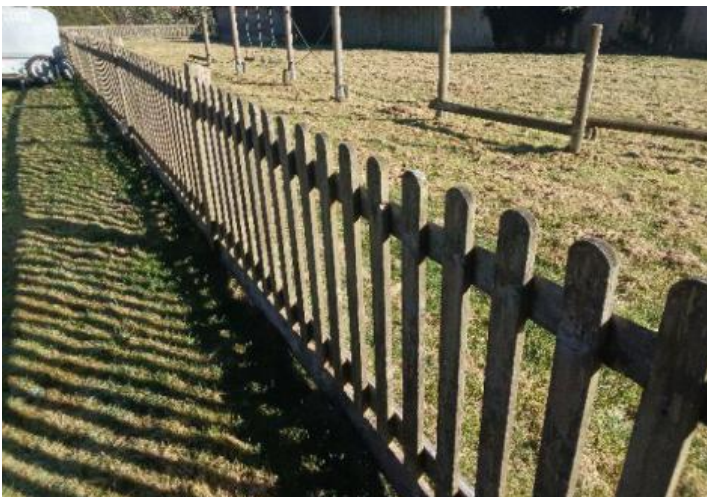
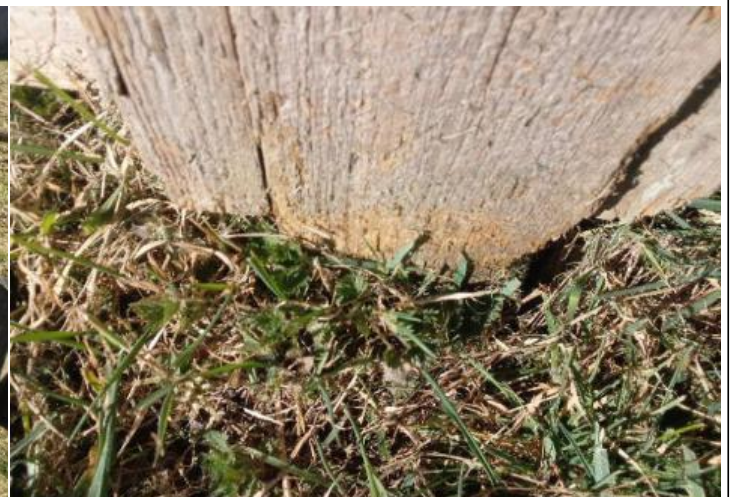
### 6 - Low Risk (Finding 2)

**Finding:** There is some strimmer / machinery damage apparent on the posts, this can penetrate the preservative applied to the timber and accelerate the rotting process

**Action:** Monitor for any deterioration (rot) and replace as required

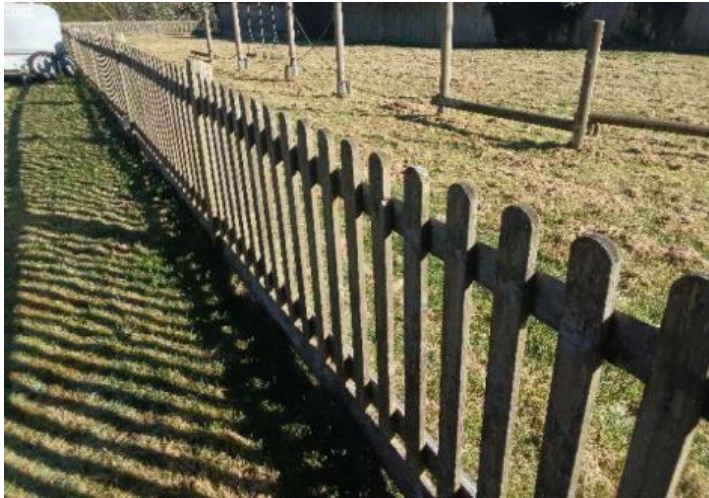
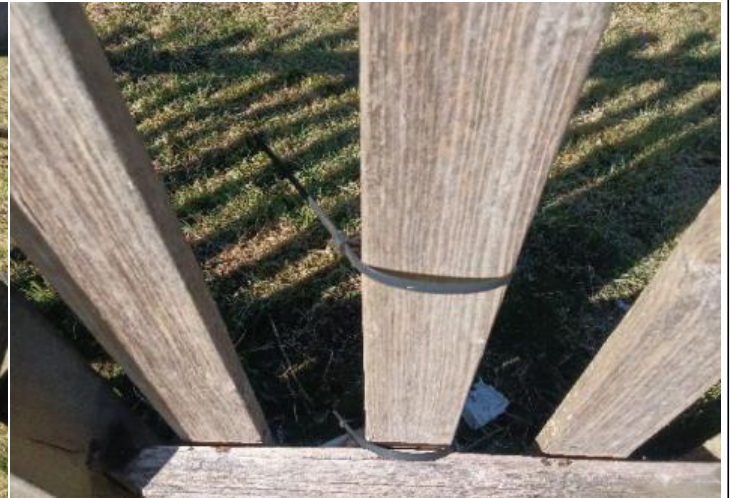
**i** 6 - Low Risk (Finding 3)

**Finding:** There are cable ties attached to the fencing

**Action:** Remove

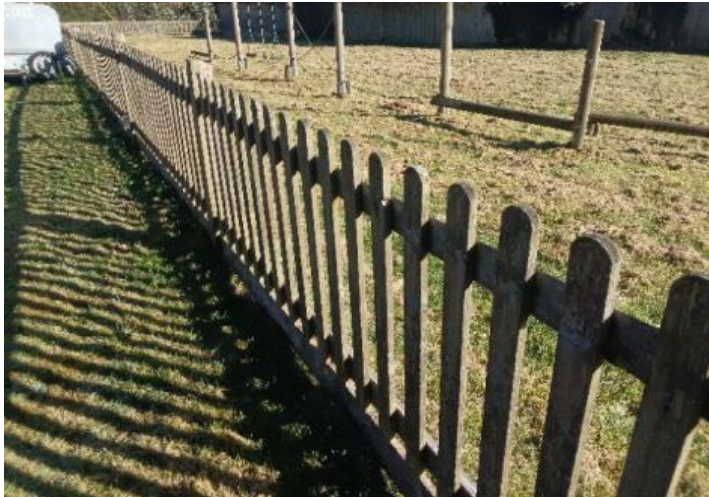
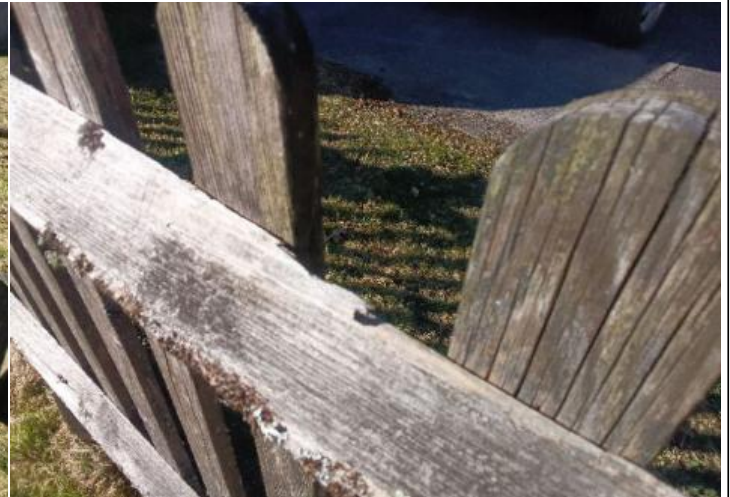
**i** 6 - Low Risk (Finding 4)

**Finding:** Parts of the timber are rough or splintered

**Action:** Remove all rough or sharp edges

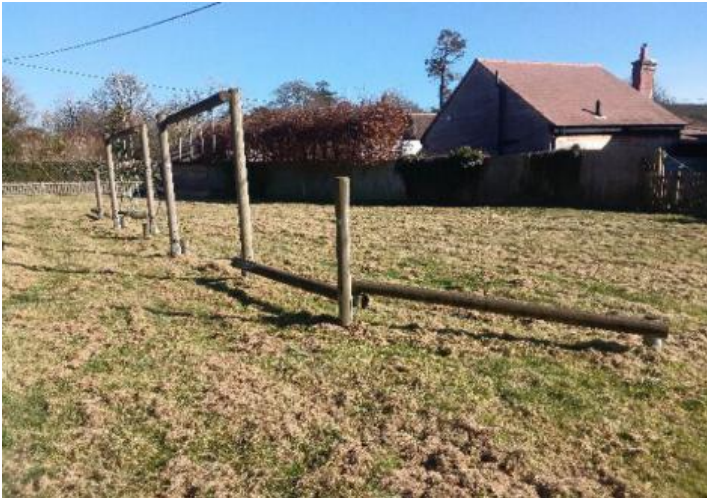
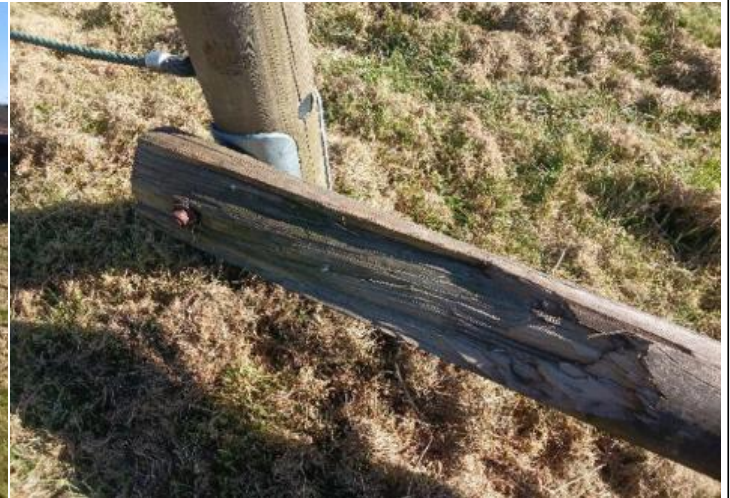
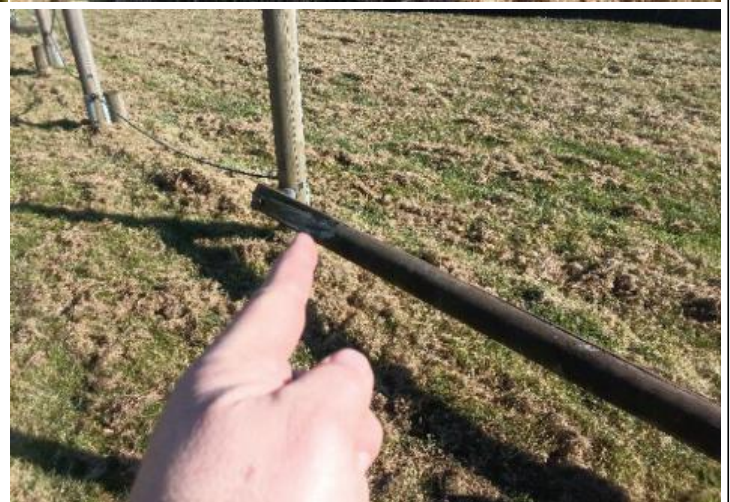
**i** 9 - Low Risk (Finding 1)

**Finding:** The balance beam is damaged

**Action:** Replace

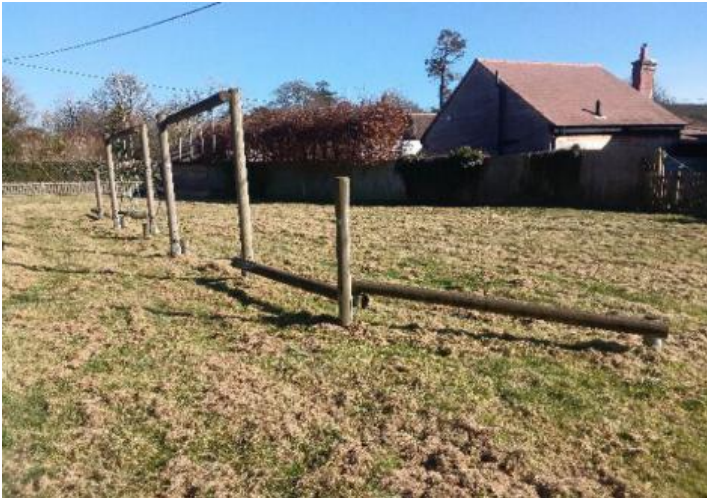
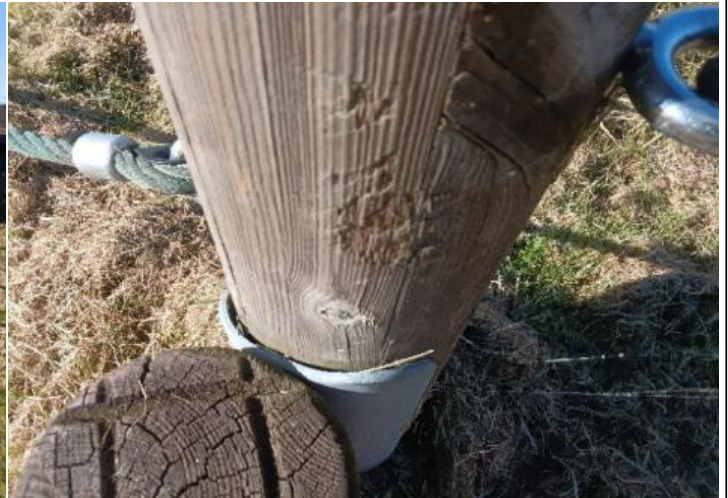
**i** 6 - Low Risk (Finding 2)

**Finding:** Parts of the timber are rough or splintered

**Action:** Remove all rough or sharp edges

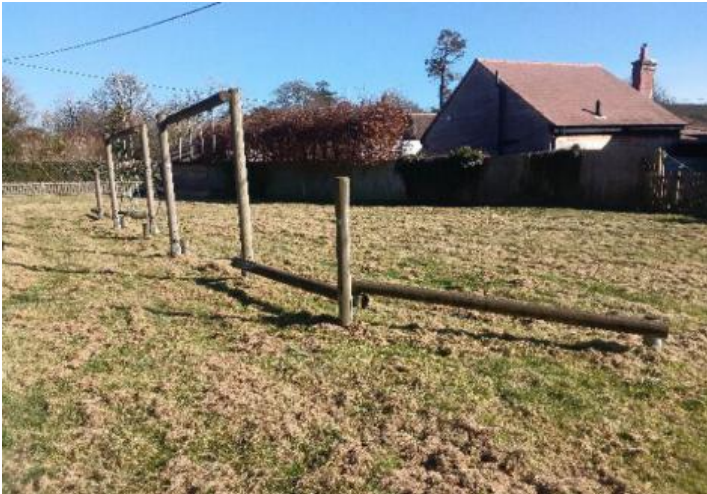
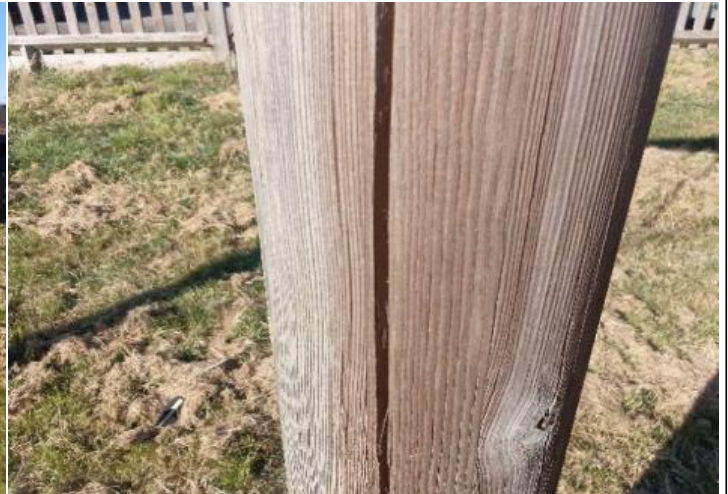
**i** 6 - Low Risk (Finding 3)

**Finding:** The timber has a number of splits/shakes or air cracks and this may affect the stability or allow water ingress which will accelerate the rotting process

**Action:** Monitor to ensure the splits do not cross through fixing points of the structure and/or cause any instability

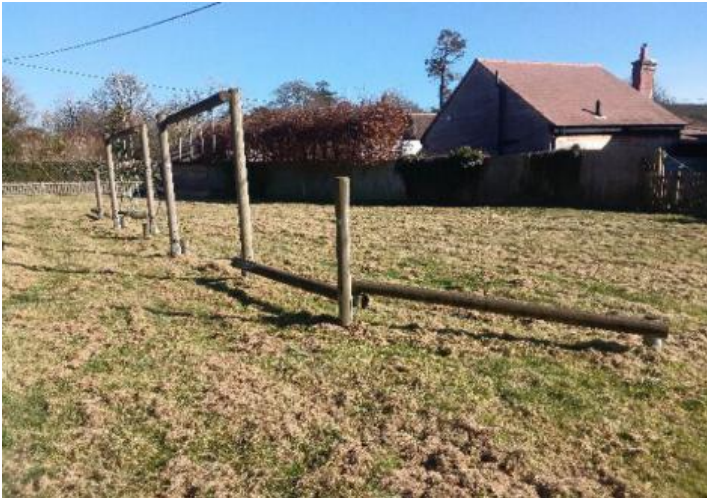
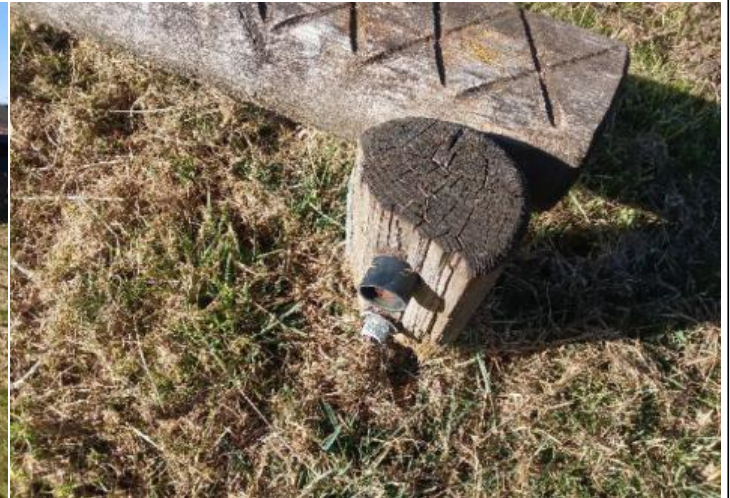
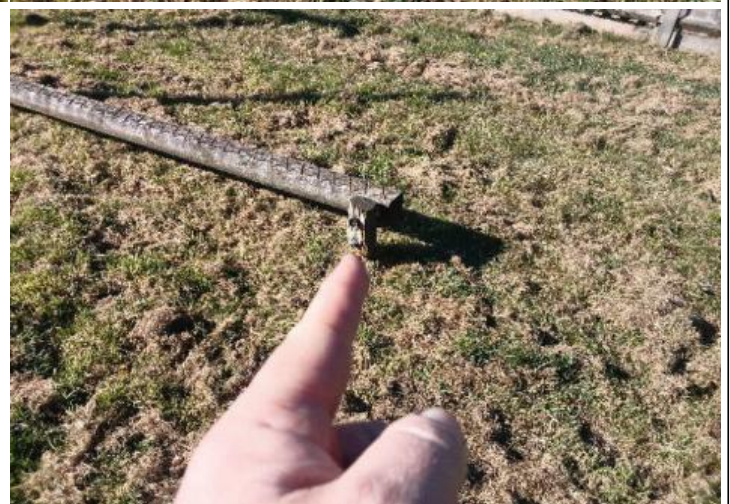
**i** 9 - Low Risk (Finding 4)

**Finding:** The balance beam post is damaged

**Action:** Replace

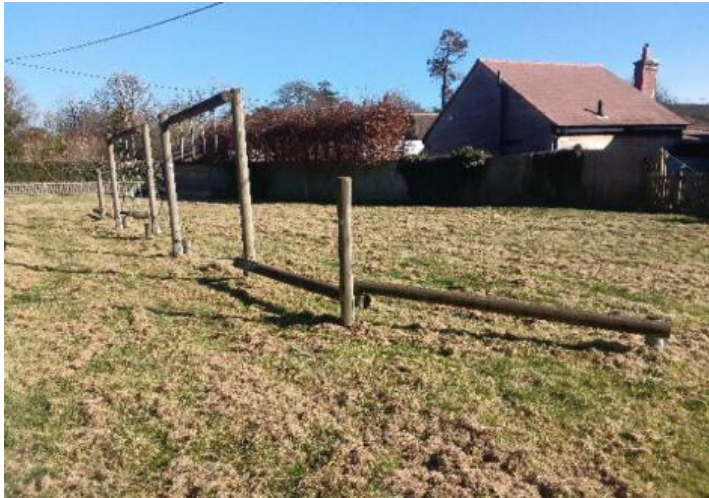
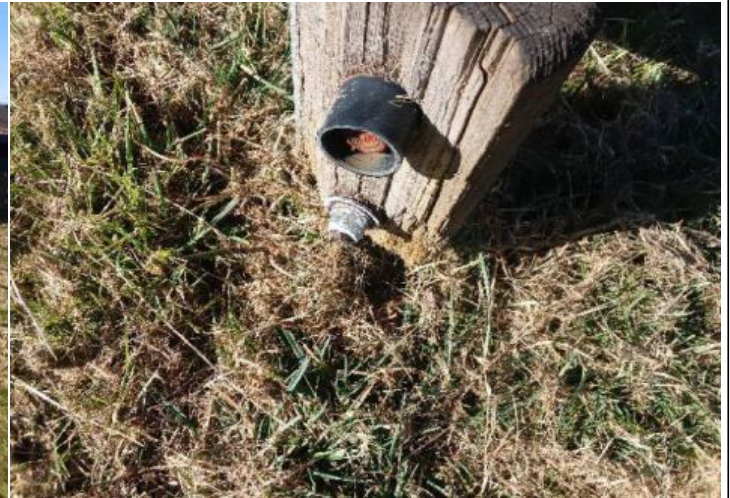
**i** 4 - Very Low Risk (Finding 5)

**Finding:** There is/are bolt cap covers missing or damaged on the item

**Action:** Replace missing or damaged bolt cap covers

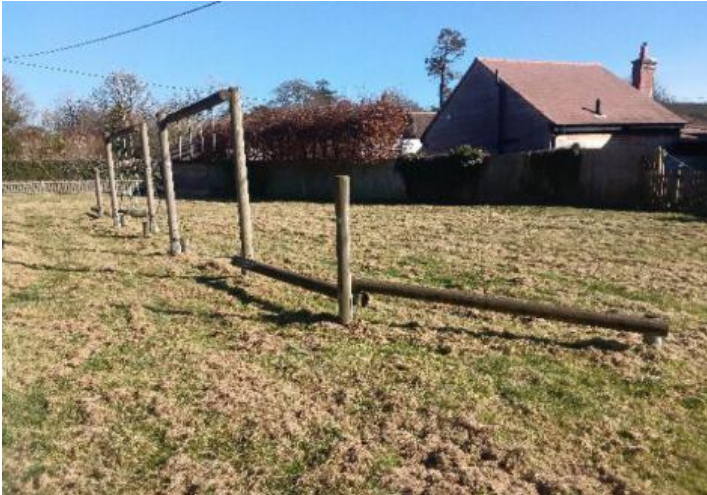
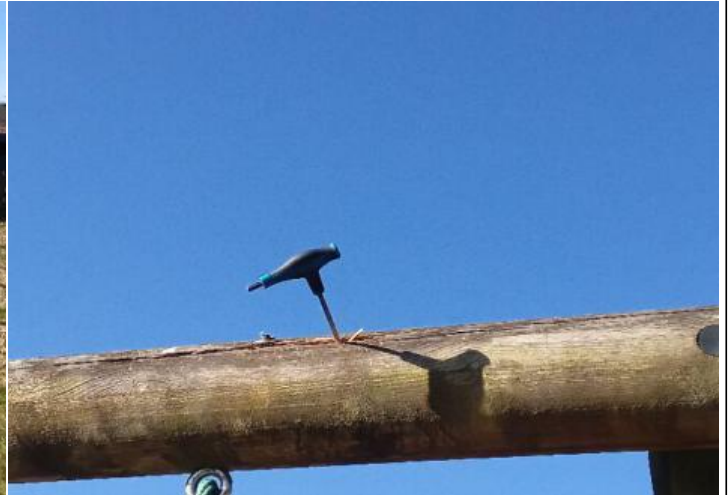
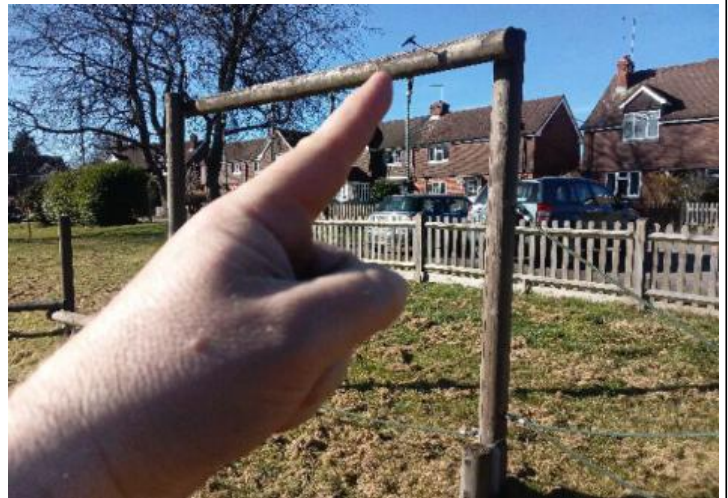
**!** 12 - Moderate Risk (Finding 6)

**Finding:** There are areas or parts of the crossbeam on the rope walk that have rotted

**Action:** Replace all affected timbers

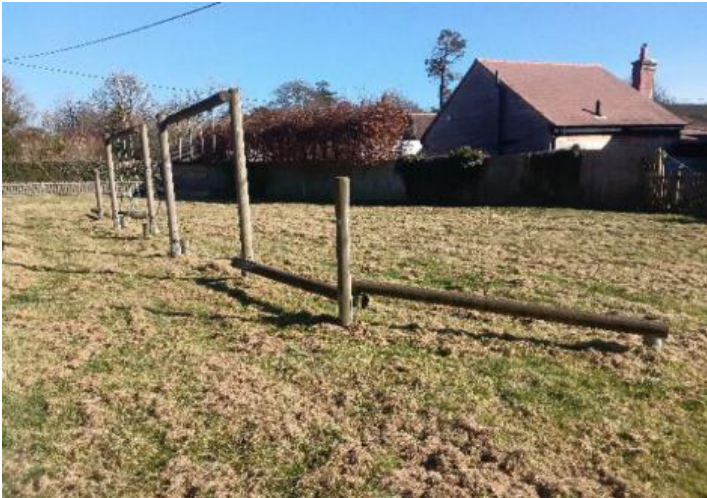
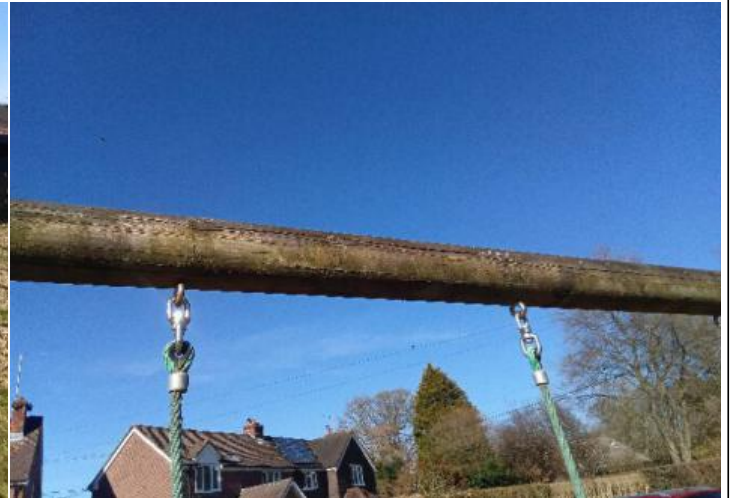
### 8 - Low Risk (Finding 7)

**Finding:** There is algae or moss on the surface of the equipment that can lead to the onset of rot

**Action:** Monitor condition of the timbers (rot), clean and treat appropriately

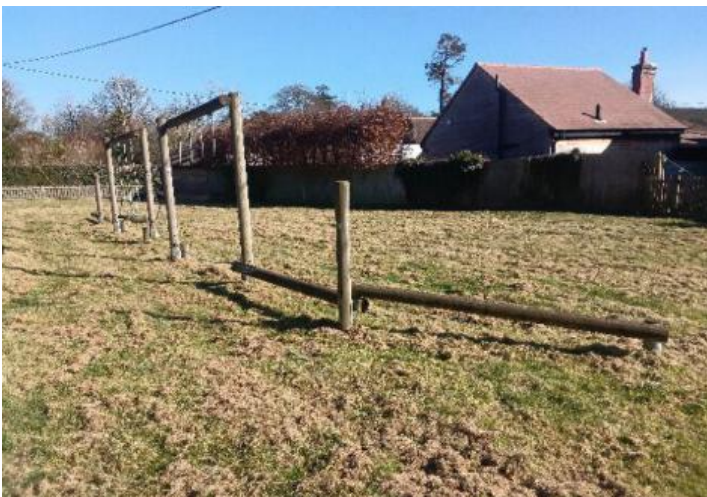
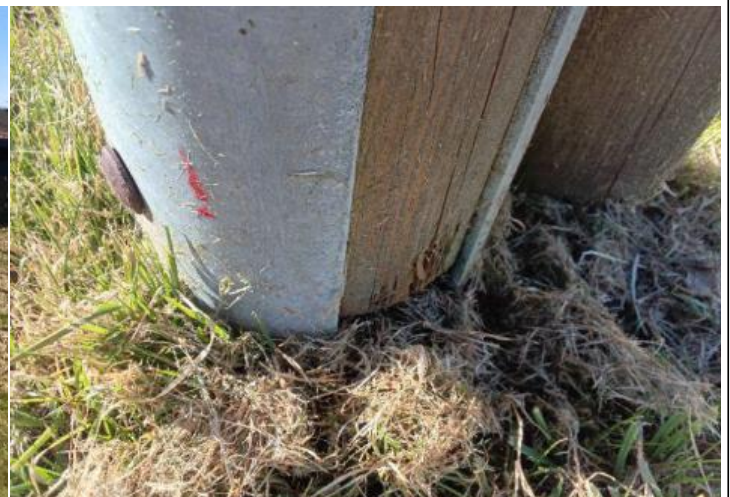
### 6 - Low Risk (Finding 8)

**Finding:** There is some strimmer / machinery damage apparent on the posts, this can penetrate the preservative applied to the timber and accelerate the rotting process

**Action:** Monitor for any deterioration (rot) and replace as required

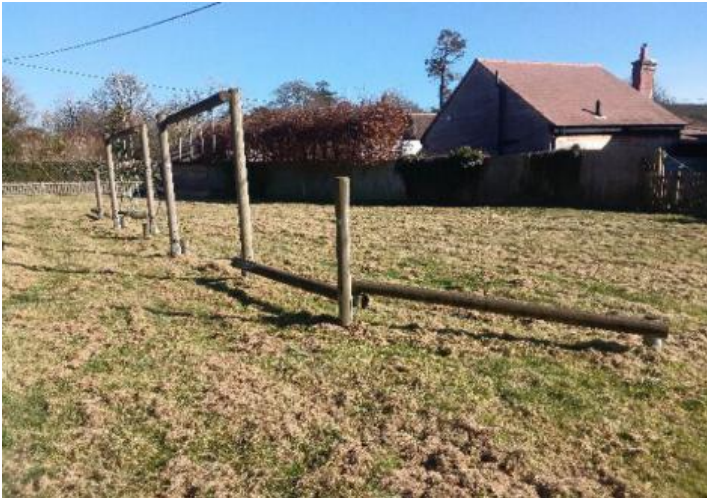
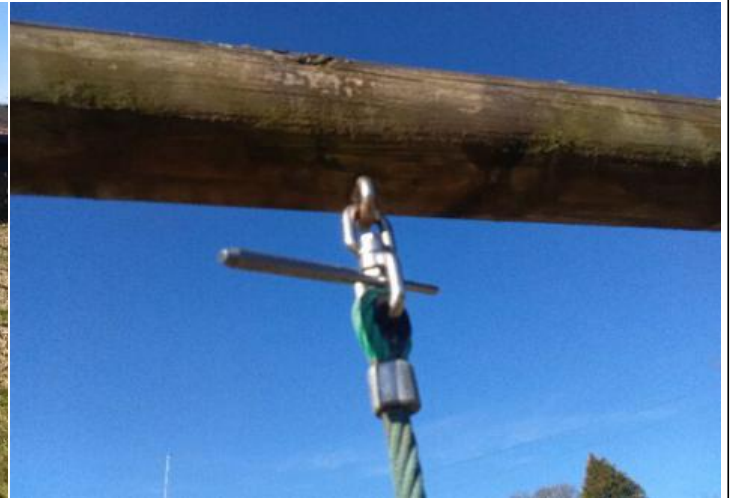
**i** 5 - Very Low Risk (Finding 9)

**Finding:** The connecting links are in excess of 8.6mm and less than 12mm and fail the requirements of BS EN 1176 Part 1; clause 4.2.13, Chains

**Action:** Monitor - No action given the risk assessment
