| <div>KEY PLAN</div> <div><div><div></div></div><div>Key Structure Failures (labelled in order of priority)</div></div> | <div>NOTES</div> <div>Contains OS data © Crown copyright and database right (2025)</div> | REVISIONS | | | | <div><div><div></div></div><div>Stantec</div></div> <div>172 Edmund Street, Birmingham B3 2HB, United Kingdom</div> | TITLE West Meon Mitigation Summary | | |
| REV. | REVISION NOTES/COMMENTS | | | | PROJECT River Meon, West Meon | DRAWING NO. 34101-HYD-XX-XX-DR-WENV-0001 | REVISION P01 | | |

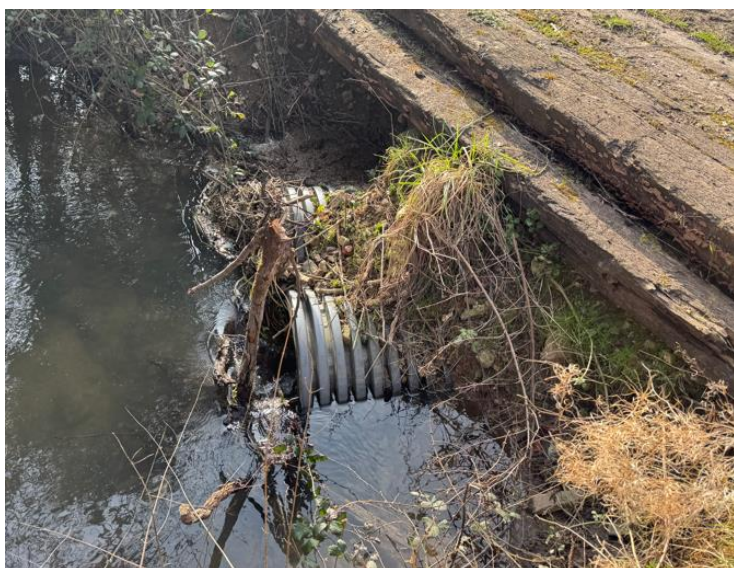
1 Area 1

Structure 1 is located under an access road to Hall Place Farm. It is a twin 650mm diameter plastic pipe at the upstream (eastern end), and a singular 650mm diameter plastic pipe at the downstream (western end). As shown in the photo below, the structure is inefficient and greatly reduces the capacity of the channel in this area. This, coupled with the fact that the culvert itself reduces in width under the road, either due to blockage or being poorly laid, is a significant cause of flooding to the surrounding area (Vinnells Lane, West Meon Road) and requires attention.

Replacement of this structure to a slot or boxed culvert would improve the capacity of the channel in this area, which is 4.5m wide from top of bank to top of bank. Consent would need to be sought from the Environment Agency to do this as they are responsible for maintaining the river, as it is designated as a Main River.

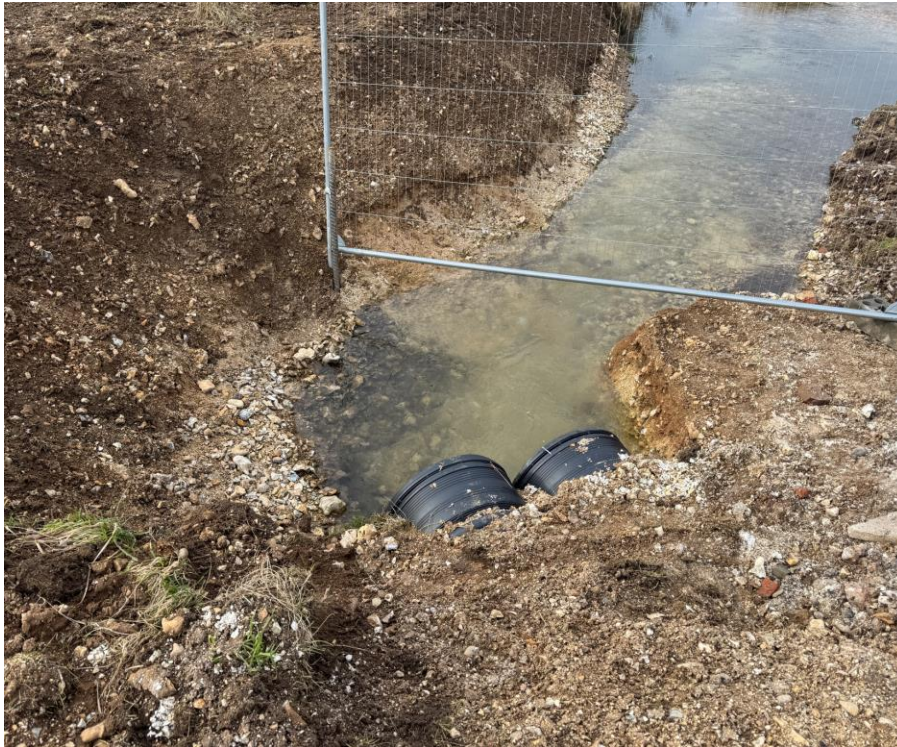
2 Area 2

Structure 2 is another twin 650mm diameter plastic pipe to a parcel of land located 135m east of Coombe Lane, that is currently undergoing construction. The pipe that has been laid is undersized and appears to have greatly reduced the channel capacity and width in this area. It is responsible for causing flooding to West Meon Road, Coombe Lane and Vinnells Lane.

As the River Meon is a designated Main River, consultation should have been undertaken with the Environment Agency to obtain the necessary permits to lay this culvert. Depending on whether this structure is temporary or permanent, consideration should be given to either removing or upgrading this structure to a slot or boxed culvert that has less impact on channel capacity. The channel is 3.5m to 4m wide in this location.

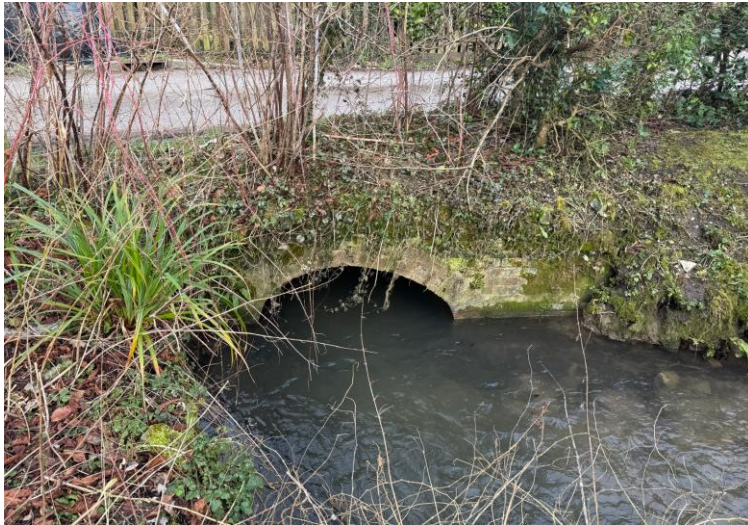
3 Area 3

This is an arched culvert under Lynch Lane that is approximately 1.7m wide at it's widest point, and approximately 1m high. The culvert becomes full during high flow conditions and is not suitably sized, causing backing up of flows and flooding to properties surrounding Lynch Lane.

Replacement of the culvert to a boxed type structure that matches the channel width of 3.5m in this location would improve flow conveyance under Lynch Lane. Further hydraulic modelling would be required by the Environment Agency to prove that this does not push the problem downstream or make flood risk worse elsewhere. A photo of this culvert is shown below.

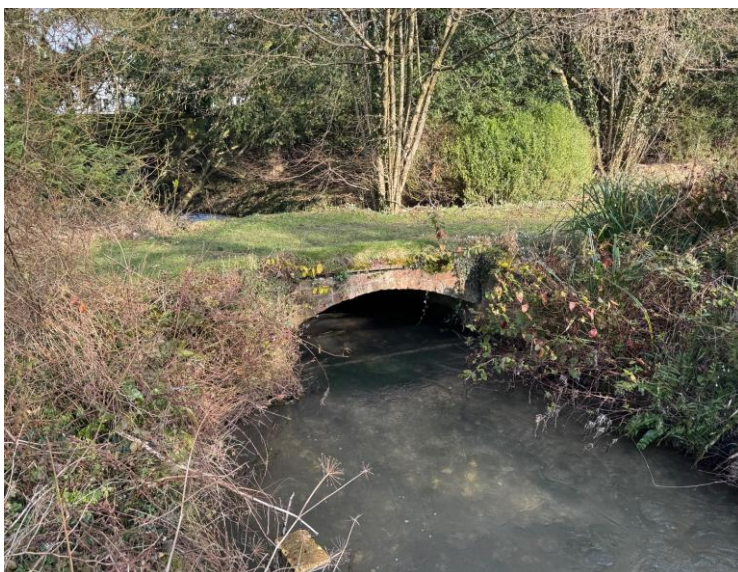
4 Area 4

This is a small irregular shaped culvert that is 1.9m wide at its widest point and 0.8m high. Due to the age of this structure, it will not have been bespoke designed to take the flow of the River Meon during larger storm events and the culvert becomes full and overtops, with a flood route that eventually leads to Lynch Lane. The river channel is over 5m wide at this point, which demonstrates how this structure greatly reduces channel capacity.

Consultation with the Environment Agency and landowner would need to be undertaken to obtain a permit and replace this structure to something that is wider and has less of an impact on channel capacity. Other areas of floodplain may need to be lowered to compensate for any increase in flows passed downstream.
