the **play inspection** company

Annual Inspection

West Meon Village Hall RG (West Meon PC)

Headon View, West Meon, Hampshire, GU32 1LH

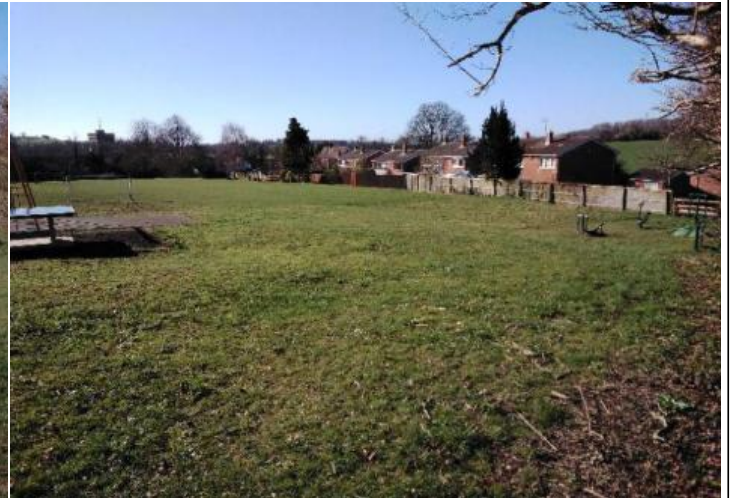
Item: Ancillary Items - Site General
Manufacturer: Owner/Operator

Finding: It is recommended that Adult Outdoor Fitness equipment is installed a minimum of 25m away from a children's playground or separated and screened to discourage access by younger children

Action: Monitor use and review risk assessment regularly

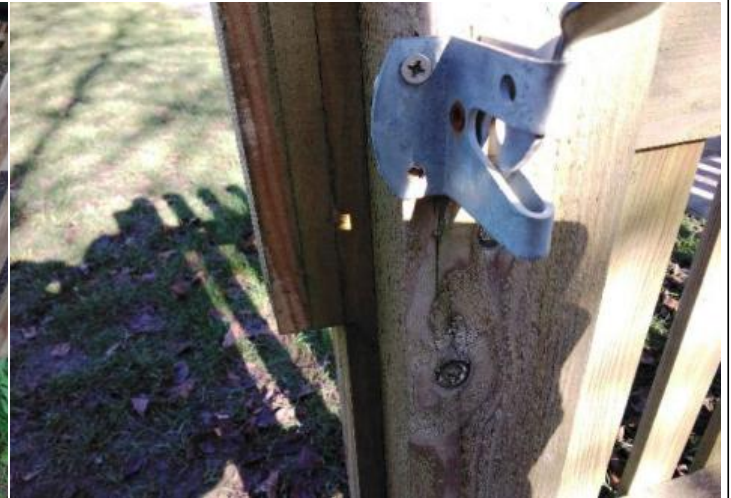
Item: Gates - Gate - Self Closing
Manufacturer: Owner/Operator

Finding: There is or are fixings missing on the item

Action: Replace all missing fixings

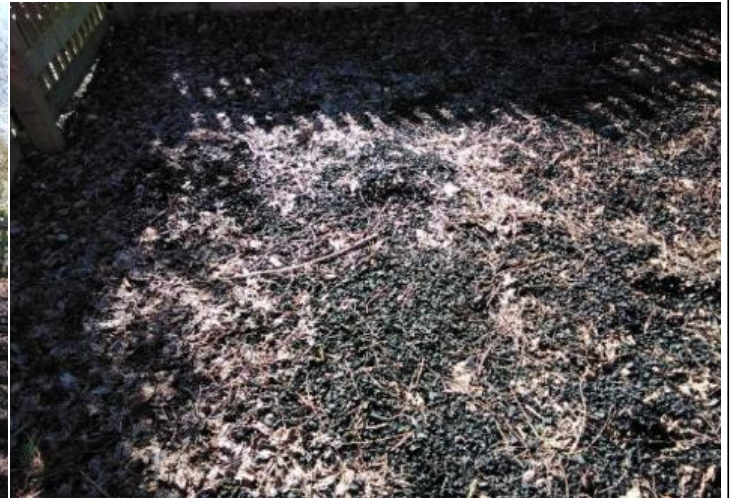
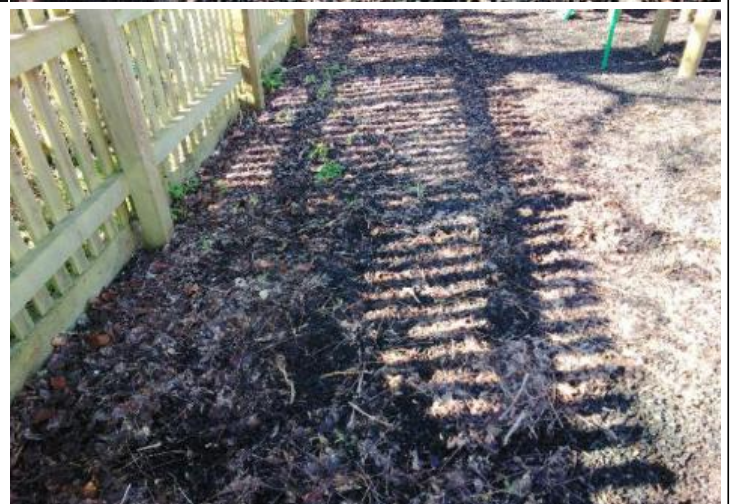
Item: Activity Equipment - Multi Play (Junior)
Manufacturer: A.E.Evans

Finding: There is some tree debris on the surfacing

Action: Remove and maintain

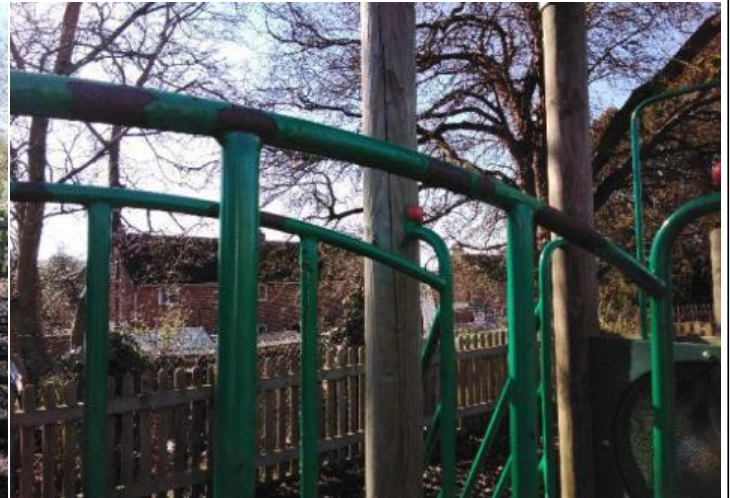
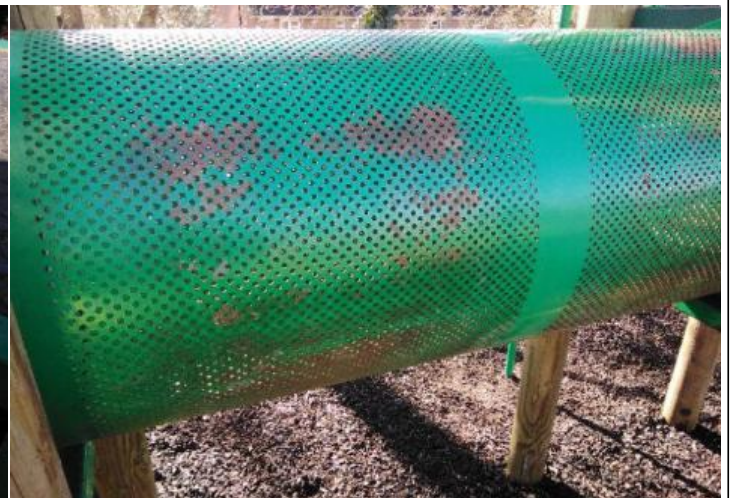
Item: Activity Equipment - Multi Play (Junior)
Manufacturer: A.E.Evans

Finding: The paintwork on this item has been damaged or worn exposing the metal underneath which is rusting

Action: Treat any rusting components and repaint

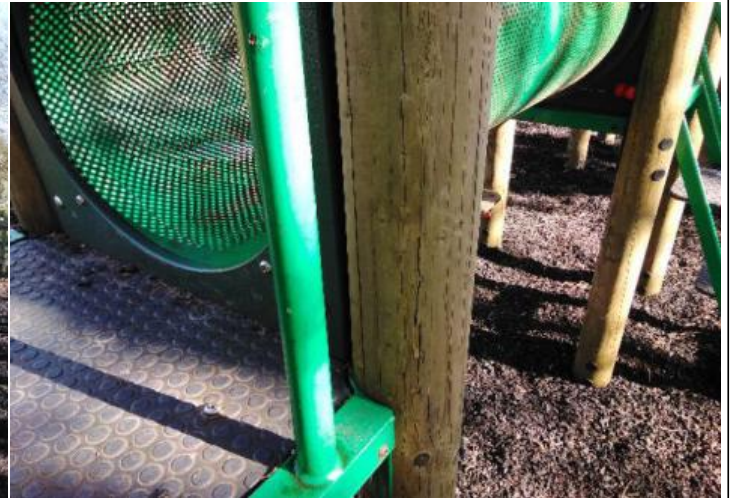
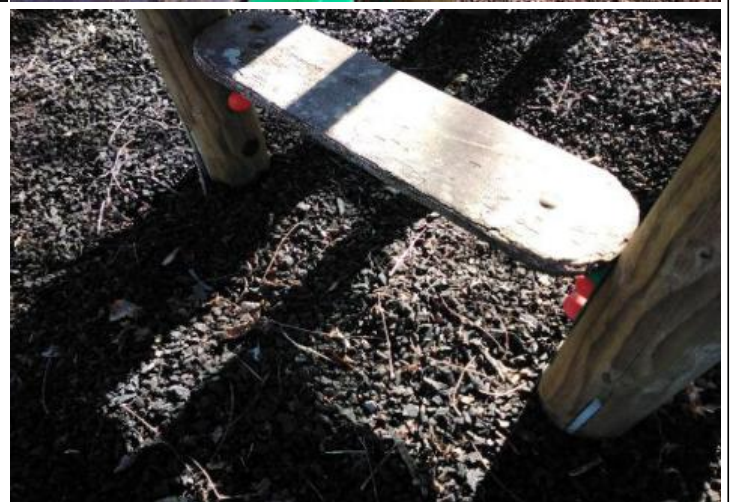
Item: Activity Equipment - Multi Play (Junior)
Manufacturer: A.E.Evans

Finding: Parts of the timber are rough or splintered

Action: Remove all rough or sharp edges

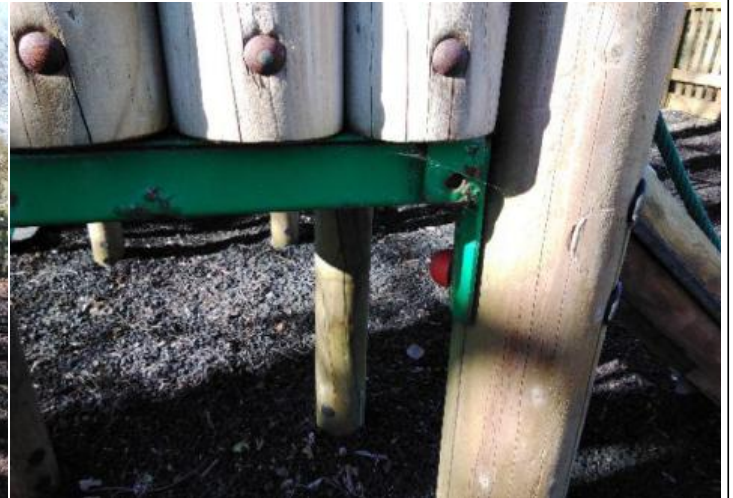
Item: Activity Equipment - Multi Play (Junior)
Manufacturer: A.E.Evans

Finding: There is or are fixings missing on the item

Action: Replace all missing fixings

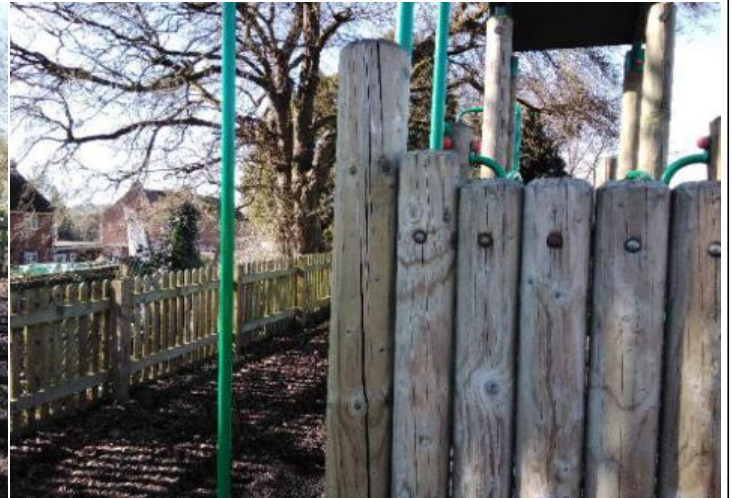
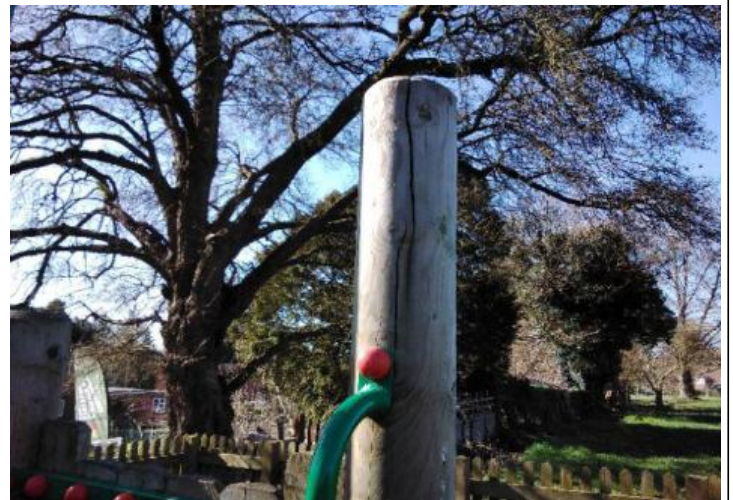
Item: Activity Equipment - Multi Play (Junior)
Manufacturer: A.E.Evans

Finding: The timber has a number of splits/shakes or air cracks and this may affect the stability or allow water ingress which will accelerate the rotting process

Action: Monitor to ensure the splits do not cross through fixing points of the structure and/or cause any instability

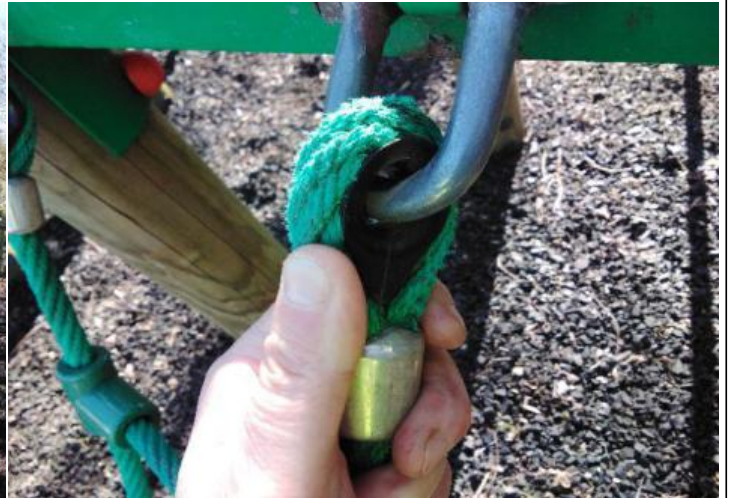
Item: Activity Equipment - Multi Play (Junior)
Manufacturer: A.E.Evans

Finding: There is some wear to the shackles

Action: Monitor for any further deterioration and replace when 40% worn

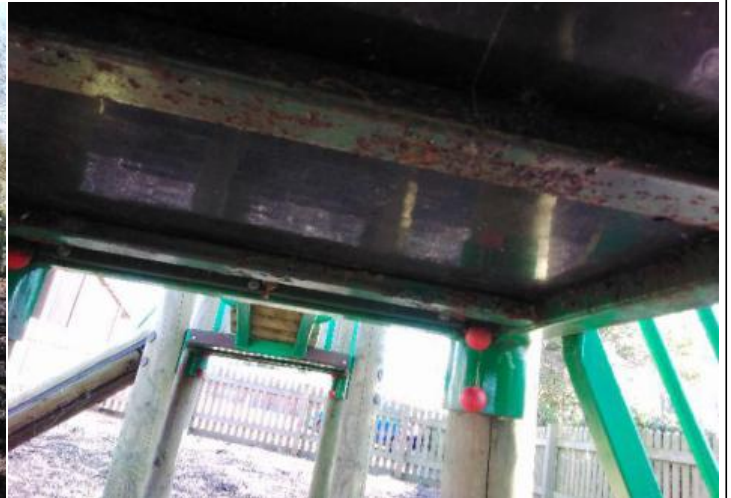
Item: Activity Equipment - Multi Play (Junior)
Manufacturer: A.E.Evans

Finding: There is surface corrosion present on the item

Action: Consider treating the item

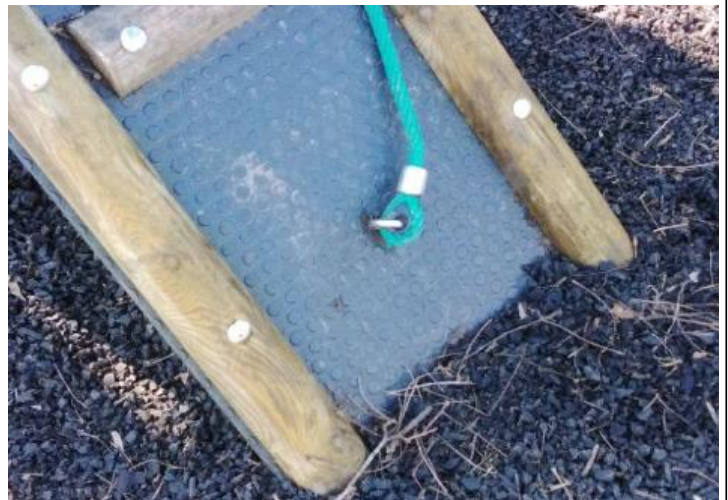
Item: Activity Equipment - Multi Play (Junior)
Manufacturer: A.E.Evans

Finding: The ropes/nets are worn/damaged in places

Action: Monitor for any further deterioration and repair or replace as required

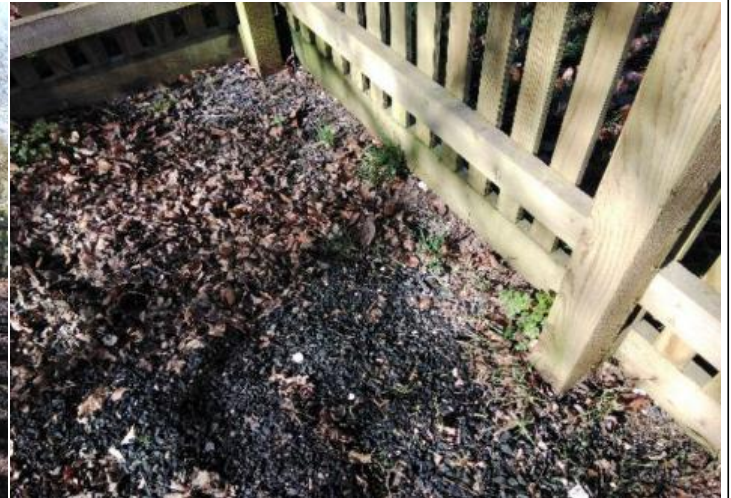
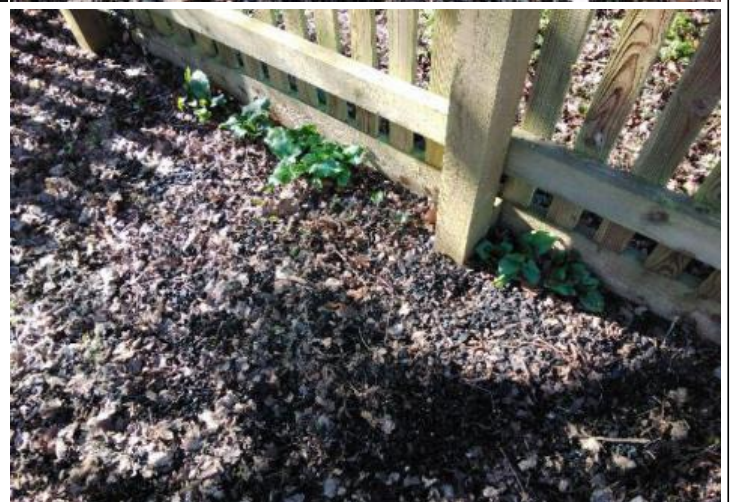
Item: Activity Equipment - Multi Play (Junior)
Manufacturer: A.E.Evans

Finding: There is weed / vegetation growth on, between, or around the edges of the surfacing
Action: Remove weed / vegetation growth

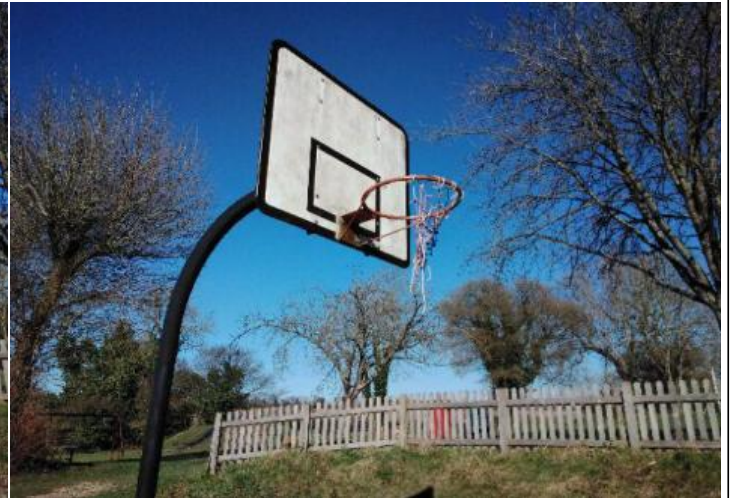
Item: Multi Use Games Area - Basketball Post
Manufacturer: Not Identified

Finding: The net has been damaged

Action: Replace the net

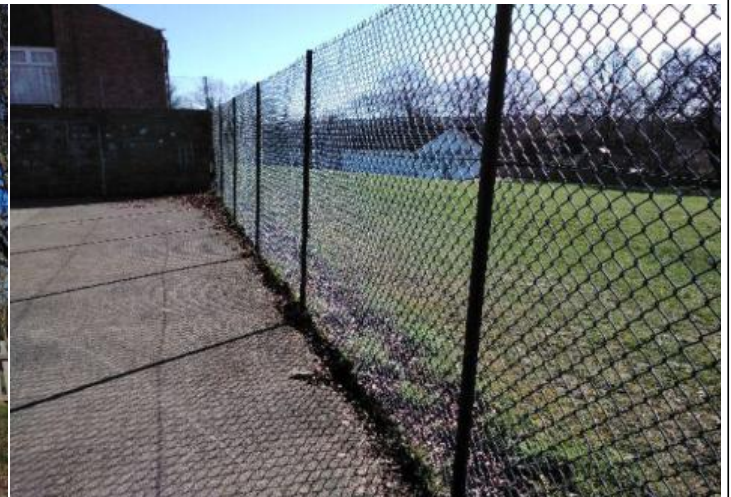
Item: Multi Use Games Area - Basketball Post
Manufacturer: Not Identified

Finding: There are a number of loose posts around the fence

Action: Monitor for any further deterioration and reset as required

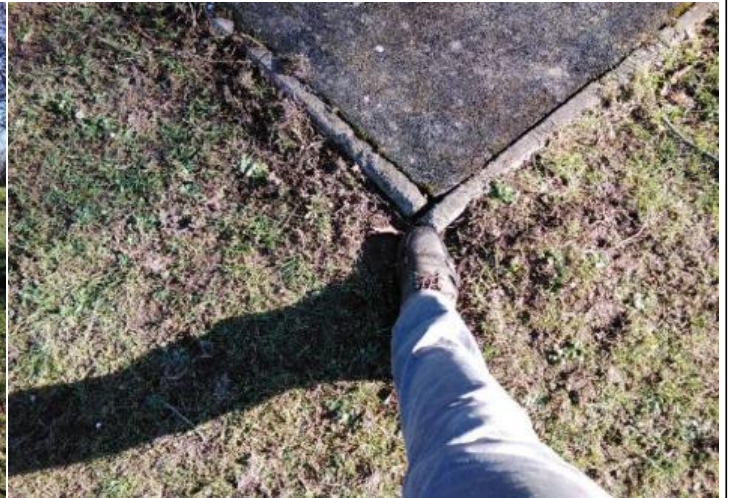
Item: Swings - 1 Bay 2 Seat (Cradle)
Manufacturer: Wicksteed Playgrounds

Finding: There are trip hazards at the edges of the surface

Action: Reinststate surrounding surface levels to remove the trip points

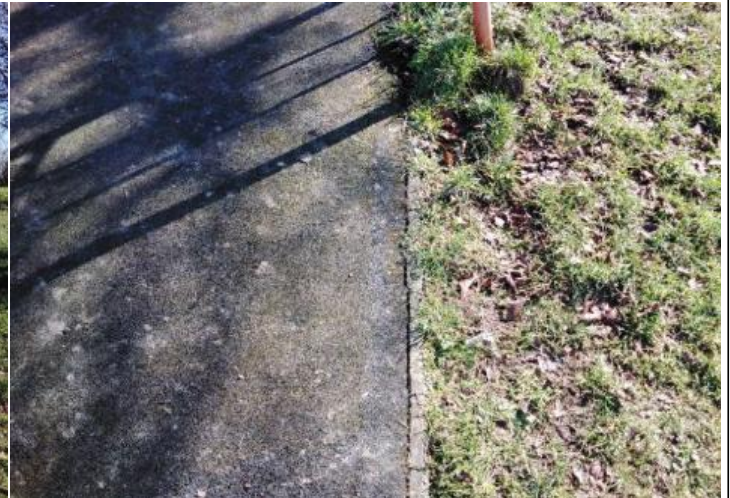
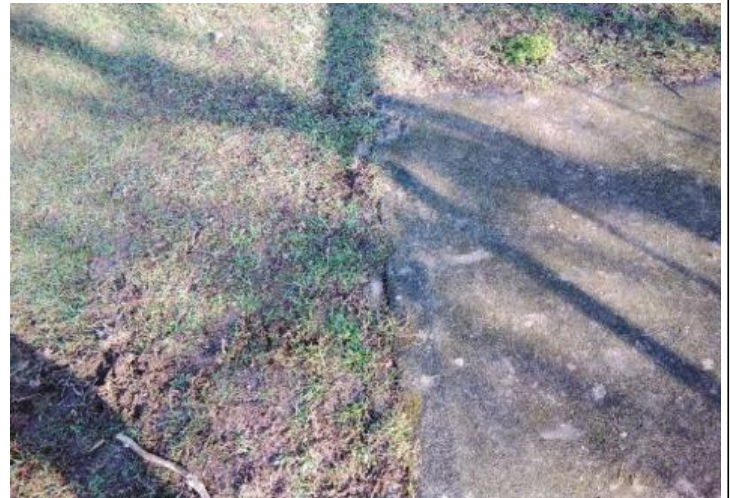
Item: Swings - 1 Bay 2 Seat (Cradle)
Manufacturer: Wicksteed Playgrounds

Finding: There are gaps opening between the surfacing and the edging surround or between the joints in the surfacing
Action: Monitor for any further deterioration and repair as required

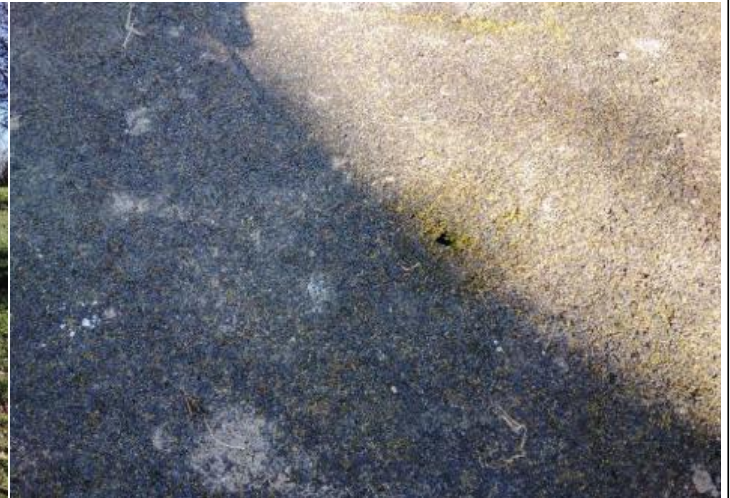
Item: Swings - 1 Bay 2 Seat (Cradle)
Manufacturer: Wicksteed Playgrounds

Finding: The safety surface under or around this unit has been damaged

Action: Monitor for any further deterioration and repair as required

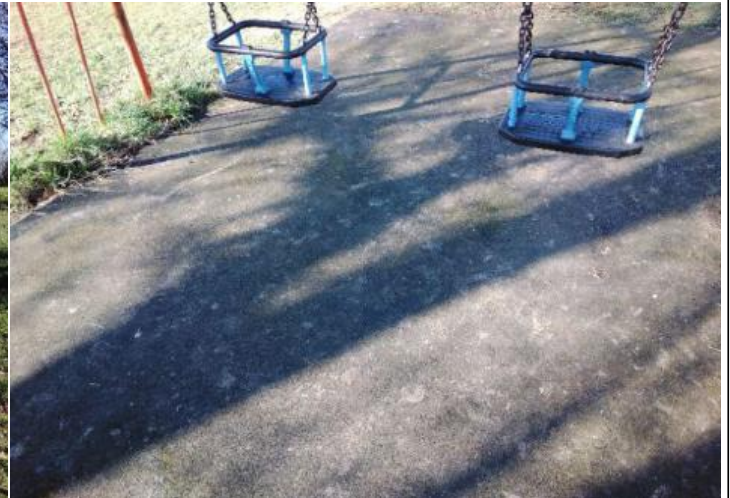
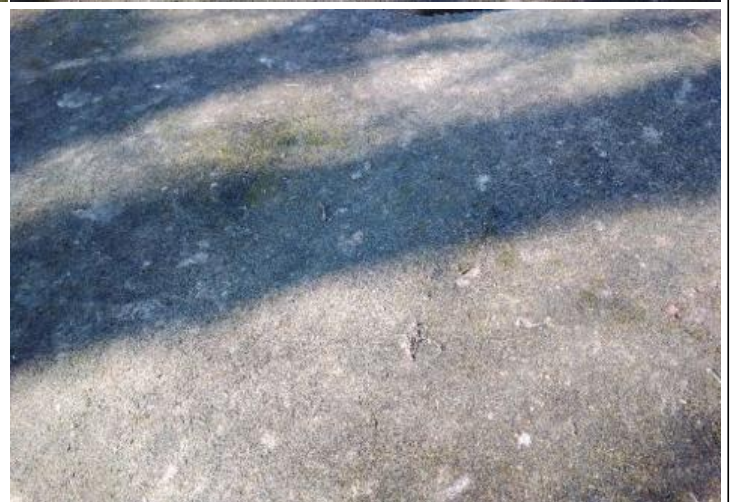
Item: Swings - 1 Bay 2 Seat (Cradle)
Manufacturer: Wicksteed Playgrounds

Finding: The safety surface around the area is beginning to wear

Action: Monitor for any further deterioration and repair as required

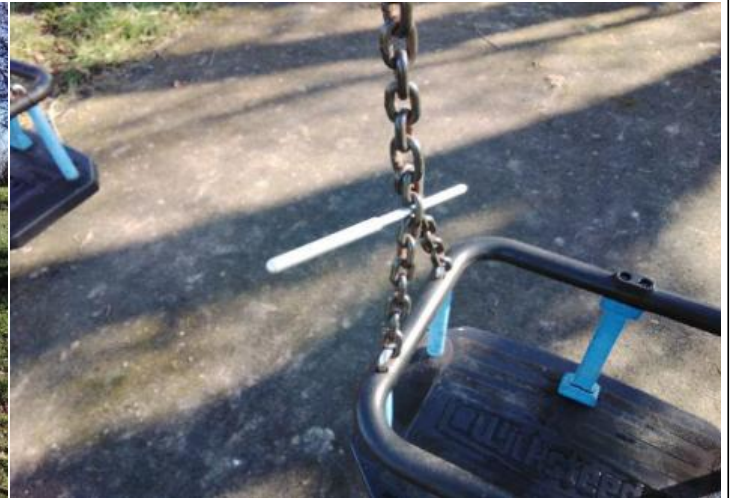
Item: Swings - 1 Bay 2 Seat (Cradle)
Manufacturer: Wicksteed Playgrounds

Finding: The chain openings are in excess of the 8.6mm as recommended by BS EN 1176 **Action:** Monitor - No remedial work recommended

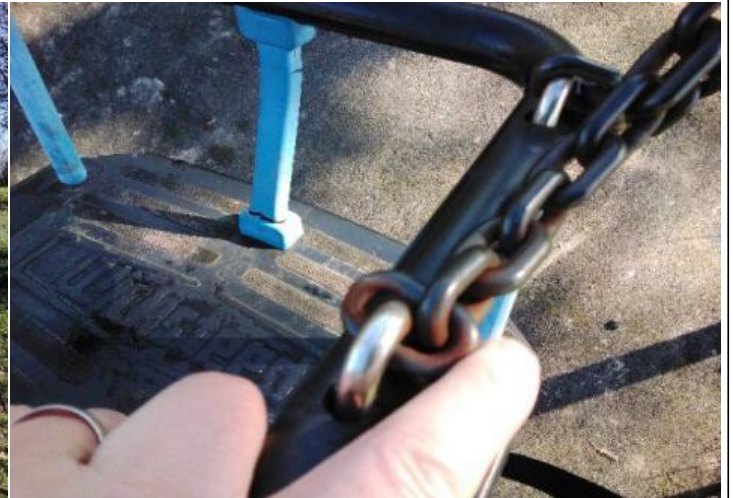
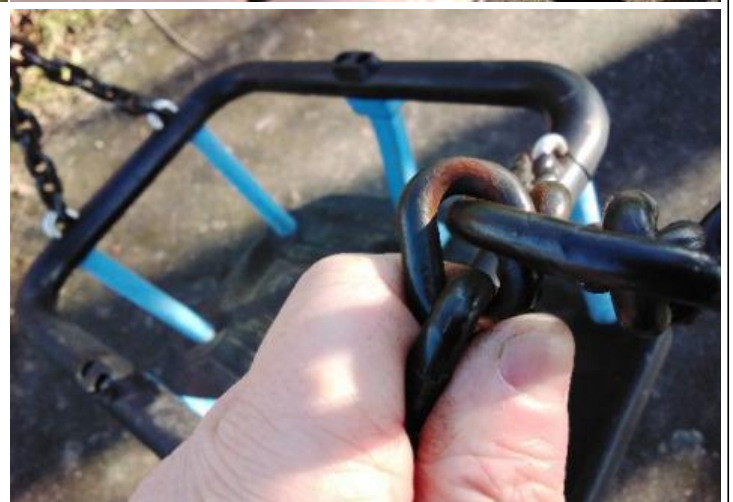
Item: Swings - 1 Bay 2 Seat (Cradle)
Manufacturer: Wicksteed Playgrounds

Finding: There is some notable evidence of chain wear

Action: Monitor for any further deterioration and replace when 40% worn

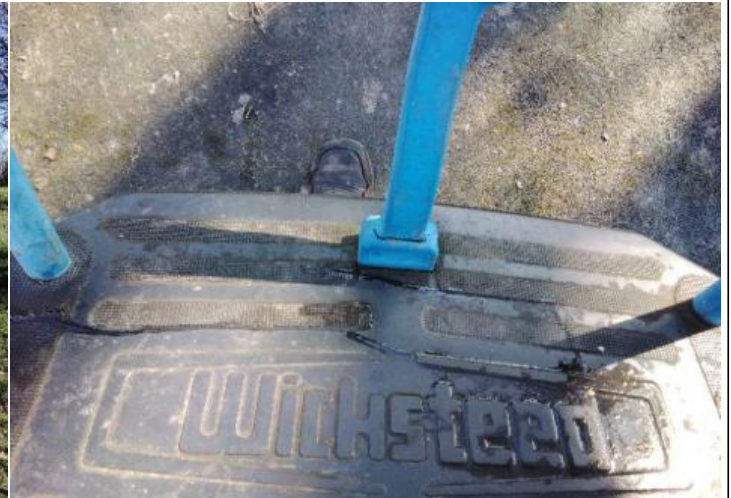
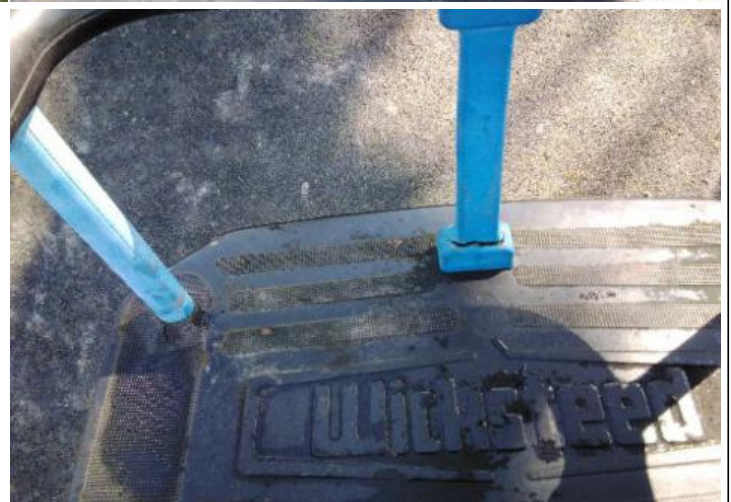
Item: Swings - 1 Bay 2 Seat (Cradle)
Manufacturer: Wicksteed Playgrounds

Finding: The seat has minor damage or wear

Action: Monitor for any further deterioration and replace as required

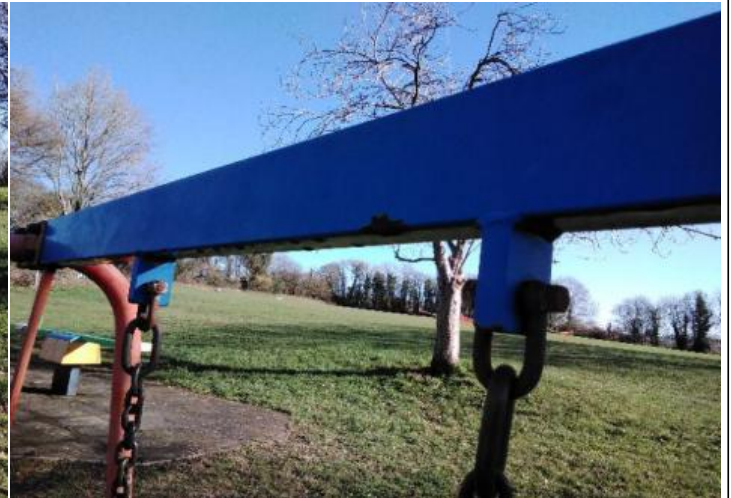
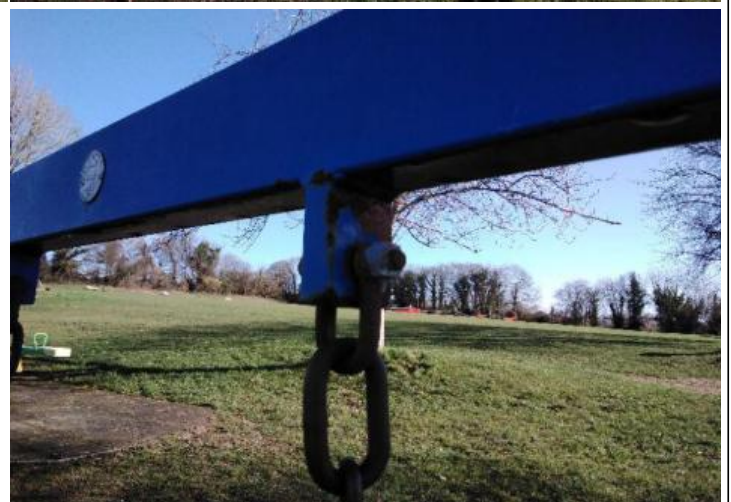
Item: Swings - 1 Bay 2 Seat (Cradle)
Manufacturer: Wicksteed Playgrounds

Finding: The paintwork on this item has been damaged or worn exposing the metal underneath which is rusting

Action: Treat any rusting components and repaint

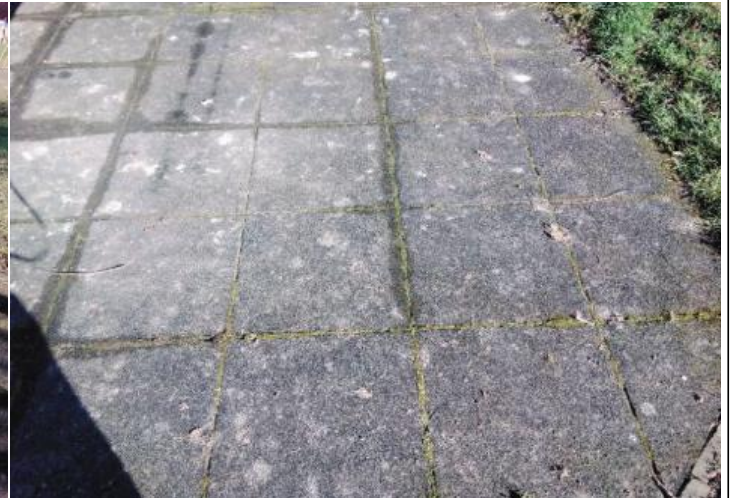
Item: Rocking Equipment - See Saw
Manufacturer: Wicksteed Playgrounds

Finding: There are gaps opening in between the tiles

Action: Monitor for any further deterioration and repair as required

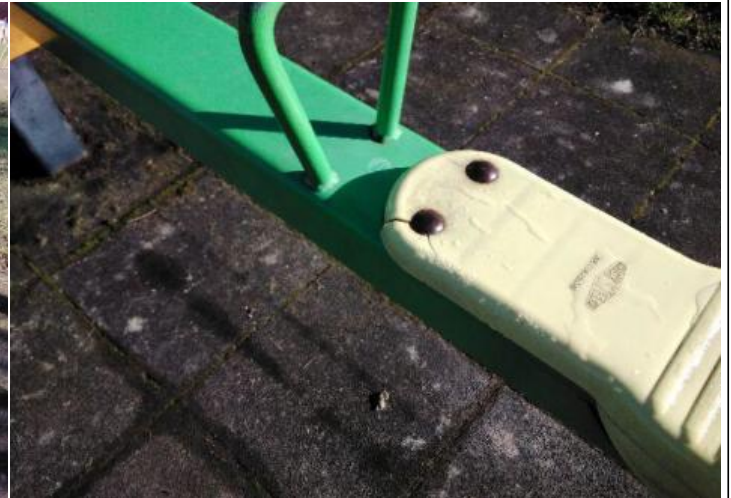
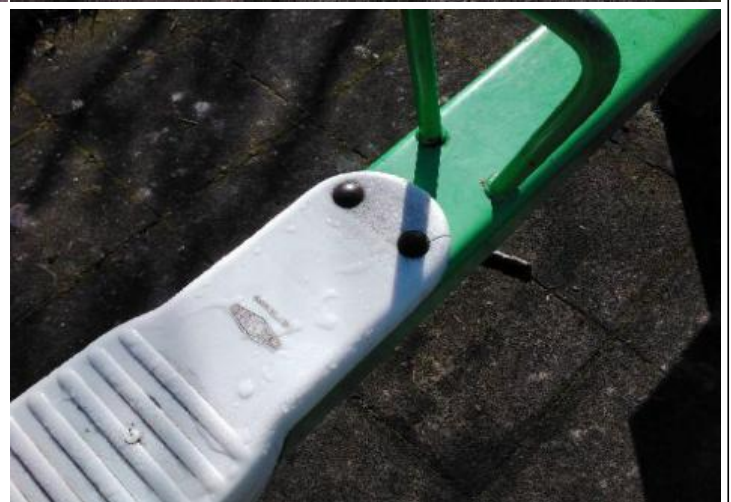
Finding: The item has been damaged

Action: Monitor for any further deterioration and replace as required

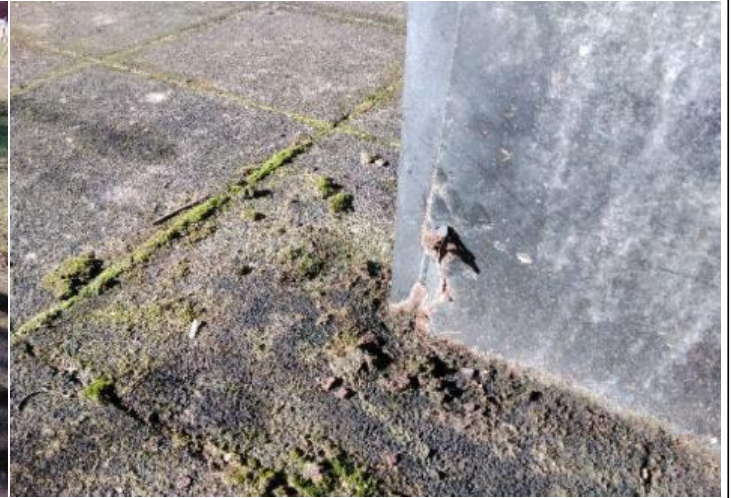
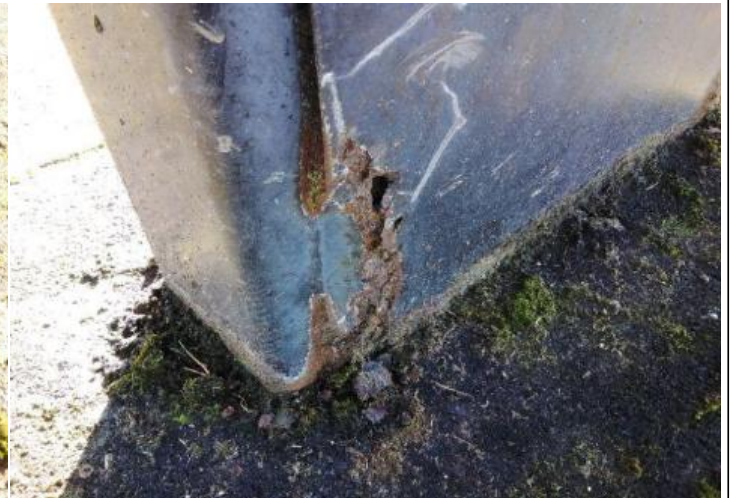
Finding: Parts of the steel on this item have corroded excessively and the metal has perforated in places

Action: Ensure all affected areas are treated and repaired

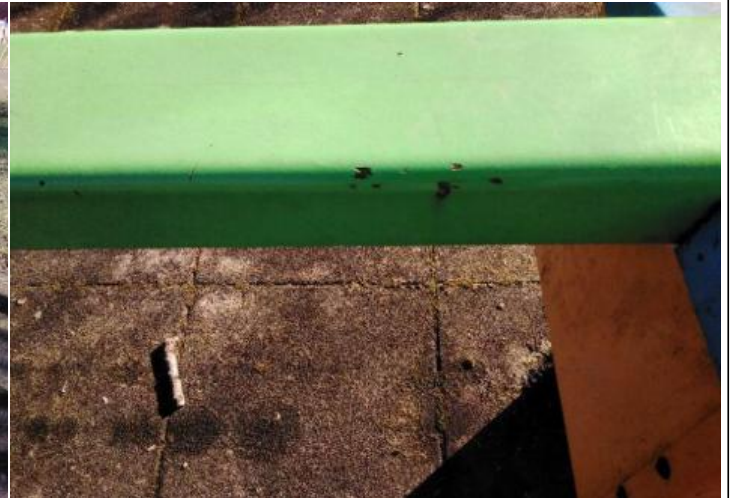
Finding: The paintwork on this item has been damaged or worn exposing the metal underneath which is rusting

Action: Treat any rusting components and repaint

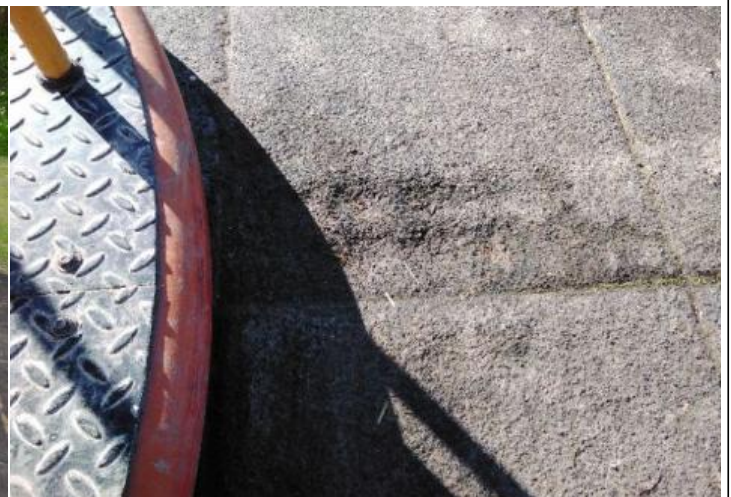
Finding: The safety surface around the area is beginning to wear

Action: Monitor for any further deterioration and repair as required

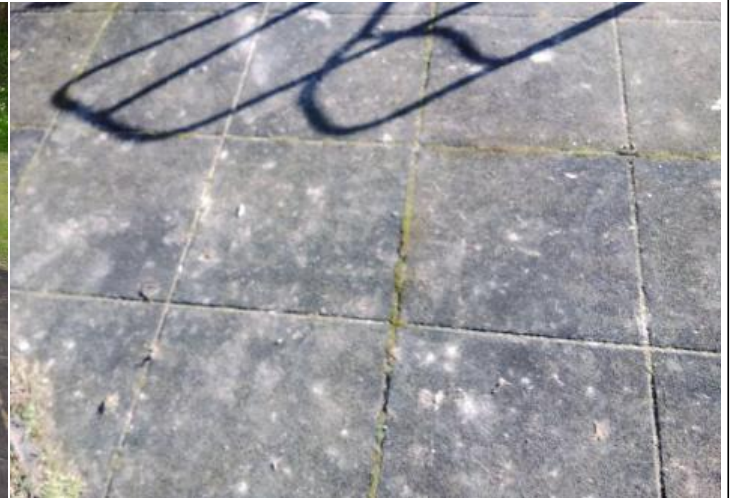
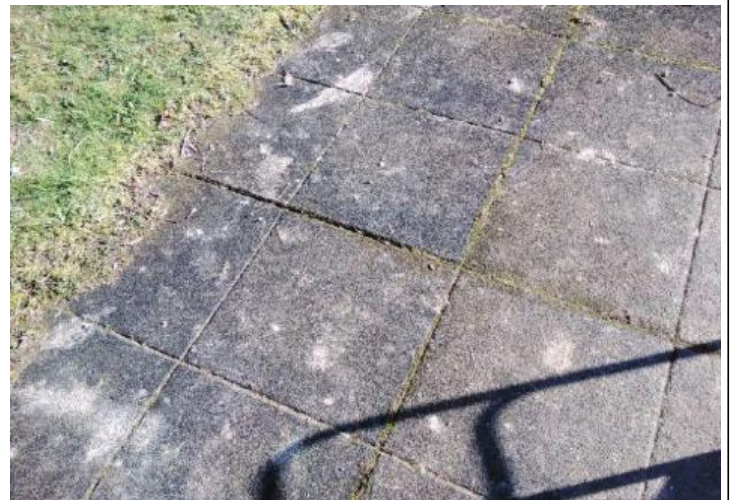
Finding: There are gaps opening in between the tiles

Action: Monitor for any further deterioration and repair as required

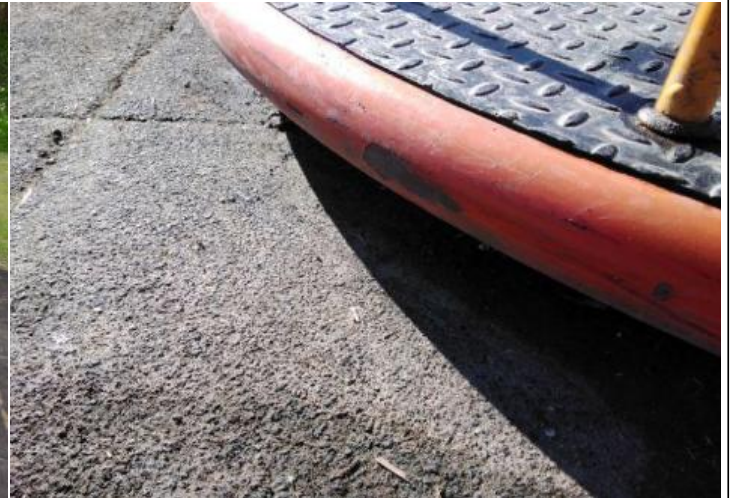
Finding: The paintwork on this item has been damaged or worn exposing the metal underneath which is rusting

Action: Treat any rusting components and repaint

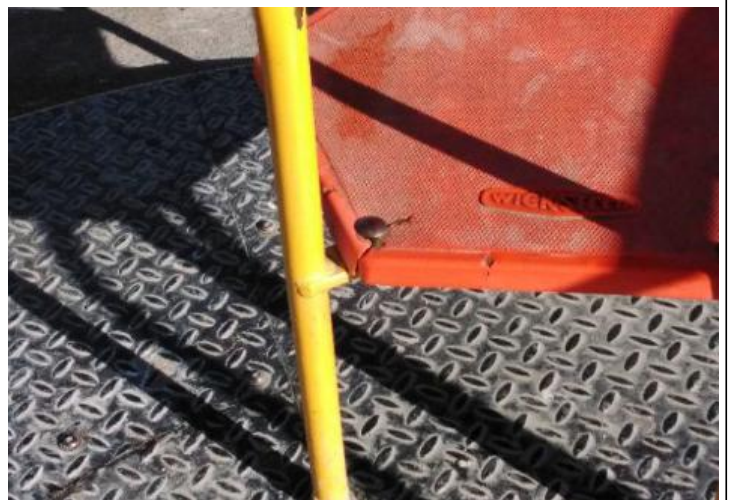
Finding: The item has been damaged

Action: Monitor for any further deterioration and replace as required

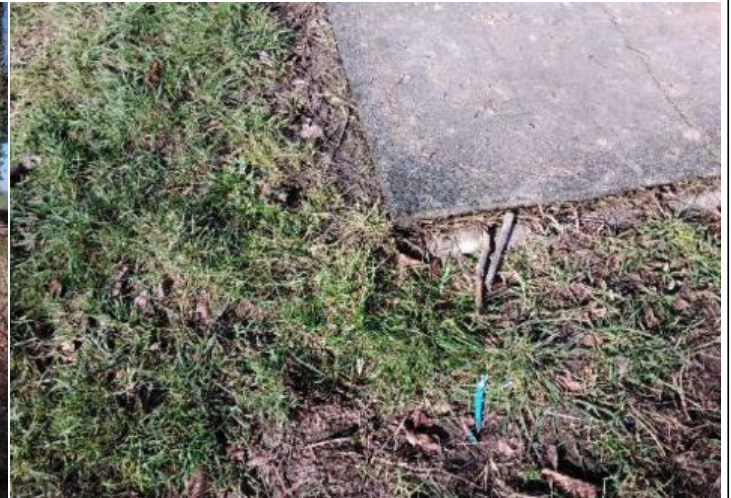
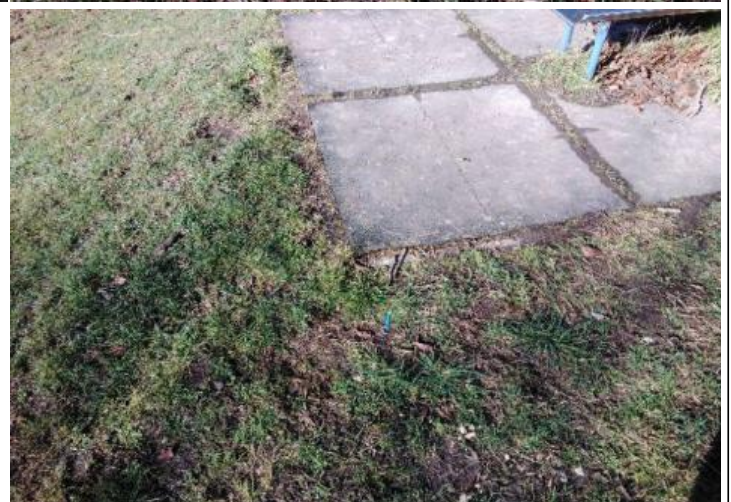
Finding: The surface is lifting at the edges and creating trip points
Action: Repair perimeter of surfacing to remove trip points

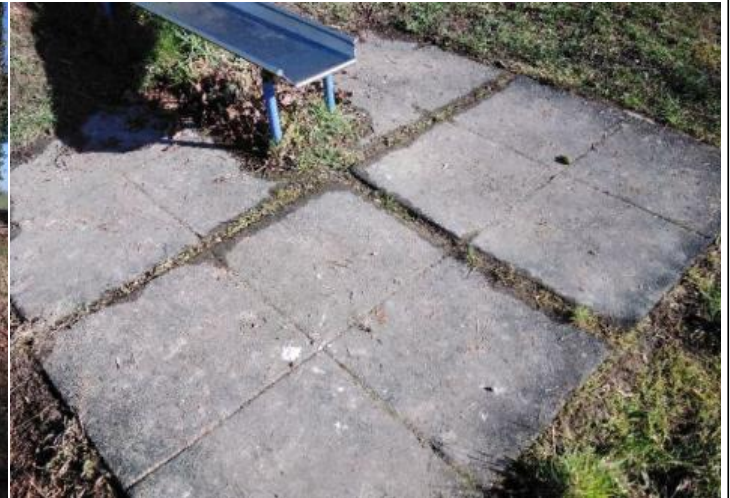
Finding: There are gaps opening in between the tiles

Action: Monitor for any further deterioration and repair as required

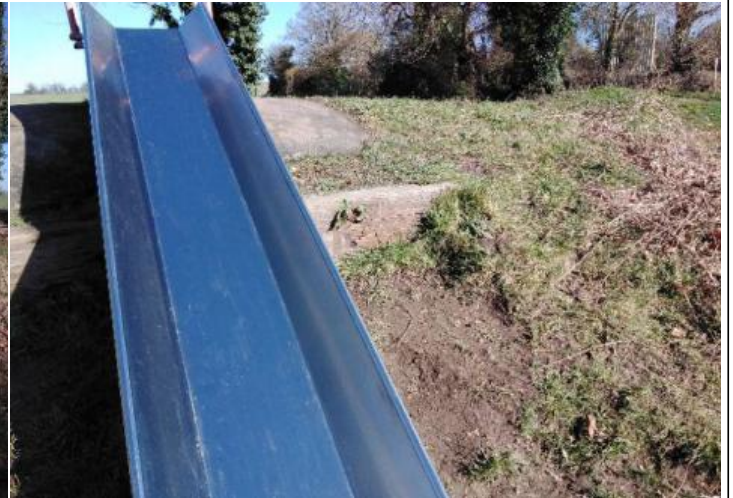
Finding: The timber sleeper forms a hard object within the impact area of the equipment in contravention of the requirements of BS EN 1176 Part 1

Action: Monitor - No remedial work recommended

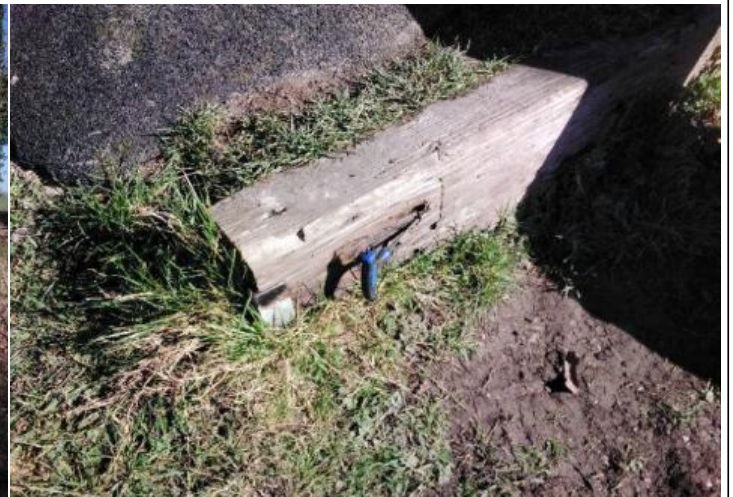
Finding: There is some evidence of rot in the timber sleeper

Action: Monitor for any further deterioration and replace as required

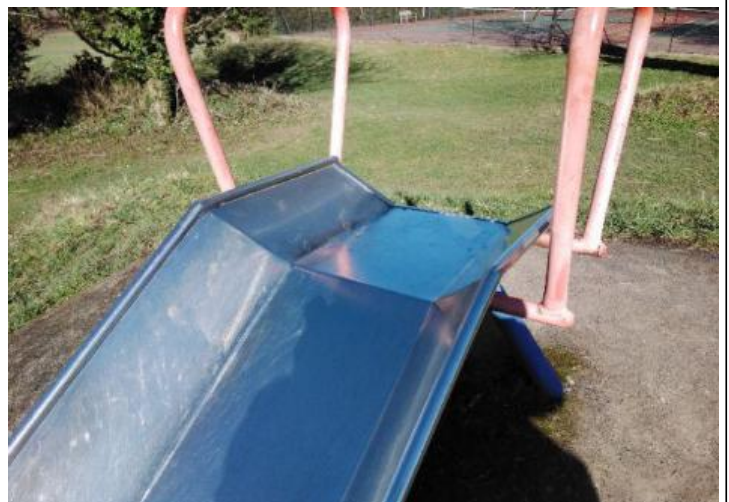
Finding: The slide start section incline is not in the direction of travel; it should slope towards the direction of the sliding surface to meet the requirements of BS EN 1176 Part 3

Action: Monitor - No remedial work recommended

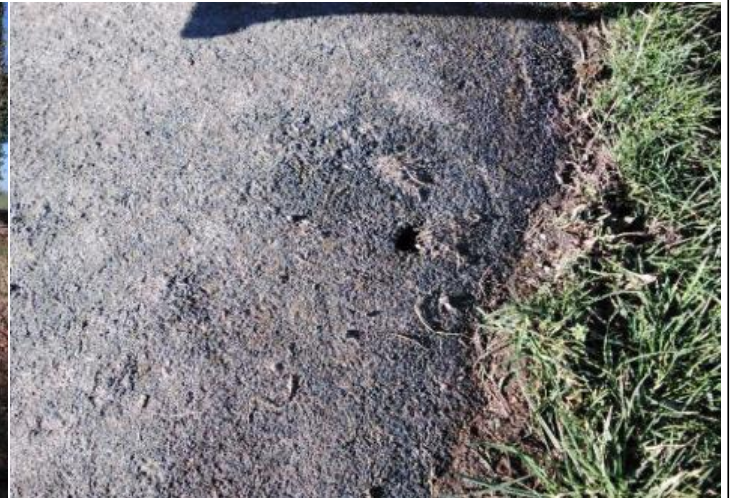
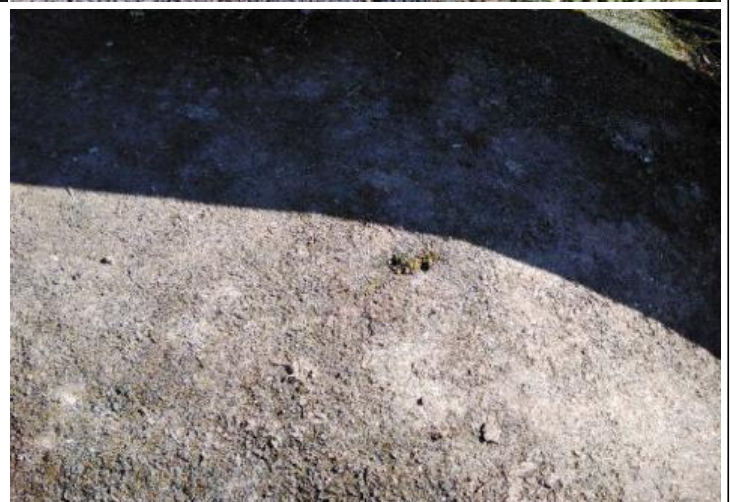
Finding: The safety surface under or around this unit has been damaged

Action: Monitor for any further deterioration and repair as required

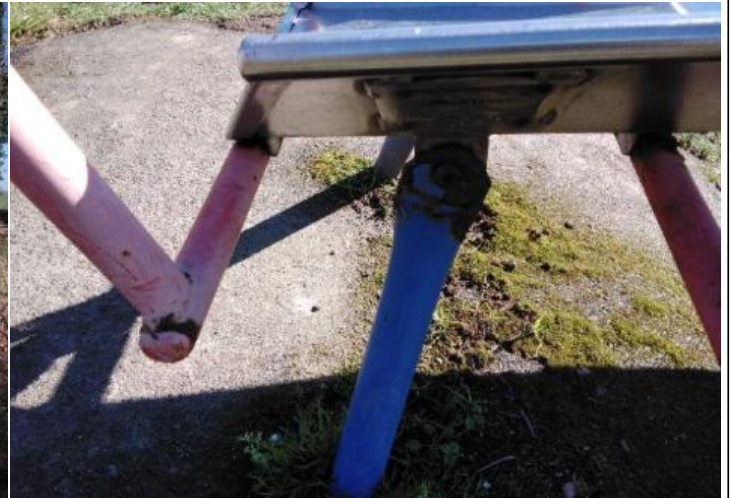
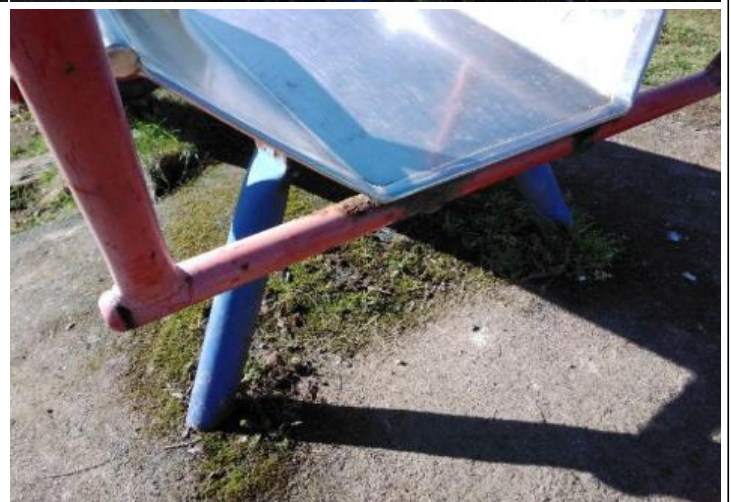
Finding: The paintwork on this item has been damaged or worn exposing the metal underneath which is rusting

Action: Treat any rusting components and repaint

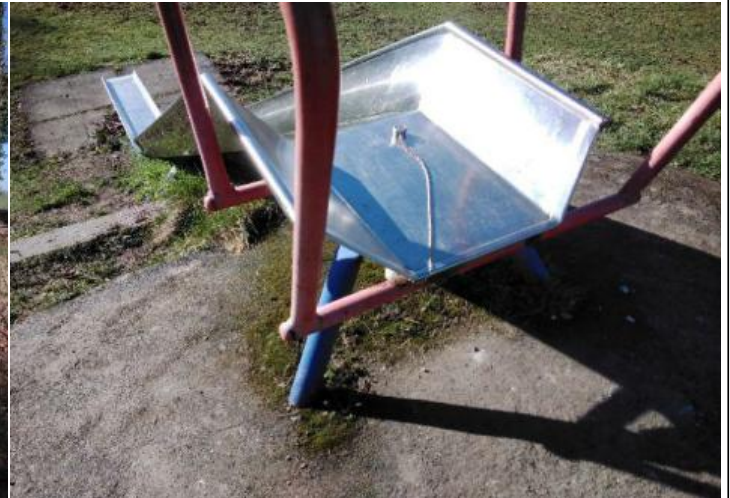
Finding: There is / are toggle entrapment/s present in contravention of the recommendations set out in BS EN 1176 Part 3

Action: Monitor - no remedial work recommended

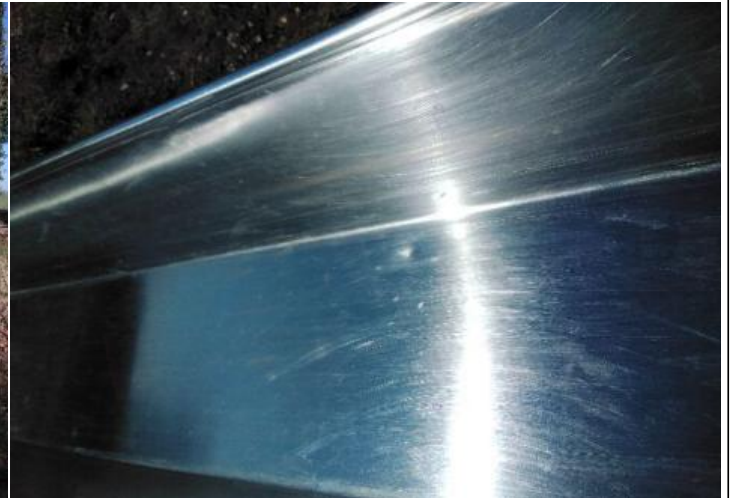
Finding: There are a number of dents in the slide surface

Action: Monitor for any further deterioration and repair as required

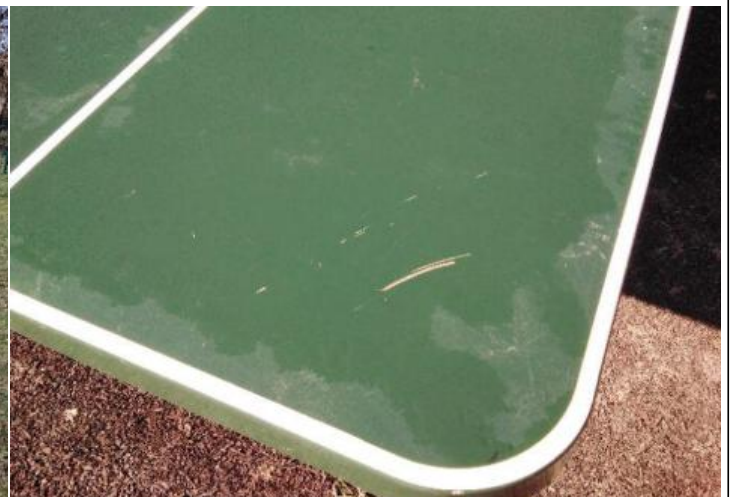
Item: Other - Table Tennis
Manufacturer: HeBlad

Finding: The item has been damaged

Action: Monitor for any further deterioration and replace as required

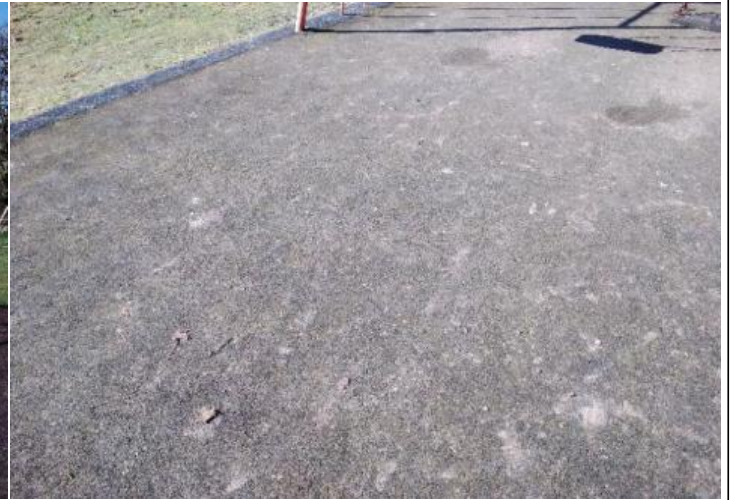
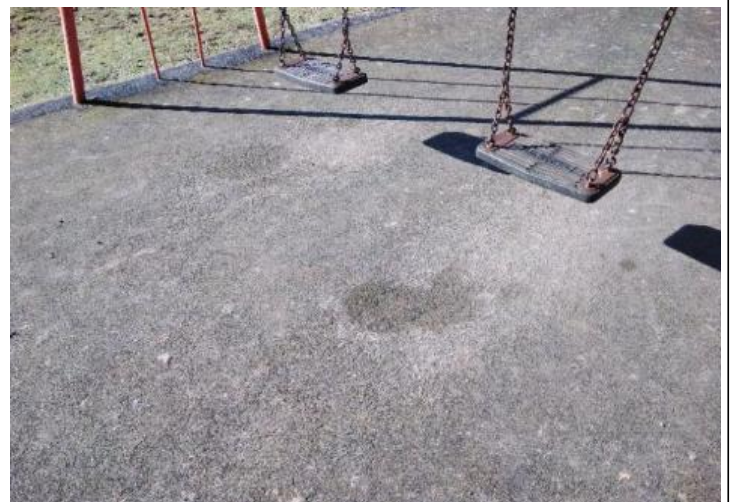
Finding: The safety surface around the area is beginning to wear

Action: Monitor for any further deterioration and repair as required
