the **play inspection** company

Annual Inspection

West Meon Village Hall RG (West Meon PC)

Headon View, West Meon, Hampshire, GU32 1LH

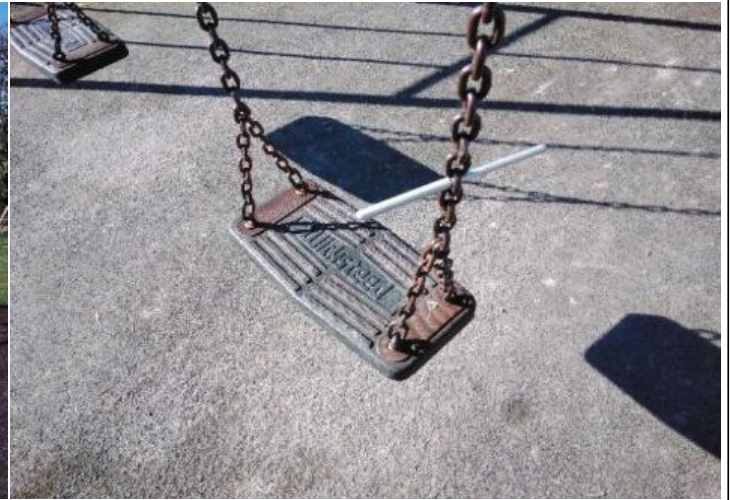
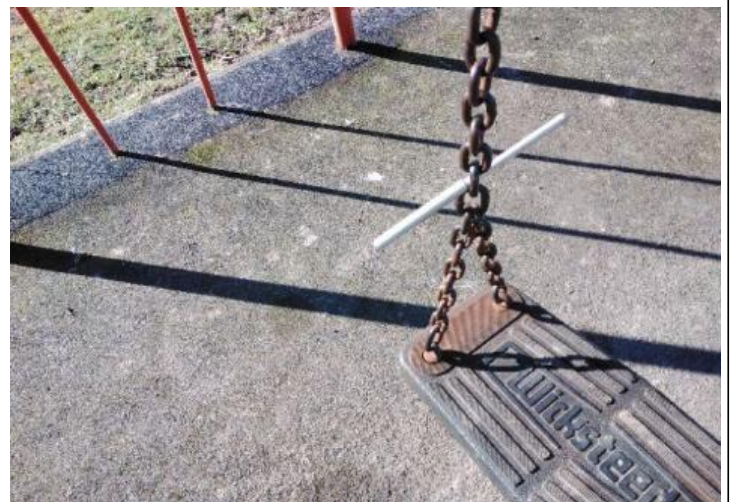
Finding: The chain openings are in excess of the 8.6mm as recommended by BS EN 1176 **Action:** Monitor - No remedial work recommended

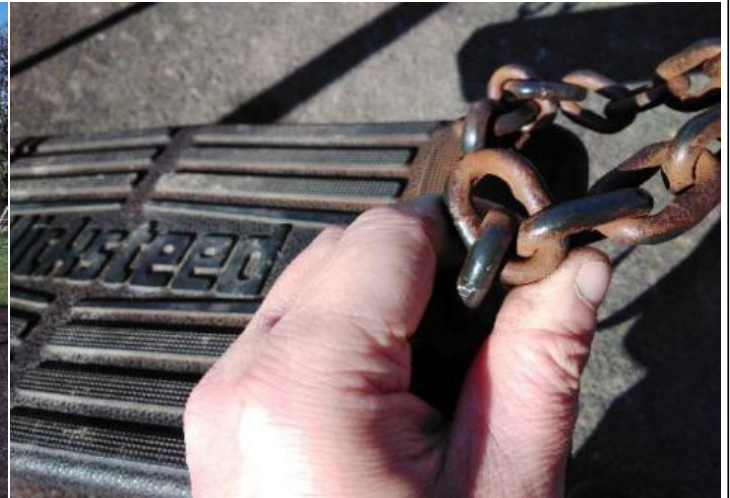
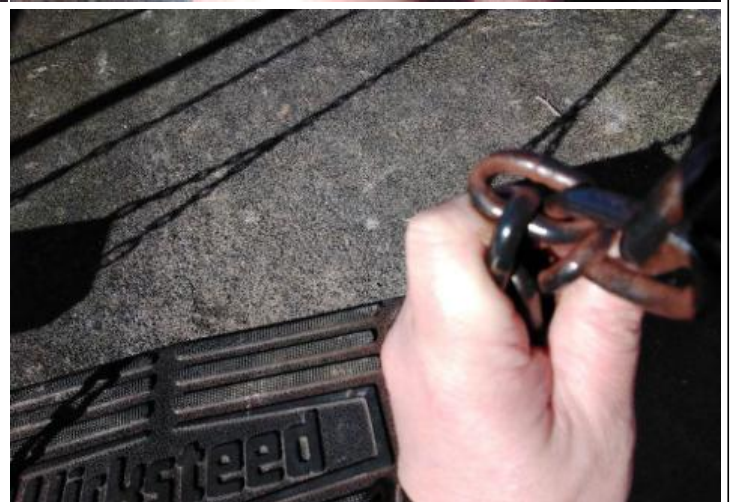
Finding: There is some notable evidence of chain wear

Action: Monitor for any further deterioration and replace when 40% worn

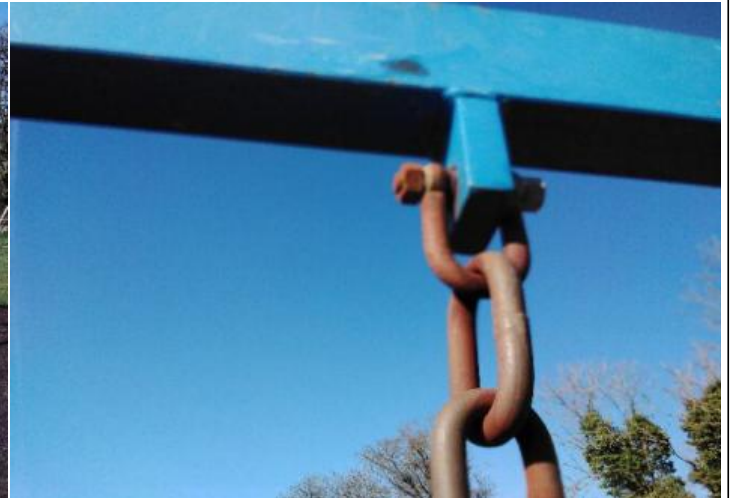
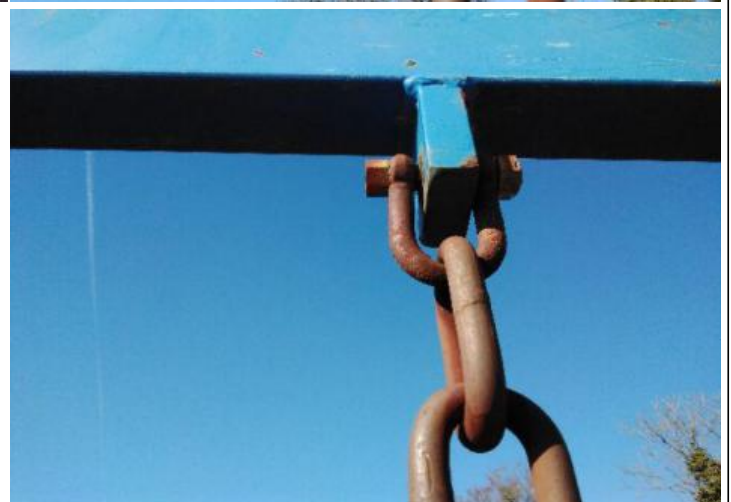
Finding: The bushes are showing signs of wear

Action: Monitor for any further deterioration and replace as required

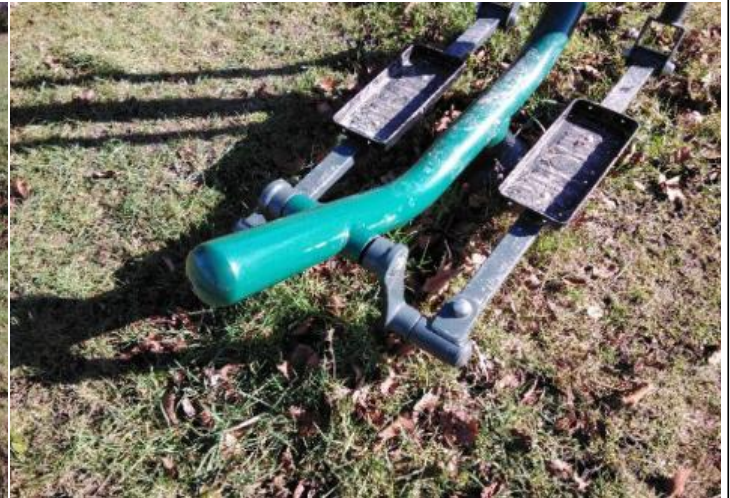
Finding: The bearing is not operating correctly

Action: Replace the bearing as required

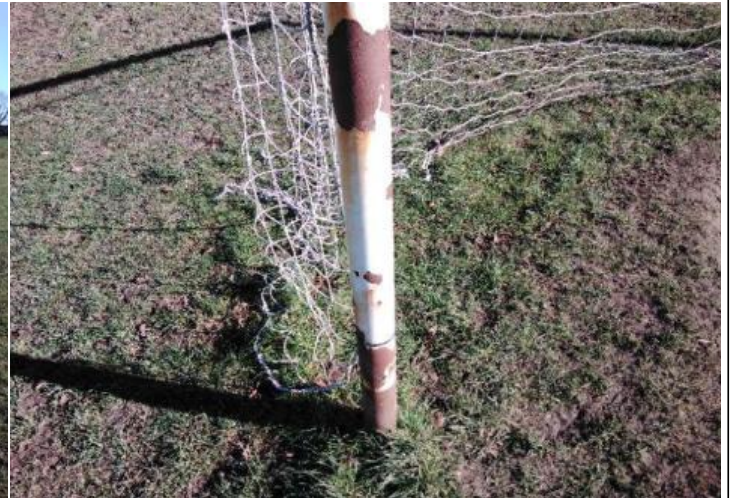
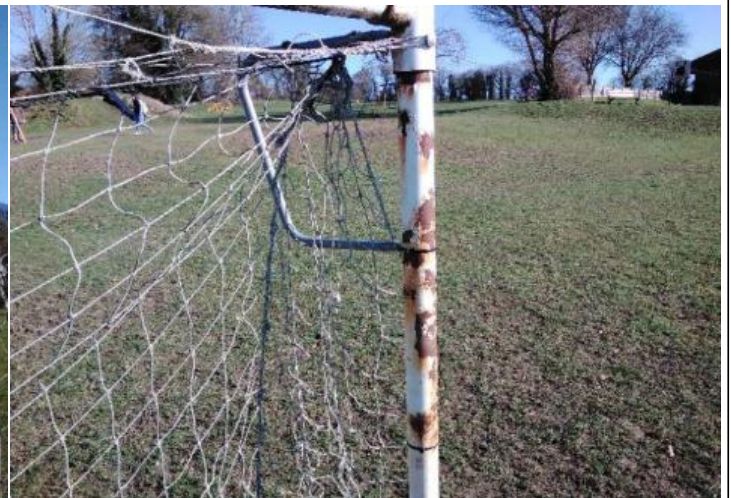
Finding: The paintwork on this item has been damaged or worn exposing the metal underneath which is rusting

Action: Treat any rusting components and repaint

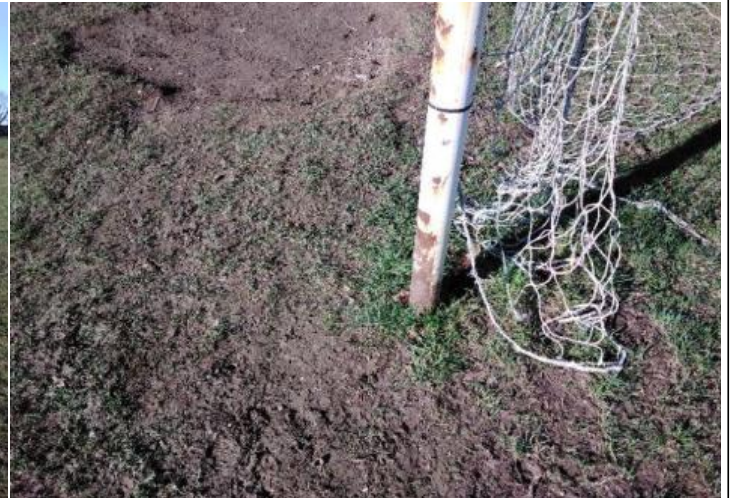
Finding: The goal posts are slightly loose in its foundations

Action: Monitor for any further deterioration and repair as required

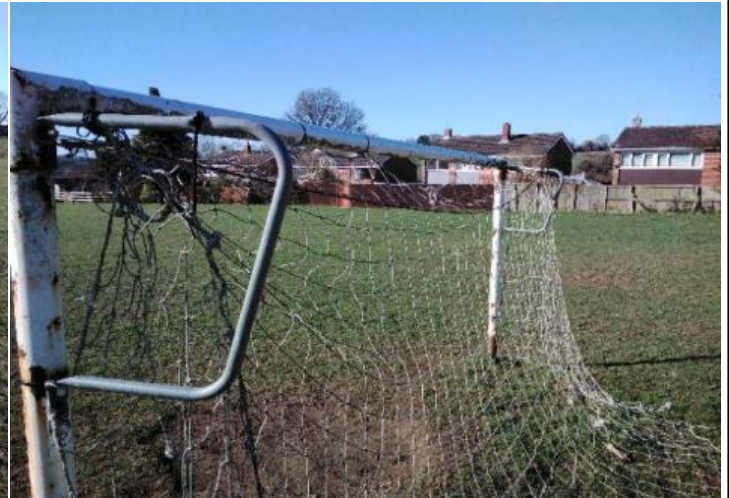
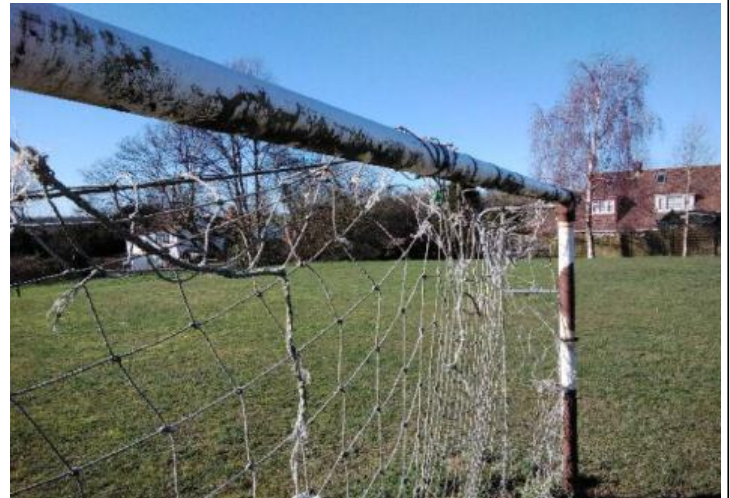
Finding: The goal nets are damaged

Action: Repair or replace as required

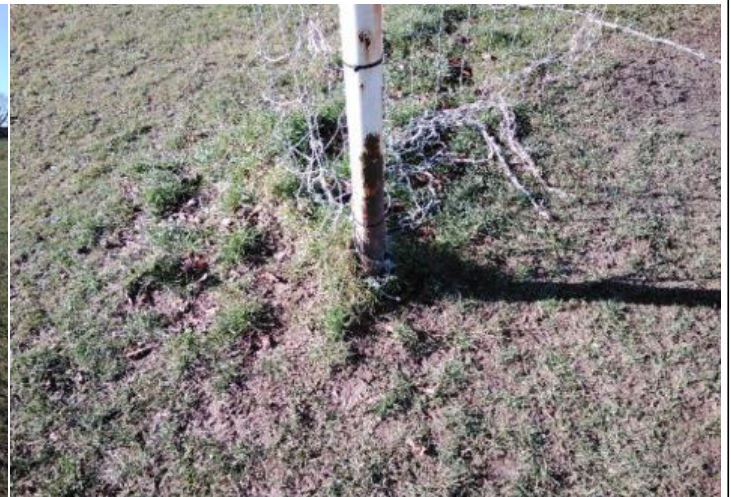
Item: Multi Use Games Area - Football Goal
Manufacturer: Not Identified
Risk Level: L - Low Risk
Surface: Grass

Finding: The goals are not secured in position

Action: Refer to manufacturer recommendations and secure as required
