Annual Inspection

Winchester City Council

Meonwara PA (West Meon PC)

Inspection Ref: 1300377

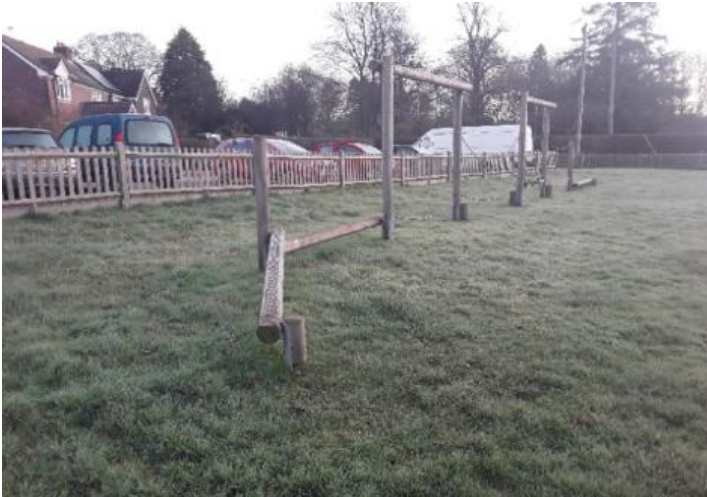
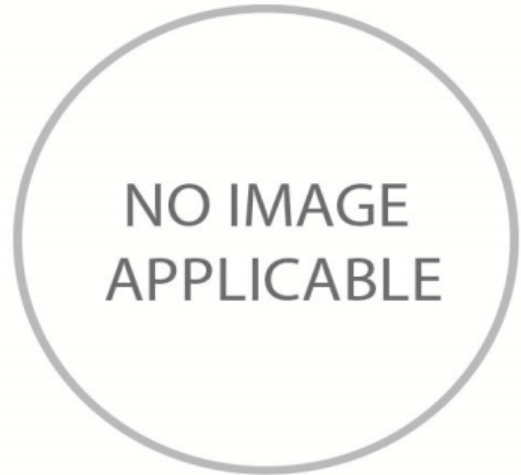
5 - Very Low Risk (Finding 1)

Finding: It is recommended that signage, with information including the site address, contact information for maintenance issues and emergency contact details are provided for the facility

Action: Provide in accordance with the recommendations

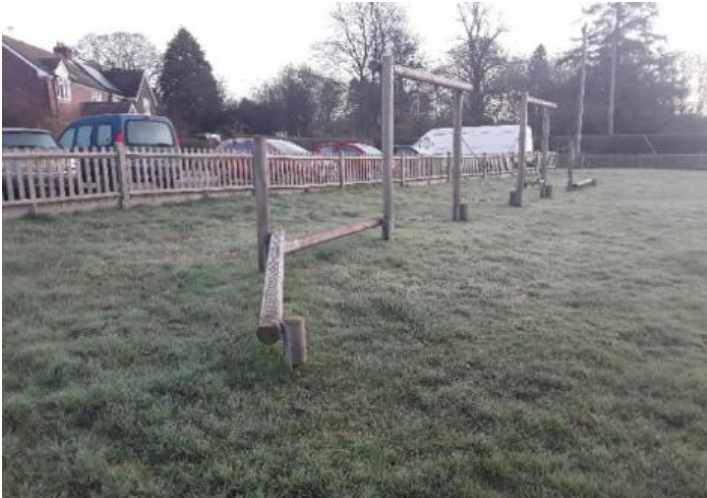
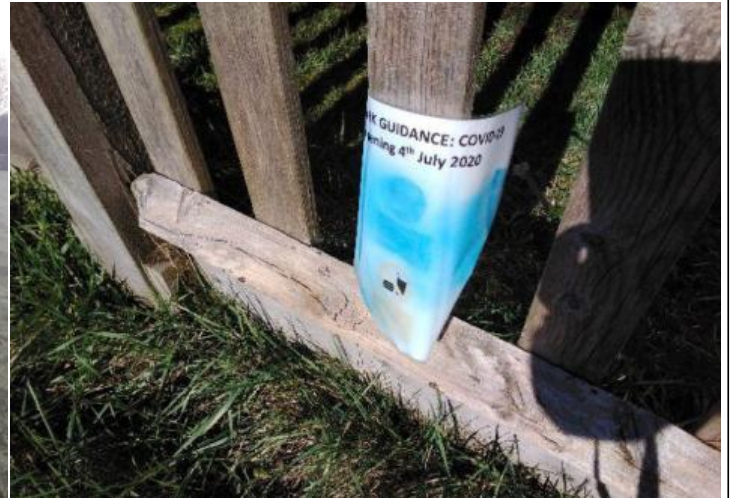
i 0 - Risk Assessment not Undertaken (Finding 2)

Finding: The site is accessible to the public during the COVID 19 pandemic. The government have released guidelines for safely re-opening these types of facilities which is available on the government website.

Action: Ensure there is an appropriate risk assessment in place and review regularly

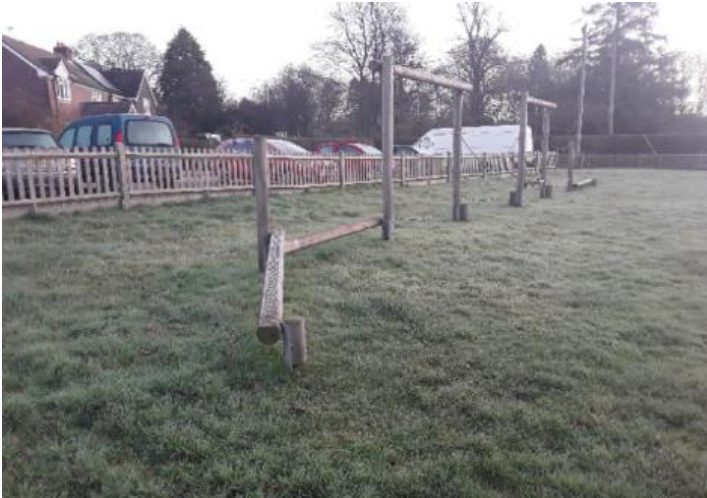
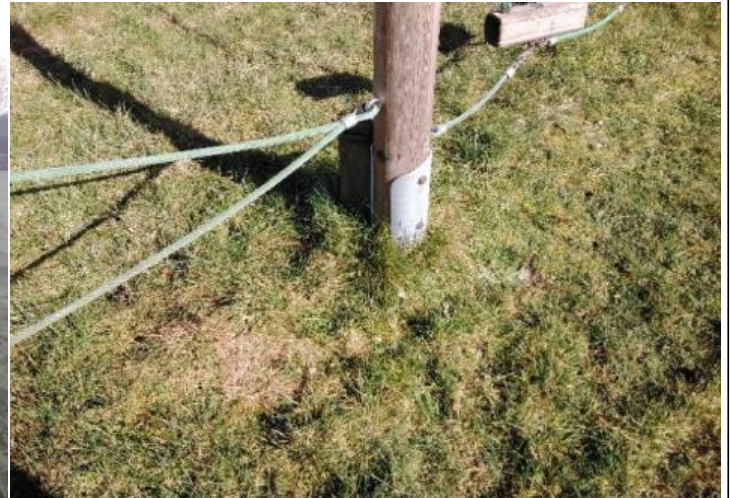
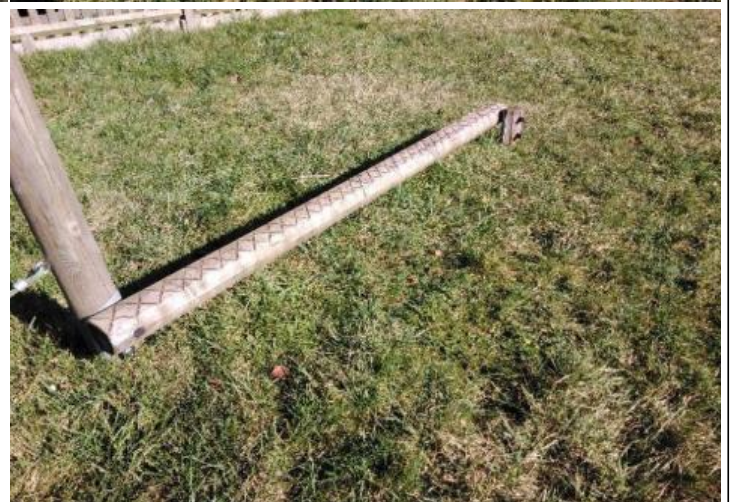
i 6 - Low Risk (Finding 3)

The grass is overgrown within the play area and may hide hazards - Reduce the length of grass to an acceptable height and maintain

Finding: The grass is overgrown within the play area and may hide hazards

Action: Reduce the length of grass to an acceptable height and maintain

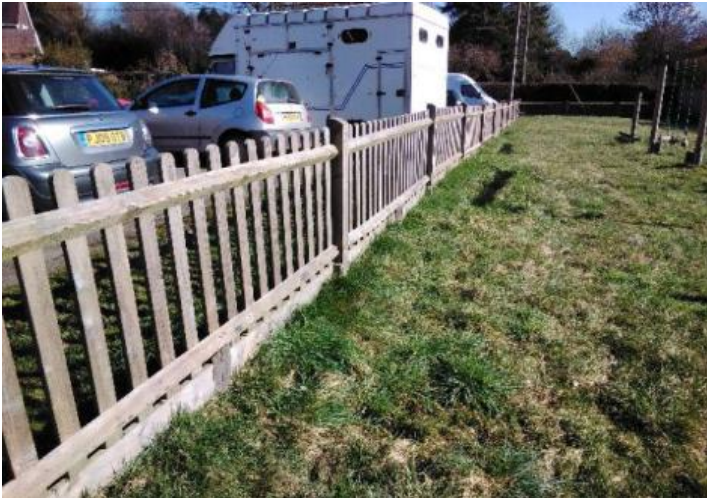
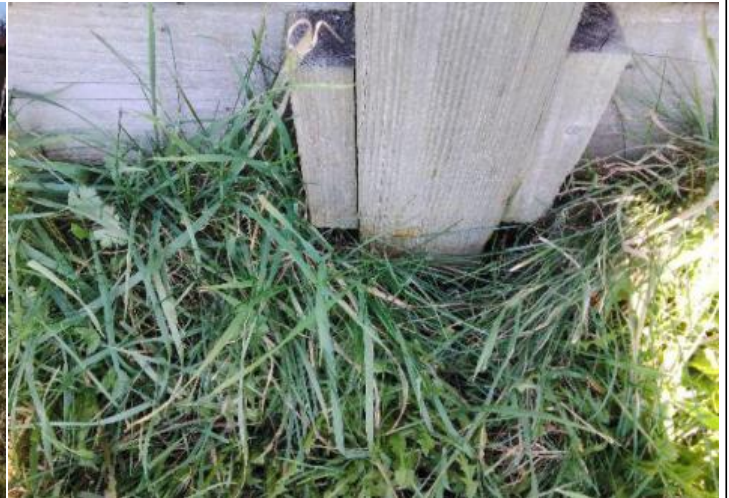
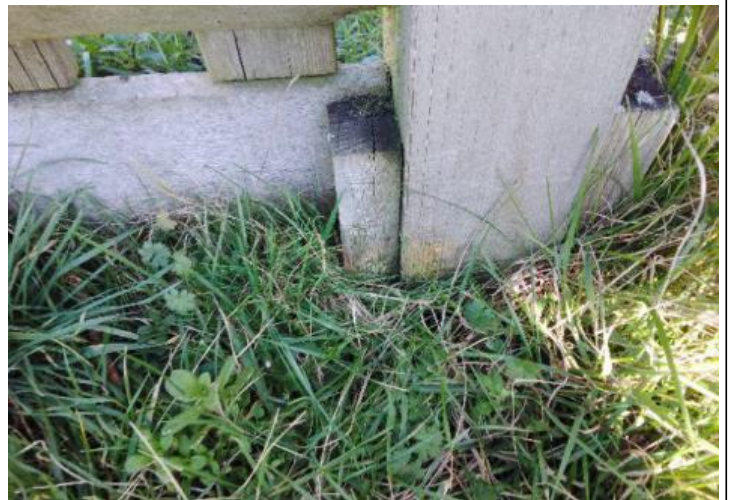
i 6 - Low Risk (Finding 1)

There is some strimmer / machinery damage apparent on the posts, this can penetrate the preservative applied to the timber and accelerate the rotting process - Monitor for any deterioration (rot) and replace as required

Finding: There is some strimmer / machinery damage apparent on the posts, this can penetrate the preservative applied to the timber and accelerate the rotting process

Action: Monitor for any deterioration (rot) and replace as required

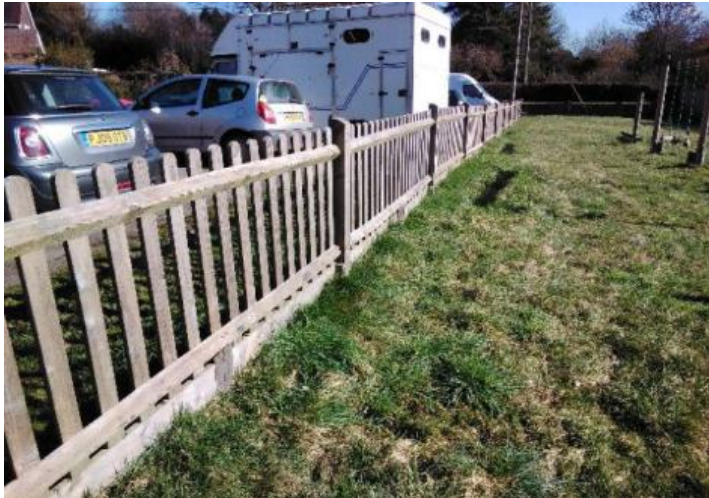
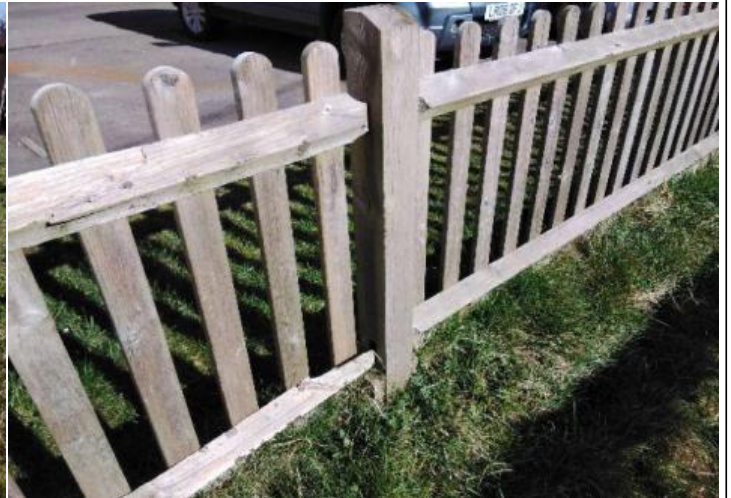
i 6 - Low Risk (Finding 2)

There are a number of loose aris rails around the fence - Monitor for any further deterioration and reset as required

Finding: There are a number of loose rails around the fence

Action: Monitor for any further deterioration and reset as required

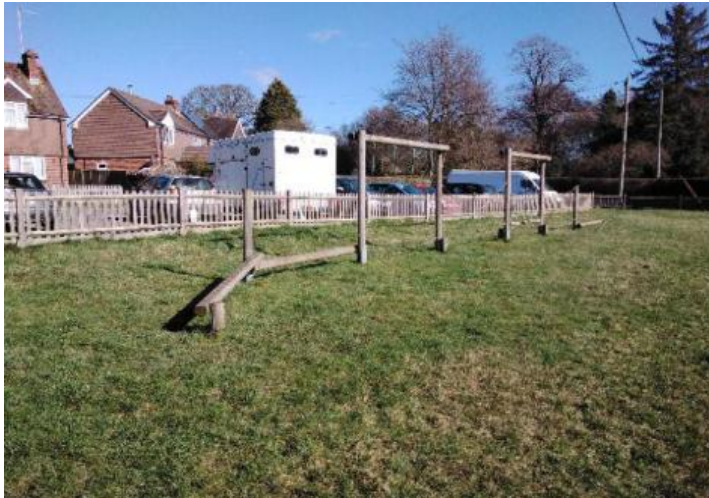
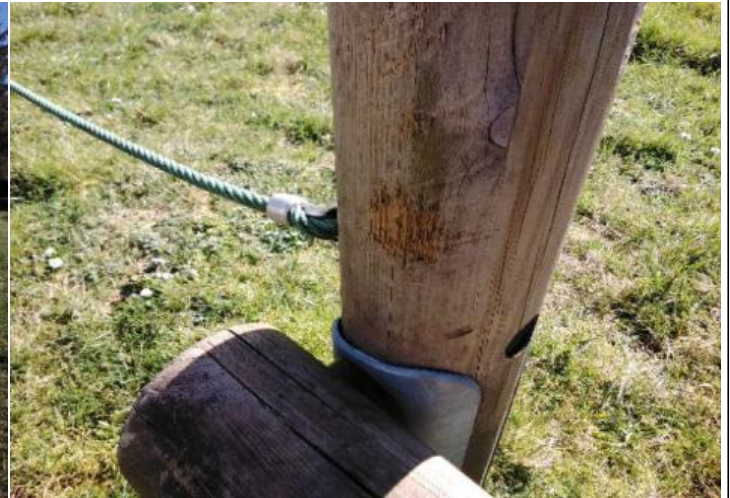
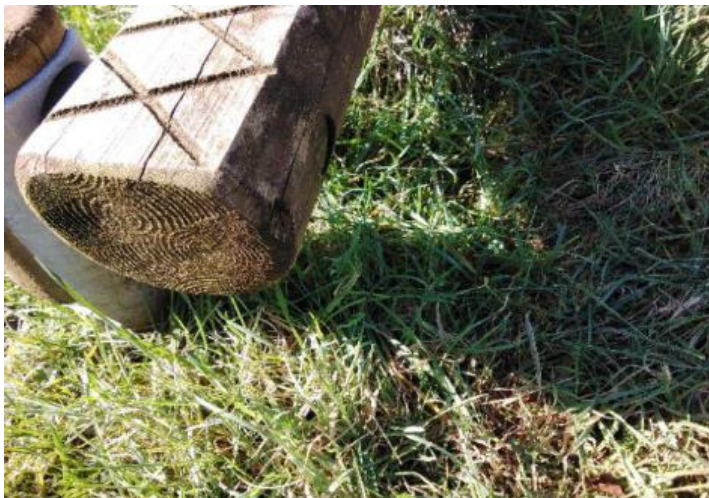
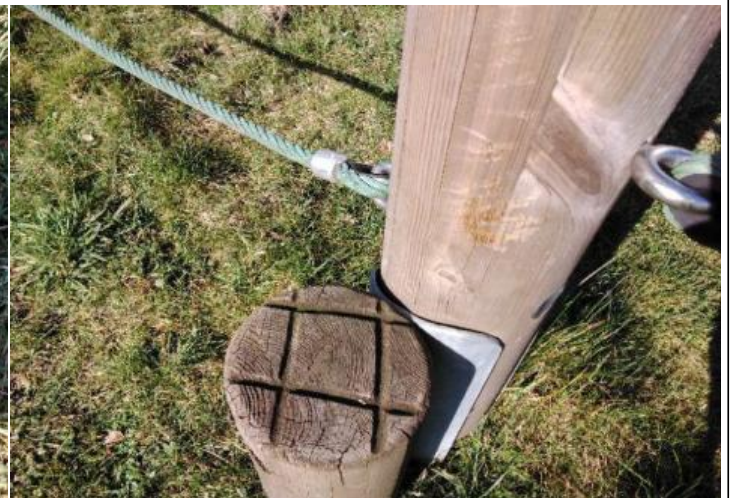
i 6 - Low Risk (Finding 1)

Parts of the timber are rough or splintered - Remove all rough or sharp edges

Finding: Parts of the timber are rough or splintered

Action: Remove all rough or sharp edges

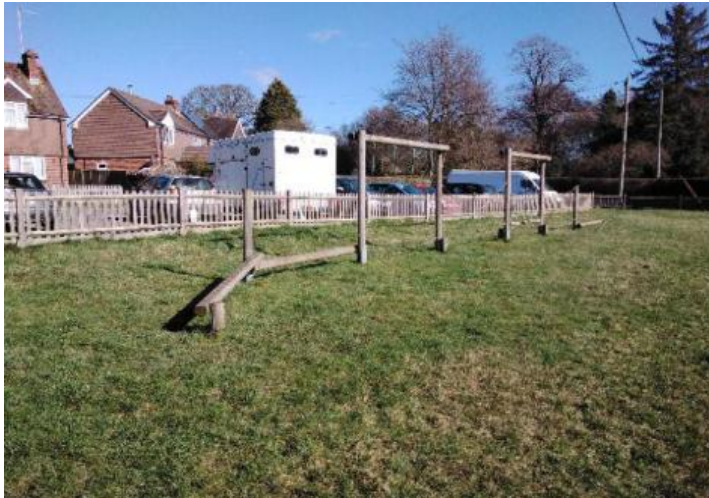
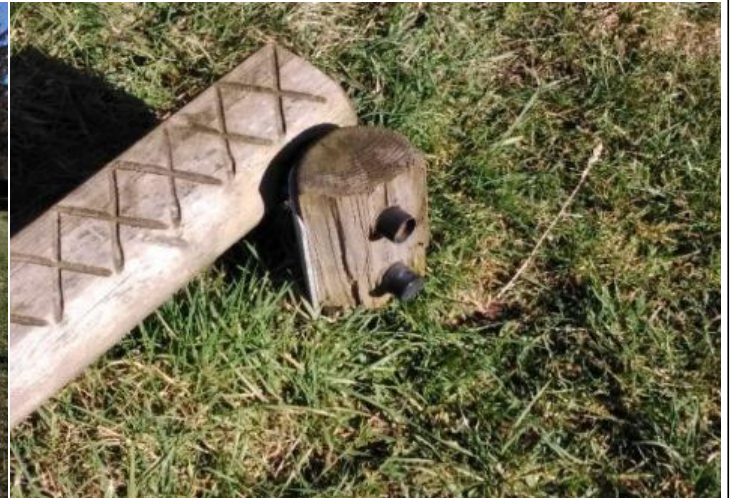
i 10 - Low Risk (Finding 2)

The balance beam support post has been severely damaged - Repair or replace the item

Finding: The balance beam support post has been severely damaged
Action: Repair or replace the item

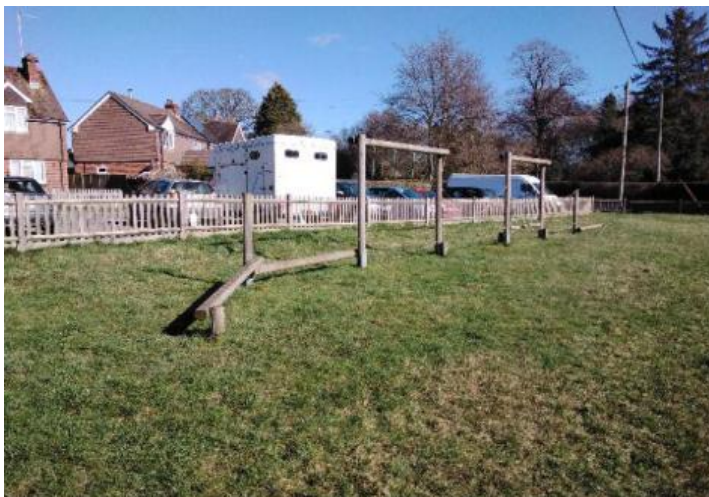
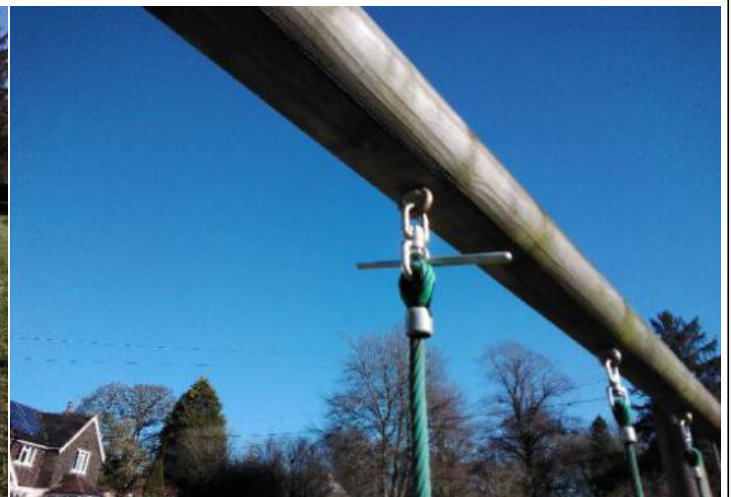
i 5 - Very Low Risk (Finding 3)

The chain openings are in excess of the 8.6mm as recommended by BS EN 1176 - Monitor - No remedial work recommended

Finding: The chain openings are in excess of the 8.6mm as recommended by BS EN 1176
Action: Monitor - No remedial work recommended

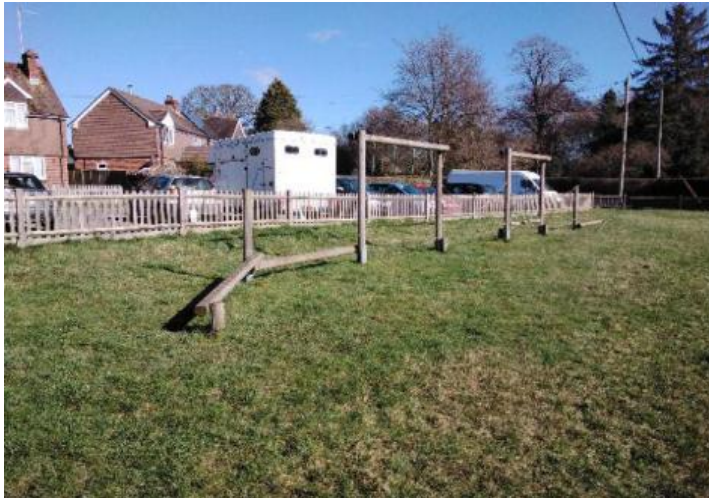
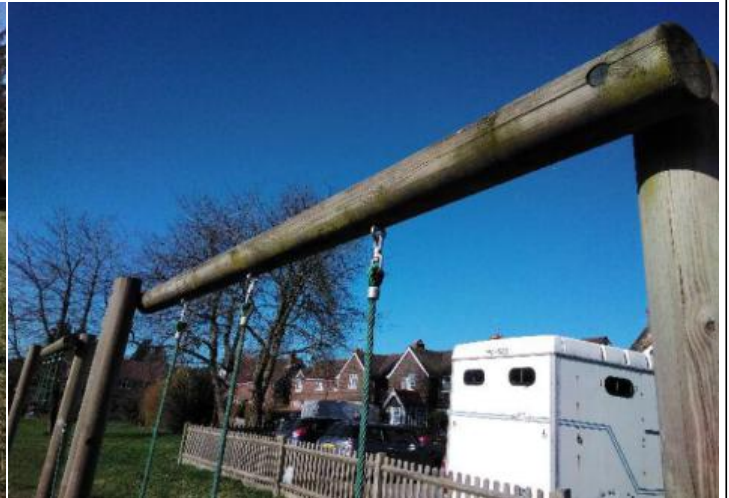
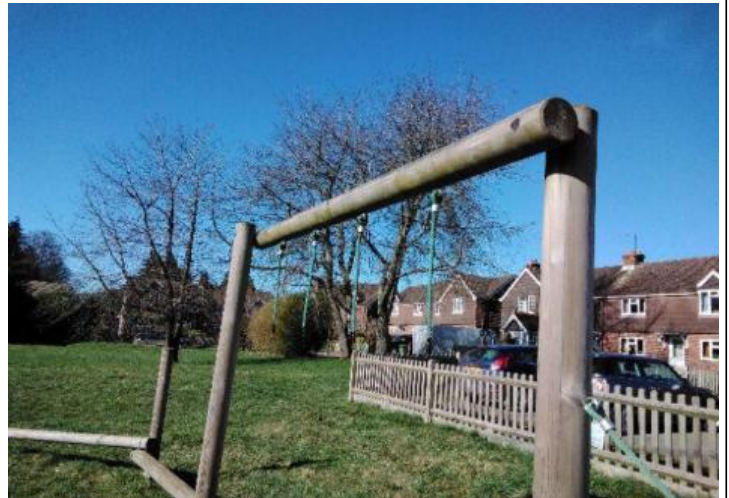
i 8 - Low Risk (Finding 4)

There is algae or moss on the surface of the equipment which can aid the onset of rot - Clean and treat appropriately

Finding: There is algae or moss on the surface of the equipment which can aid the onset of rot

Action: Clean and treat appropriately

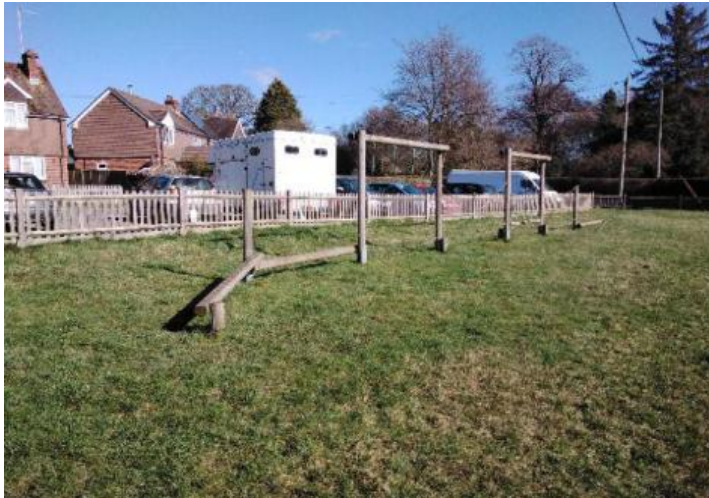
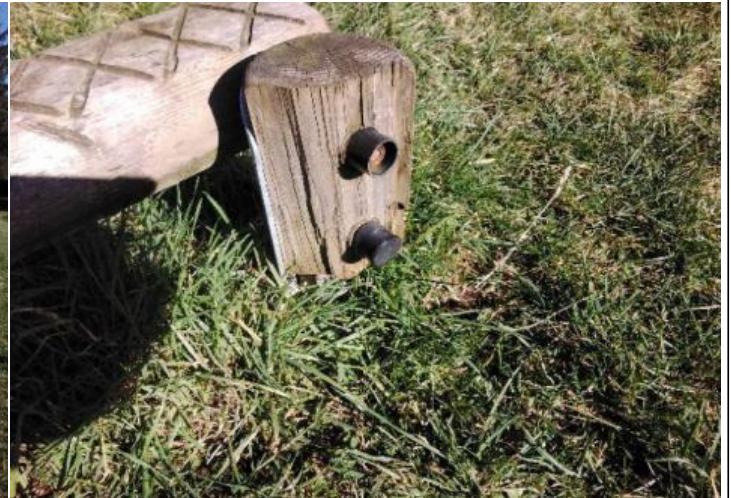
i 4 - Very Low Risk (Finding 5)

There is/are bolt cap covers missing or damaged on the item - Replace missing or damaged bolt cap covers

Finding: There is/are bolt cap covers missing or damaged on the item

Action: Replace missing or damaged bolt cap covers

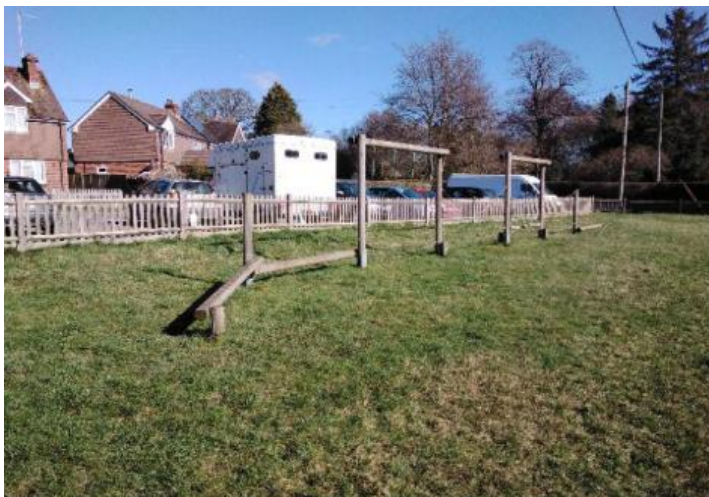
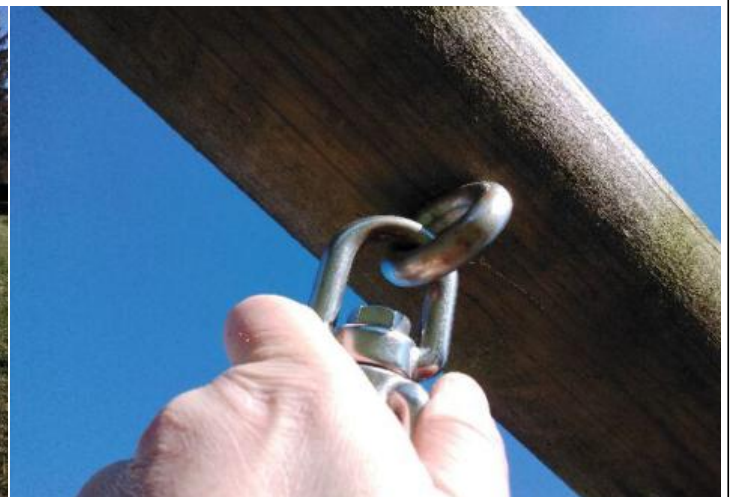
i 6 - Low Risk (Finding 6)

There is some notable evidence of wear in the rope connecting links - Monitor for any further deterioration and replace when 40% worn

Finding: There is some notable evidence of wear in the rope connecting links

Action: Monitor for any further deterioration and replace when 40% worn

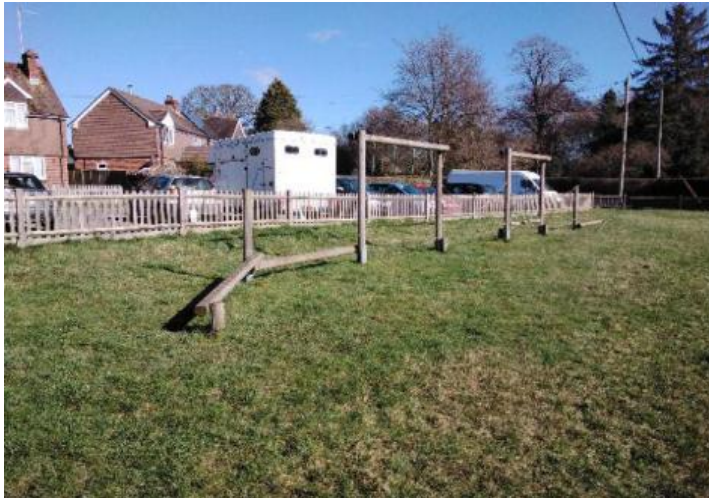
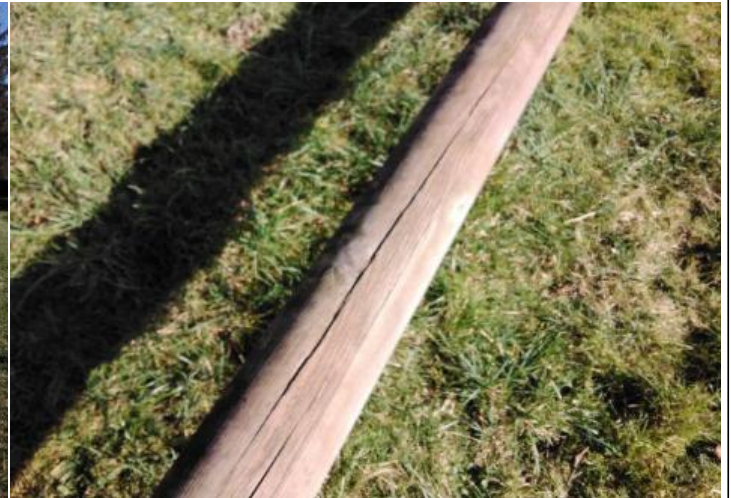
i 6 - Low Risk (Finding 7)

The timber has a number of splits/shakes or air cracks and this may affect the stability or allow water ingress which will accelerate the rotting process - Monitor to ensure the splits do not cross through fixing points of the structure and/or cause any instability

Finding: The timber has a number of splits/shakes or air cracks and this may affect the stability or allow water ingress which will accelerate the rotting process
Action: Monitor to ensure the splits do not cross through fixing points of the structure and/or cause any instability
