## Annual Inspection

Winchester City Council

Meonwara PA (West Meon PC)

Inspection Ref: 2654716

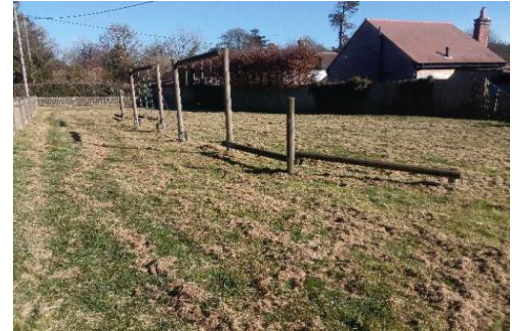
**Item:** Site General  
**Manufacturer:** Owner/Operator  
**Surface Type:** N/A  
**Item Quantity:** 1  
**Equipment Compliance:** N/A  
**Surface Area Compliance:** N/A

It is recommended that signage, with information including the site address, contact information for maintenance issues and emergency contact details are provided for the facility - Provide in accordance with the recommendations

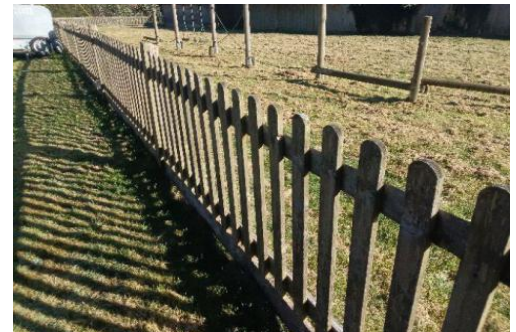
**Item:** Fencing - Timber  
**Manufacturer:** Not Identified  
**Surface Type:** Grass  
**Item Quantity:** 1  
**Equipment Compliance:** N/A  
**Surface Area Compliance:** N/A

There is some evidence of rot in the timber - Monitor for any further deterioration and replace as required

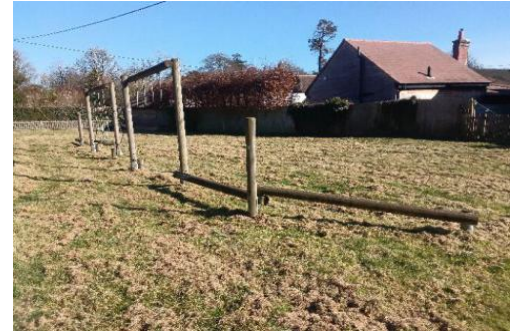
**Item:** Activity Trail  
**Manufacturer:** Playdale Playgrounds Ltd  
**Surface Type:** Grass  
**Item Quantity:** 1  
**Equipment Compliance:** No  
**Surface Area Compliance:** Yes

The balance beam is damaged - Replace
