| <div>KEY PLAN</div> <div><div><div></div></div><div>Key Structure Failures (labelled in order of priority)</div></div> | <div>NOTES</div> <div>Contains OS data © Crown copyright and database right (2025)</div> | REVISIONS | | | | <div><div><div></div></div><div>Stantec</div></div> <div>172 Edmund Street, Birmingham B3 2HB, United Kingdom</div> | TITLE West Meon Mitigation Summary | | |
| REV. | REVISION NOTES/COMMENTS | | | | PROJECT River Meon, West Meon | DRAWING NO. 34101-HYD-XX-XX-DR-WENV-0001 | REVISION P01 | | |

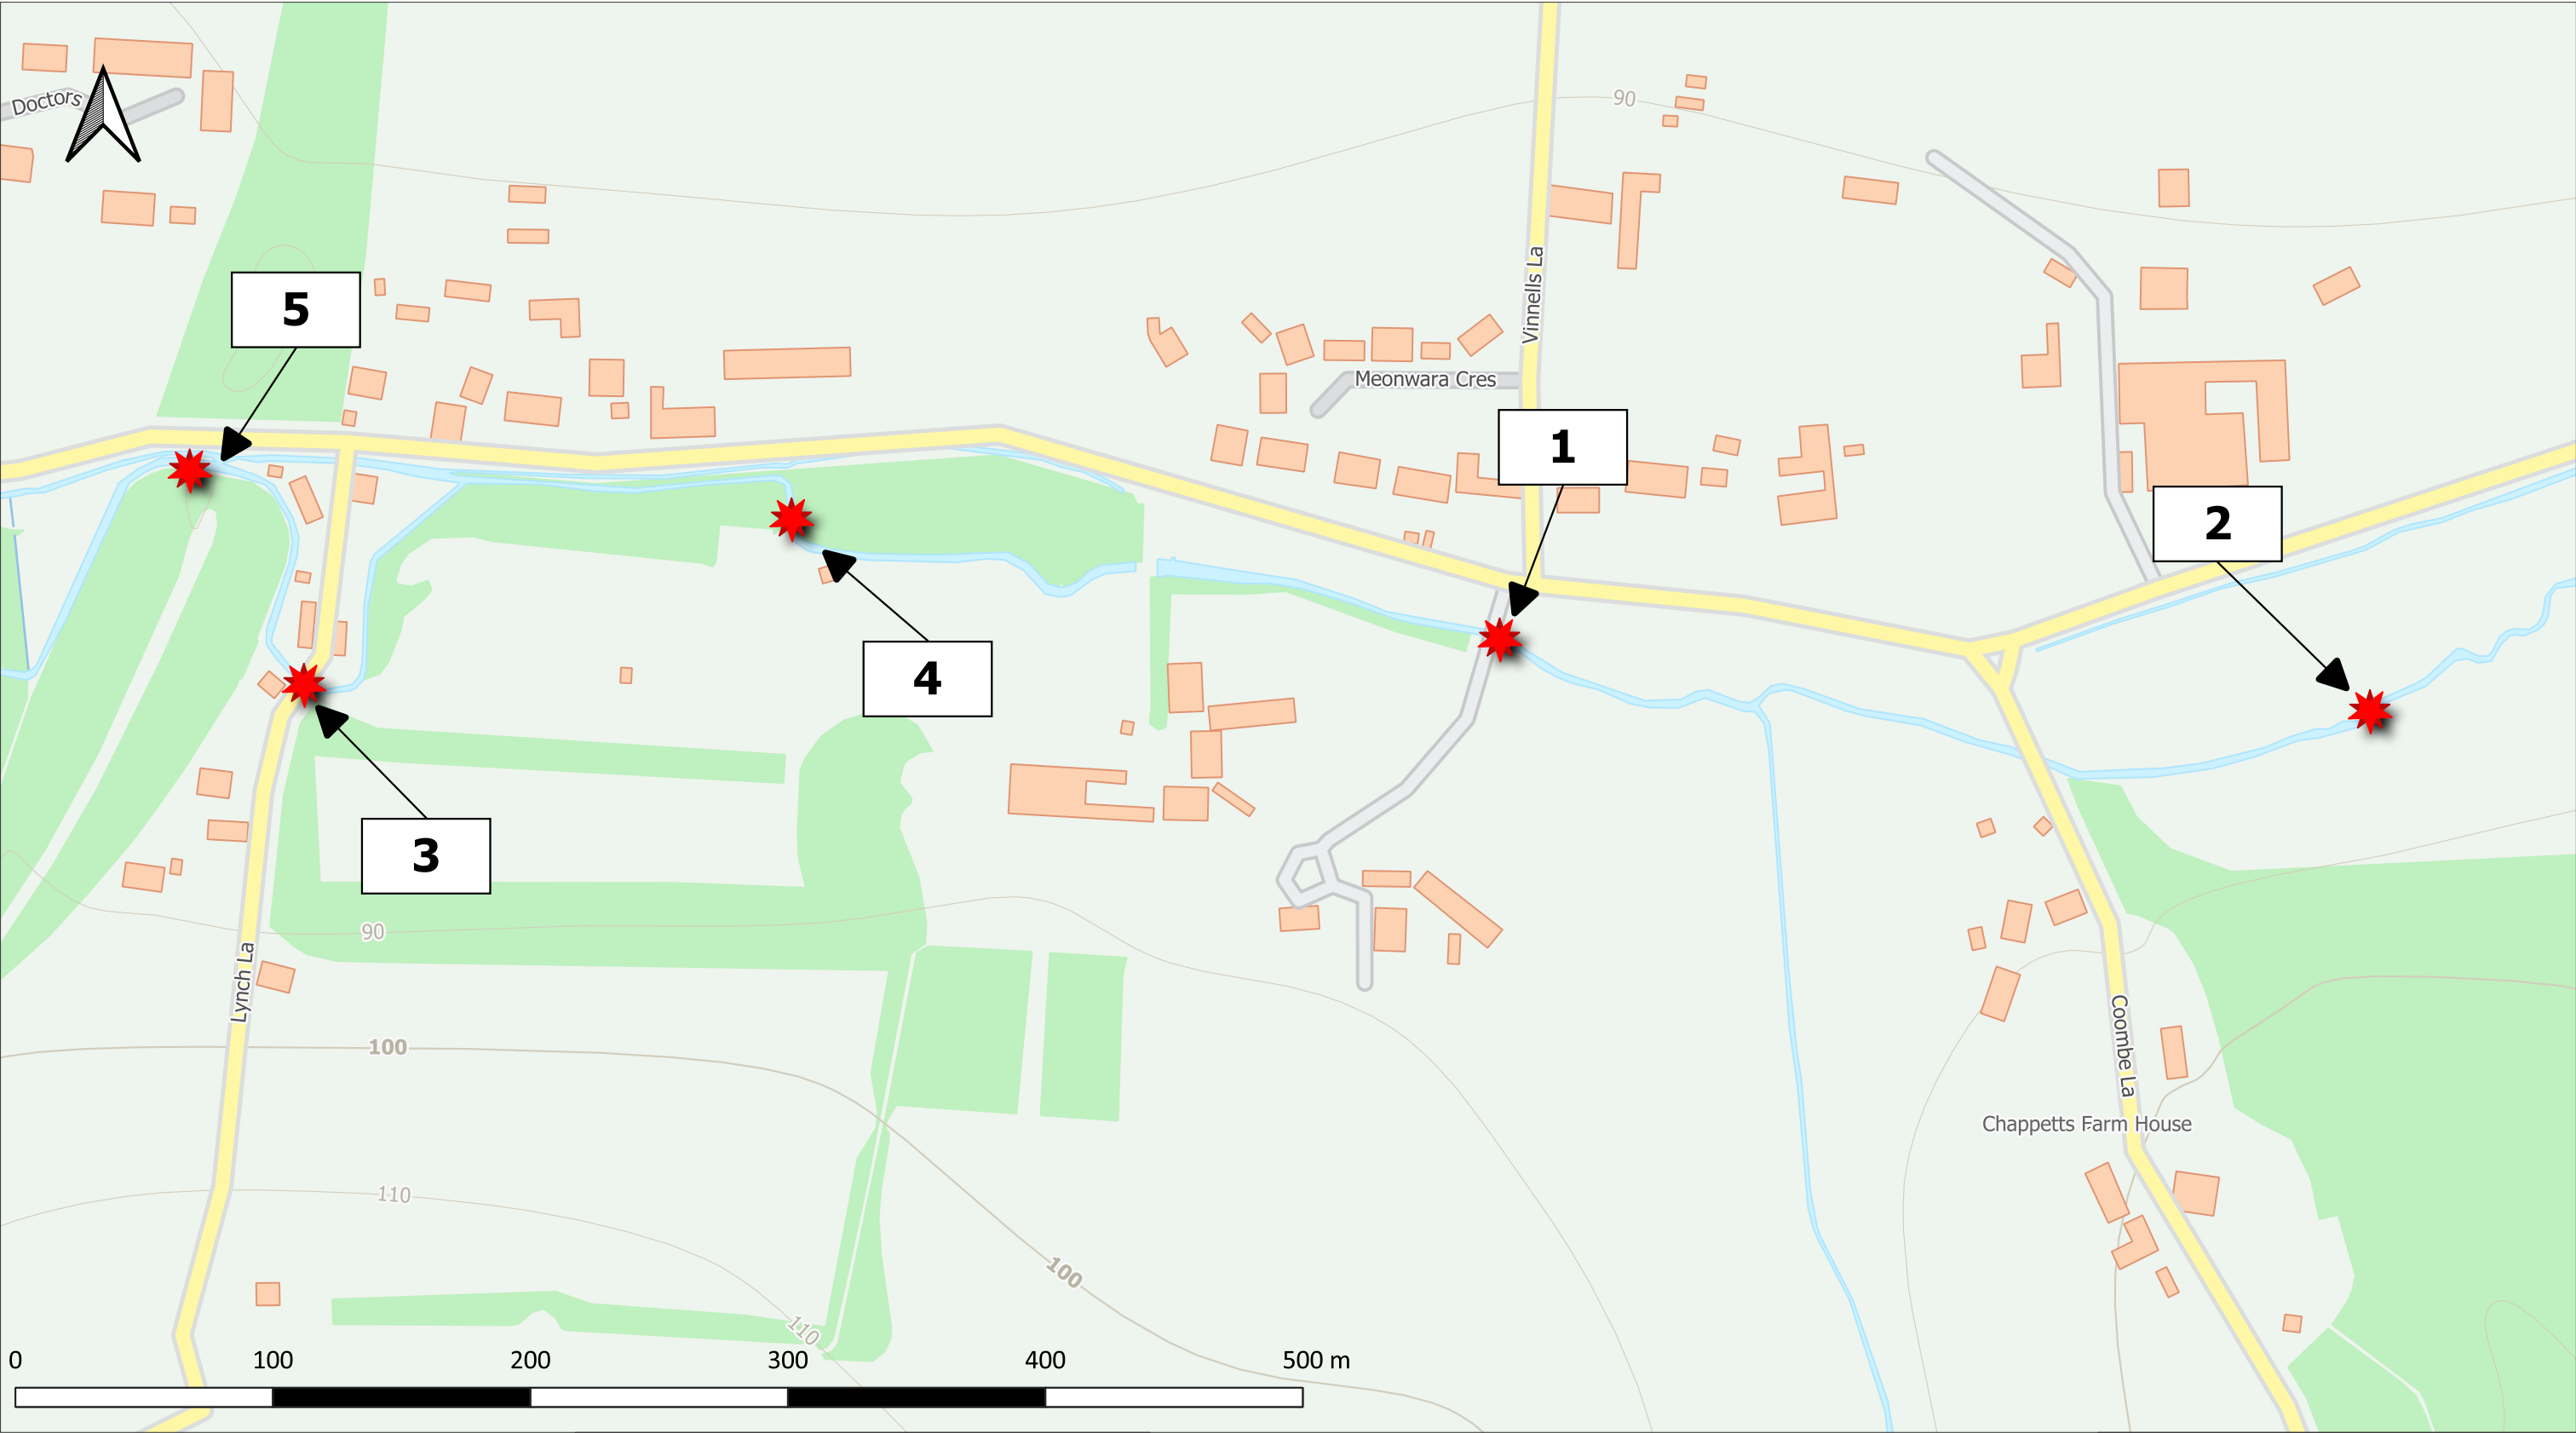
Structure 1 is located under an access road to Hall Place Farm. It is a twin 650mm diameter plastic pipe at the upstream (eastern end), and a singular 650mm diameter plastic pipe at the downstream (western end). As shown in the photo below, the structure is inefficient and greatly reduces the capacity of the channel in this area. This, coupled with the fact that the culvert itself reduces in width under the road, either due to blockage or being poorly laid, is a significant cause of flooding to the surrounding area (Vinnells Lane, West Meon Road) and requires attention.

Structure 2 is another twin 650mm diameter plastic pipe to a parcel of land located 135m east of Coombe Lane, that is currently undergoing construction. The pipe that has been laid is undersized and appears to have greatly reduced the channel capacity and width in this area. It is responsible for causing flooding to West Meon Road, Coombe Lane and Vinnells Lane.

This is an arched culvert under Lynch Lane that is approximately 1.7m wide at it's widest point, and approximately 1m high. The culvert becomes full during high flow conditions and is not suitably sized, causing backing up of flows and flooding to properties surrounding Lynch Lane.

Replacement of this structure to a slot or boxed culvert would improve the capacity of the channel in this area, which is 4.5m wide from top of bank to top of bank. Consent would need to be sought from the Environment Agency to do this as they are responsible for maintaining the river, as it is designated as a Main River.

Replacement of the culvert to a boxed type structure that matches the channel width of 3.5m in this location would improve flow conveyance under Lynch Lane. Further hydraulic modelling would be required by the Environment Agency to prove that this does not push the problem downstream or make flood risk worse elsewhere. A photo of this culvert is shown below.
