the **play inspection** company

Annual Inspection

West Meon Village Hall RG (West Meon PC)

Headon View, West Meon, Hampshire, GU32 1LH

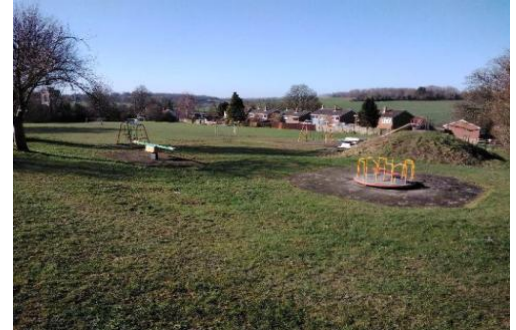
Item: Site General
Manufacturer: Owner/Operator
Surface Type: N/A
Item Quantity: 1
Equipment Compliance: N/A
Surface Area Compliance: N/A

The site is accessible to the public during the COVID 19 pandemic. The government have released guidelines for safely re-opening these types of facilities which is available on the government website. - Ensure there is an appropriate risk assessment in place and review regularly

It is recommended that Adult Outdoor Fitness equipment is installed a minimum of 25m away from a children's playground or separated and screened to discourage access by younger children - Monitor use and review risk assessment regularly

It is recommended that signage, with information including the site address, contact information for maintenance issues and emergency contact details are provided for the facility - Provide in accordance with the recommendations

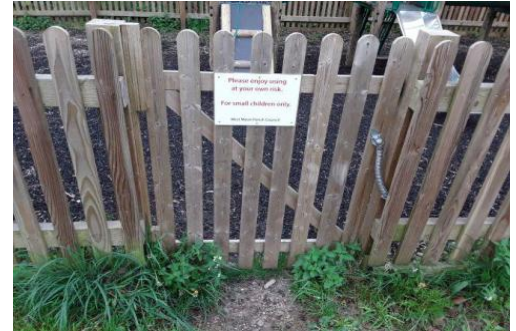
Item: Gate - Self Closing
Manufacturer: Owner/Operator
Surface Type: Grass
Item Quantity: 1
Equipment Compliance: N/A
Surface Area Compliance: N/A

There is or are fixings missing on the item - Replace all missing fixings

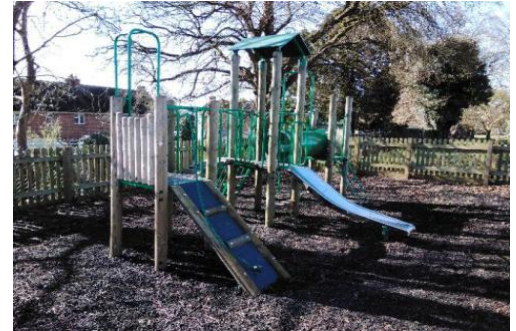
Item: Multi Play (Junior)
Manufacturer: A.E.Evans
Surface Type: Loose Rubber Mulch
Item Quantity: 1
Equipment Compliance: Yes
Surface Area Compliance: Yes

The timber has a number of splits/shakes or air cracks and this may affect the stability or allow water ingress which will accelerate the rotting process - Monitor to ensure the splits do not cross through fixing points of the structure and/or cause any instability

There is/are several inserts missing - Replace missing inserts

The side of the slide is damaged - Monitor for any further deterioration and repair as required

The paintwork on this item has been damaged or worn exposing the metal underneath which is rusting - Treat any rusting components and repaint

There is or are fixings missing on the item - Replace all missing fixings

There is some wear to the shackles - Monitor for any further deterioration and replace when 40% worn

There is surface corrosion present on the item - Consider treating the item

The ropes/nets are worn/damaged in places - Monitor for any further deterioration and repair or replace as required

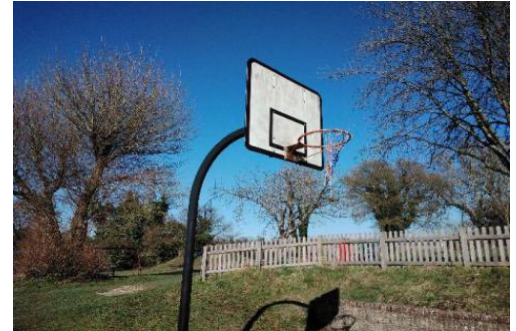
Item: Basketball Post
Manufacturer: Not Identified
Surface Type: Bitmac
Item Quantity: 1
Equipment Compliance: Yes
Surface Area Compliance: N/A

The net has been damaged - Replace the net

The paintwork on this item has been damaged or worn exposing the metal underneath which is rusting - Treat any rusting components and repaint

There are a number of loose posts around the fence - Monitor for any further deterioration and reset as required

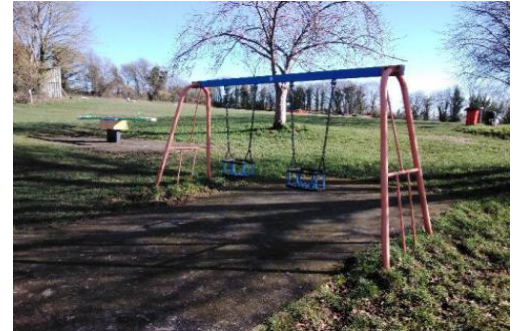
Item: 1 Bay 2 Seat (Cradle)
Manufacturer: Wicksteed Playgrounds
Surface Type: Wet Pour
Item Quantity: 1
Equipment Compliance: No
Surface Area Compliance: Yes

There are trip hazards at the edges of the surface - Reinstate surrounding surface levels to remove the trip points

The safety surface under or around this unit has been damaged - Monitor for any further deterioration and repair as required

The chain openings are in excess of the 8.6mm as recommended by BS EN 1176 - Monitor - No remedial work recommended

The seat has minor damage or wear - Monitor for any further deterioration and replace as required

There are gaps opening between the surfacing and the edging surround or between the joints in the surfacing - Monitor for any further deterioration and repair as required

The safety surface around the area is beginning to wear - Monitor for any further deterioration and repair as required

There is some notable evidence of chain wear - Monitor for any further deterioration and replace when 40% worn

The paintwork on this item has been damaged or worn exposing the metal underneath which is rusting - Treat any rusting components and repaint

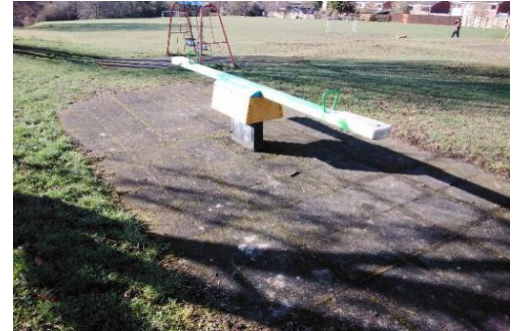
Item: See Saw
Manufacturer: Wicksteed Playgrounds
Surface Type: Rubber Tiles
Item Quantity: 1
Equipment Compliance: Yes
Surface Area Compliance: Yes

There are gaps opening in between the tiles - Monitor for any further deterioration and repair as required

There are gaps opening between the surfacing and the edging surround or between the joints in the surfacing - Monitor for any further deterioration and repair as required

The item has been damaged - Monitor for any further deterioration and replace as required

Parts of the steel on this item have corroded excessively and the metal has perforated in places - Ensure all affected areas are treated and repaired

The paintwork on this item has been damaged or worn exposing the metal underneath which is rusting - Treat any rusting components and repaint

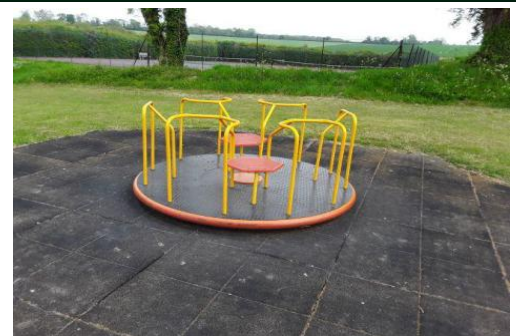
Item: Roundabout
Manufacturer: Wicksteed Playgrounds
Surface Type: Rubber Tiles
Item Quantity: 1
Equipment Compliance: Yes
Surface Area Compliance: Yes

The safety surface around the area is beginning to wear - Monitor for any further deterioration and repair as required

There are gaps opening in between the tiles - Monitor for any further deterioration and repair as required

The paintwork on this item has been damaged or worn exposing the metal underneath which is rusting - Treat any rusting components and repaint

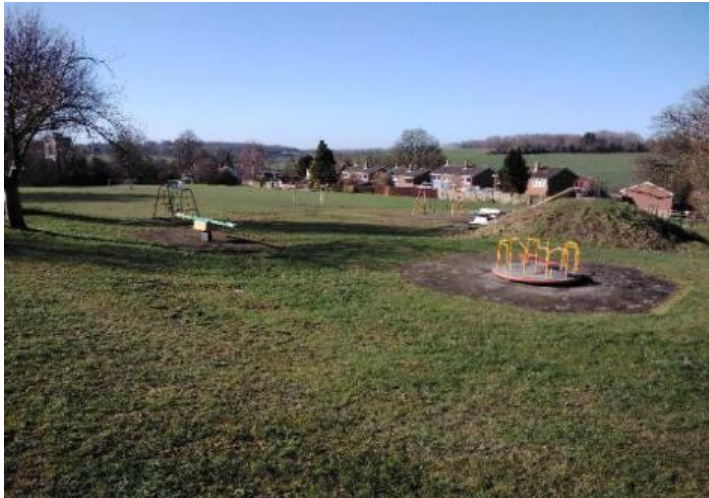
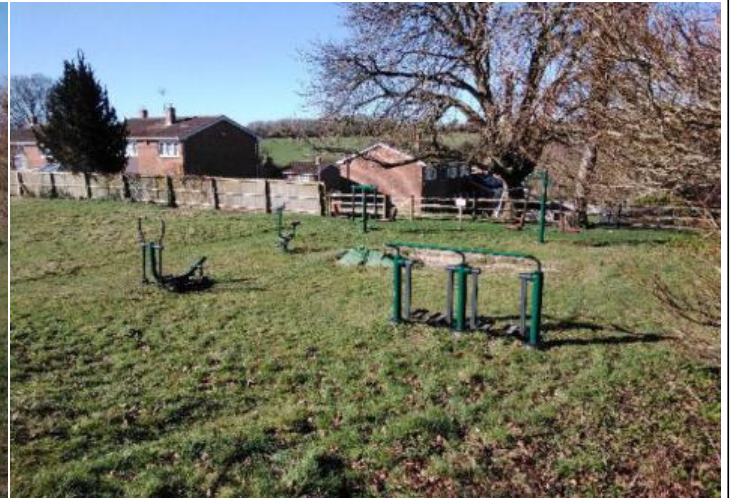
Finding: Signage should be provided for the outdoor fitness equipment in accordance with the requirements of BS EN 16630, key requirements of the sign include, but are not limited to, intended users, medical safety and emergency contact details

Action: Provide appropriate signage

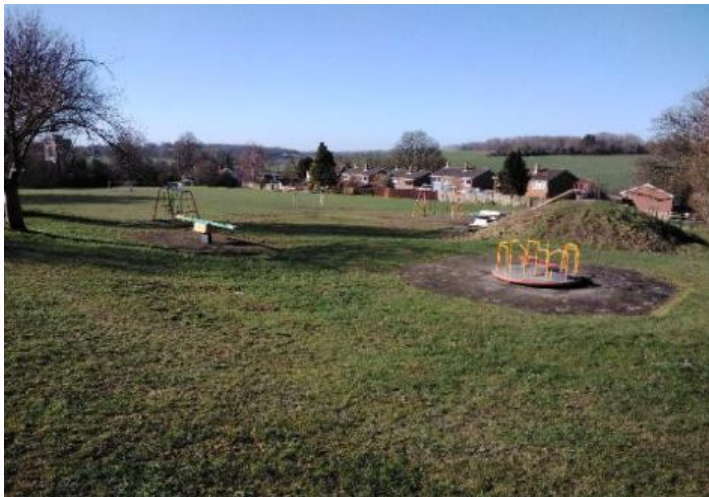
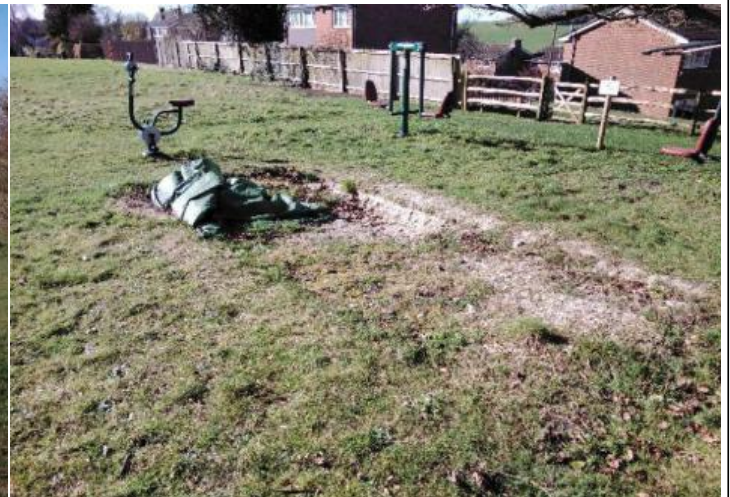
Finding: There is work been undertaken to the surface around the fitness equipment

Action: Complete the works

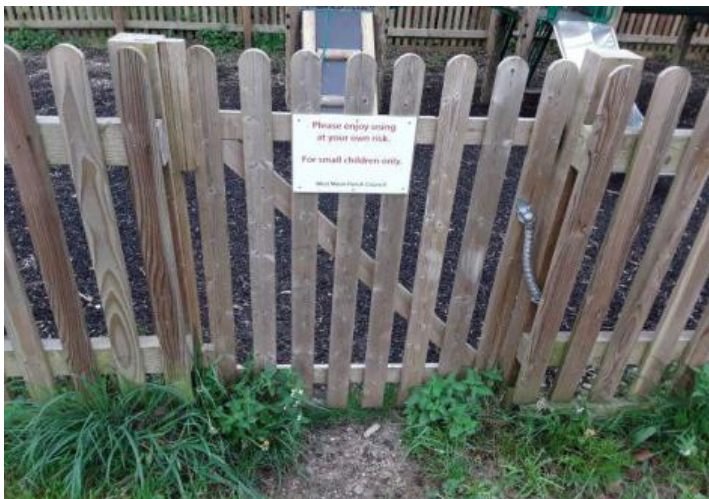
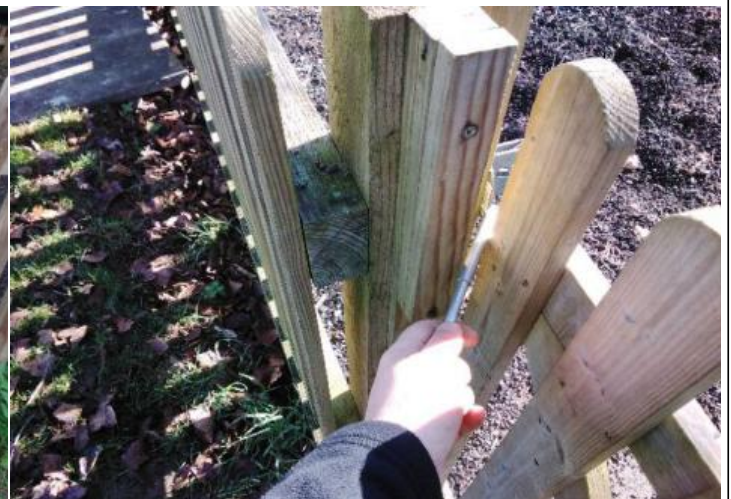
Finding: There are openings that are less than 12mm that could trap or crush fingers

Action: Where possible a 12mm gap should be maintained on both sides or between the gate leaves

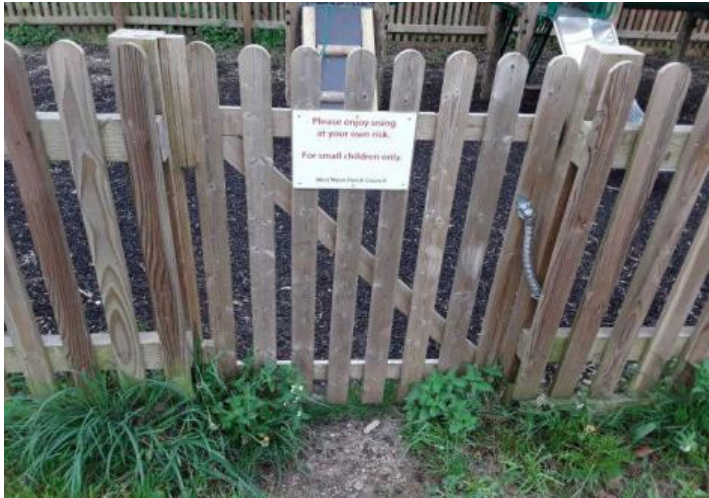
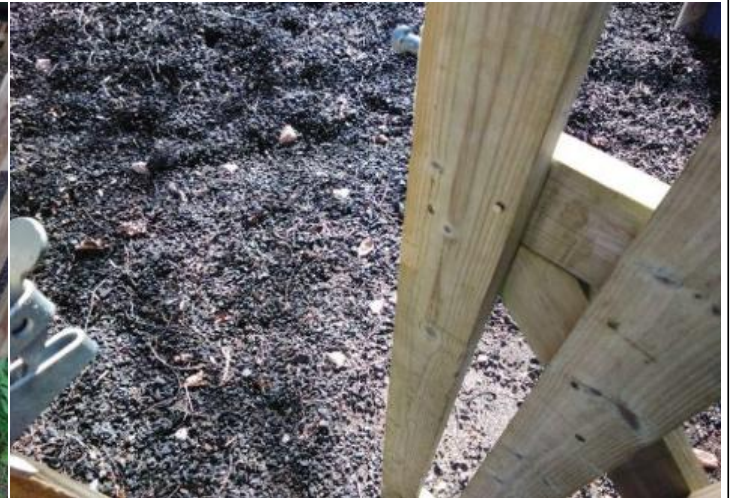
Finding: There are projecting nail ends present

Action: Remove and provide more appropriate fixings if required

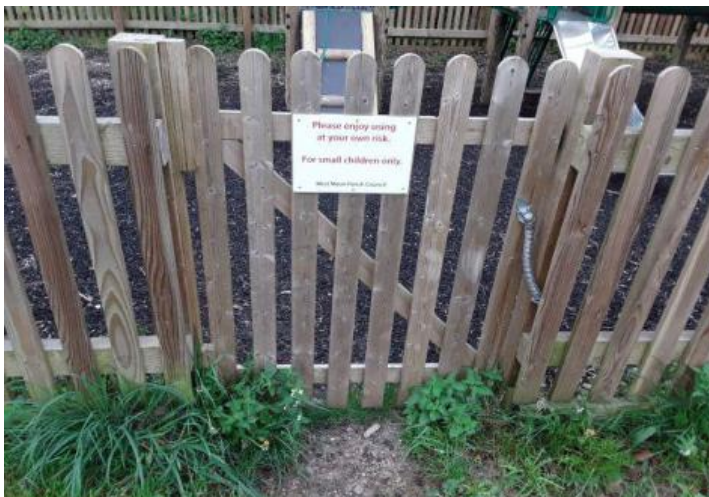
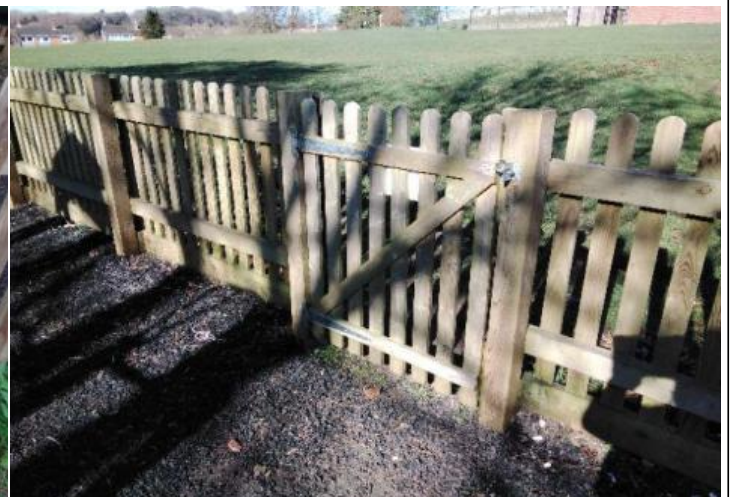
Finding: The gate is closing too quickly (less than 4 seconds)

Action: Take corrective action to ensure that the gate closes in 4-8 seconds

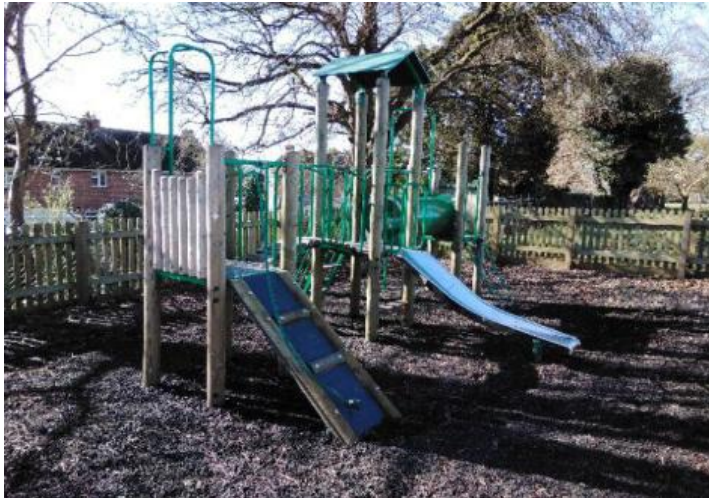
Finding: There is some tree debris on the surfacing

Action: Remove and maintain

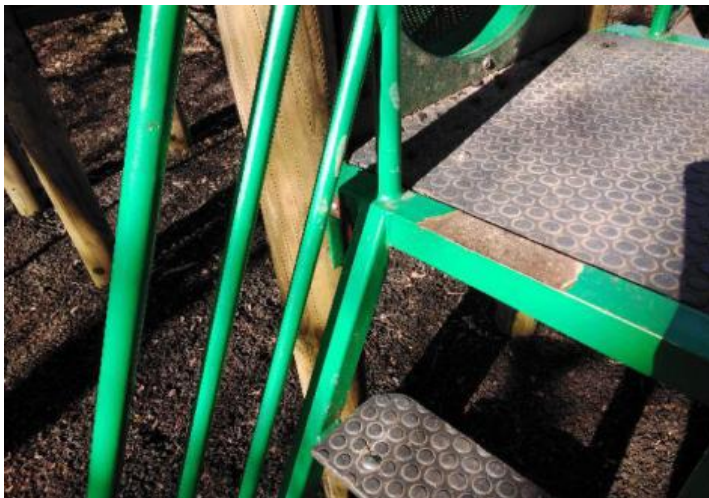
Finding: The paintwork on this item has been damaged or worn exposing the metal underneath which is rusting

Action: Treat any rusting components and repaint

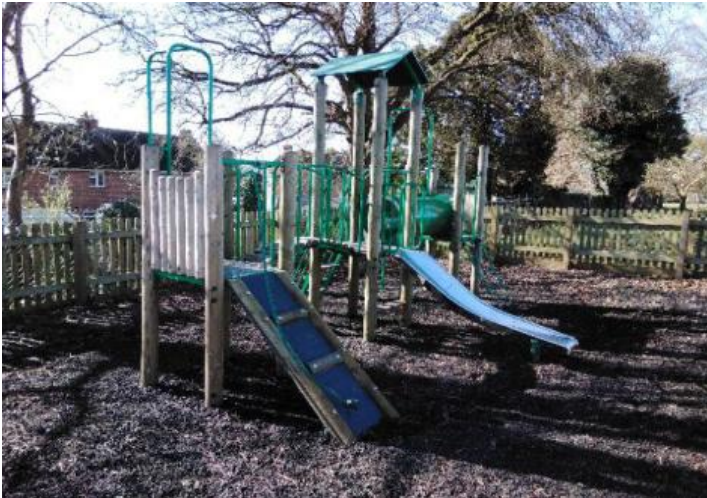
Finding: Parts of the timber are rough or splintered

Action: Remove all rough or sharp edges

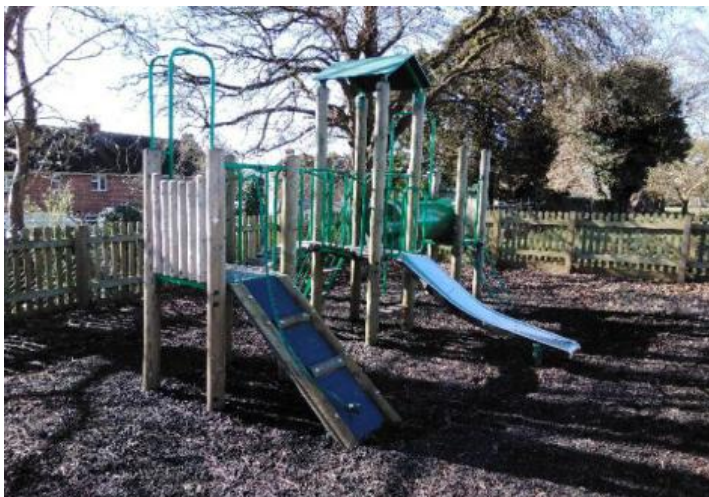
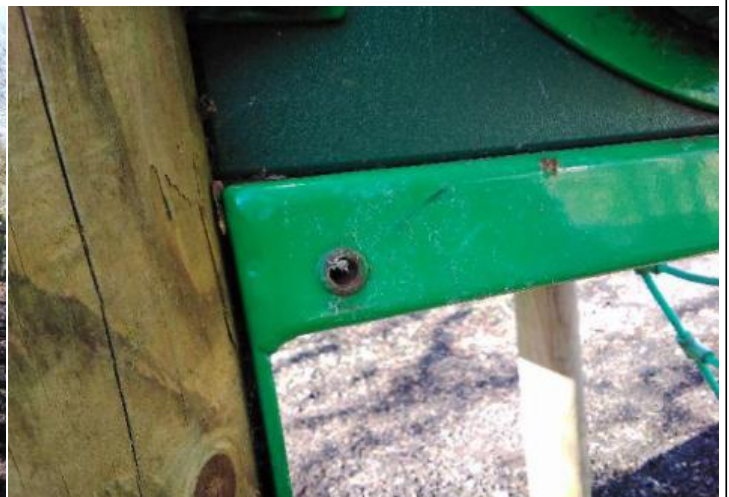
Finding: There is/are several inserts missing

Action: Replace missing inserts

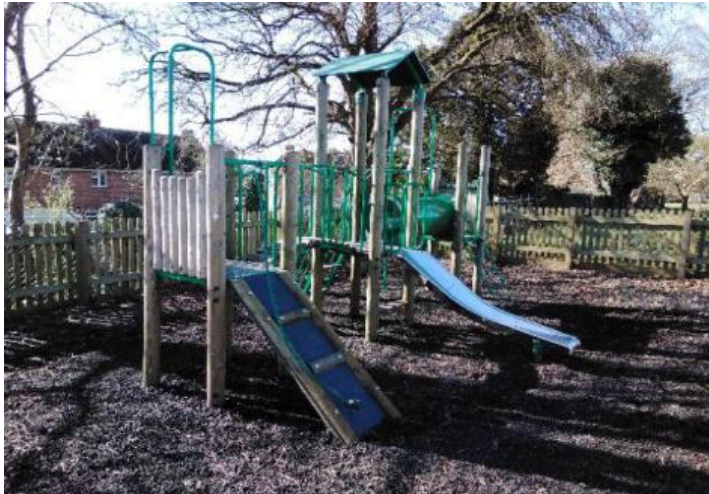
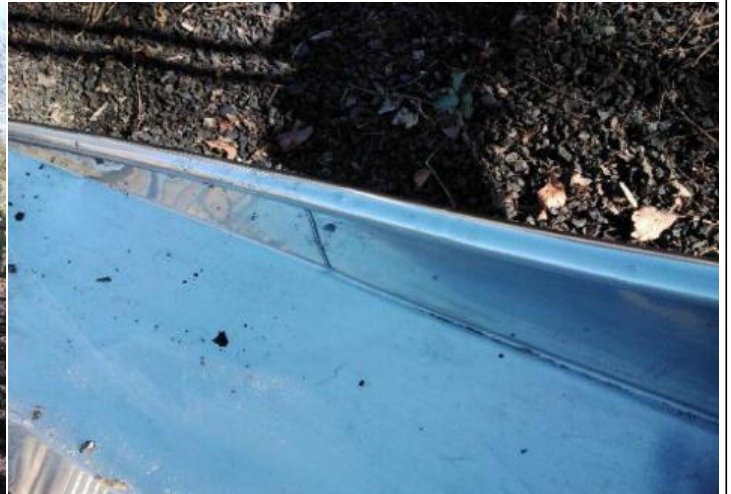
Finding: The side of the slide is damaged

Action: Monitor for any further deterioration and repair as required

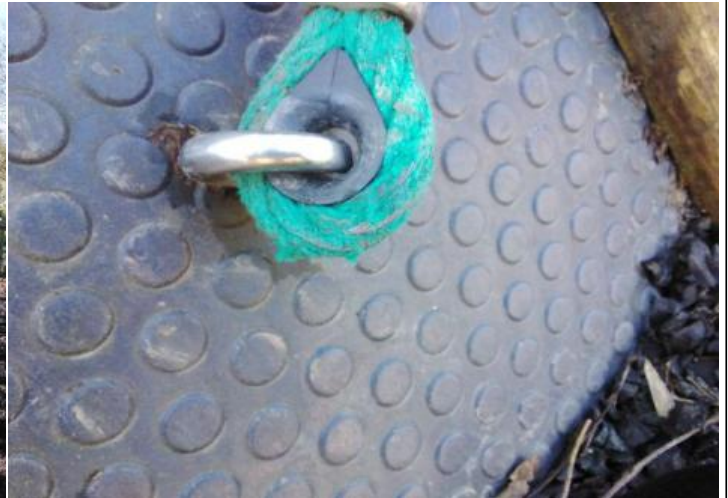
Finding: The ropes/nets are worn/damaged in places

Action: Monitor for any further deterioration and repair or replace as required

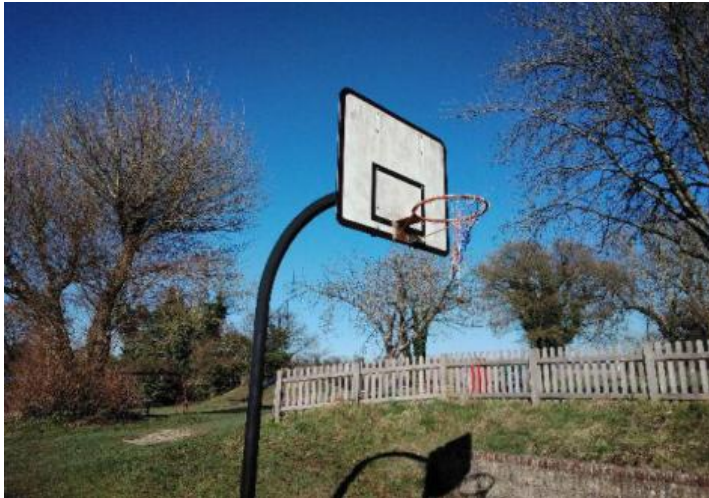
Finding: The net has been damaged

Action: Replace the net

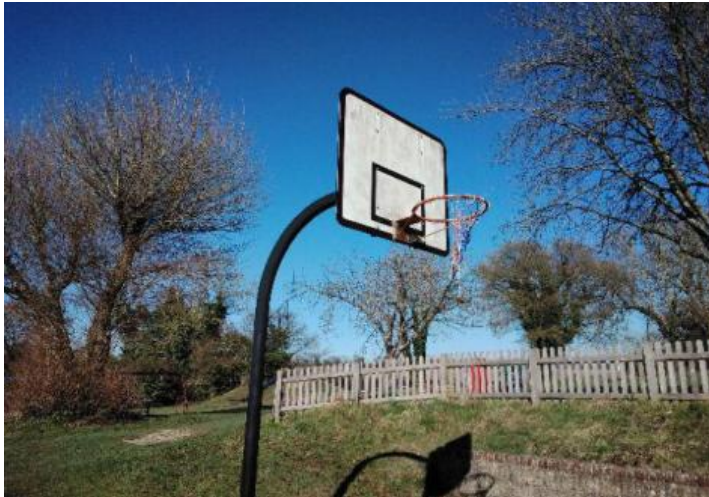
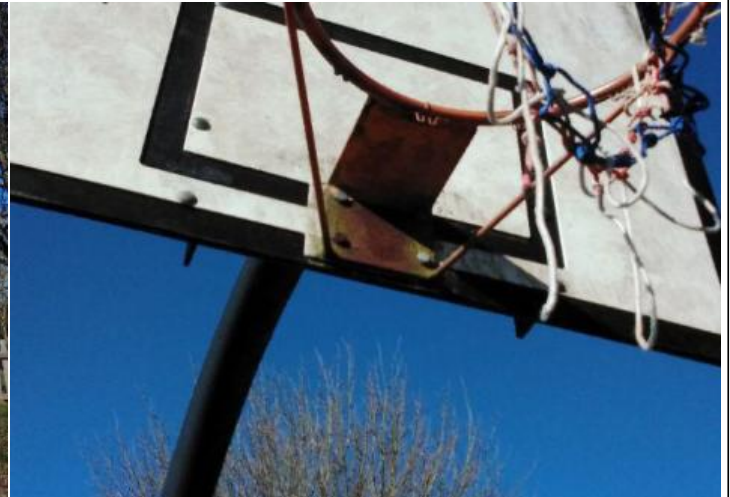
Item: Multi Use Games Area - Basketball Post
Manufacturer: Not Identified

Finding: The paintwork on this item has been damaged or worn exposing the metal underneath which is rusting

Action: Treat any rusting components and repaint

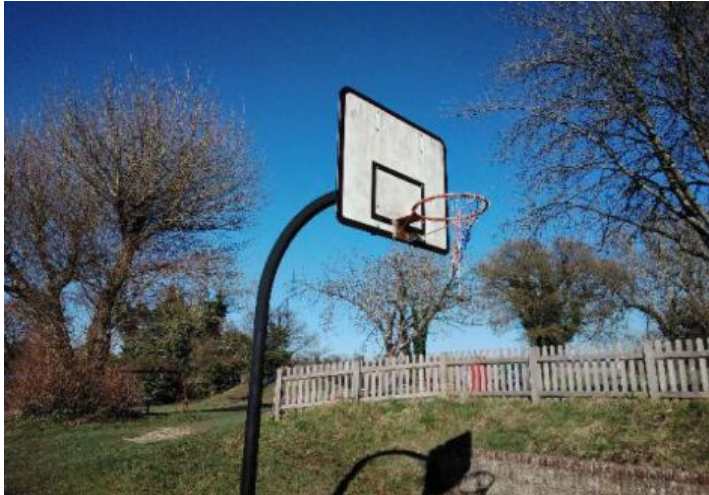
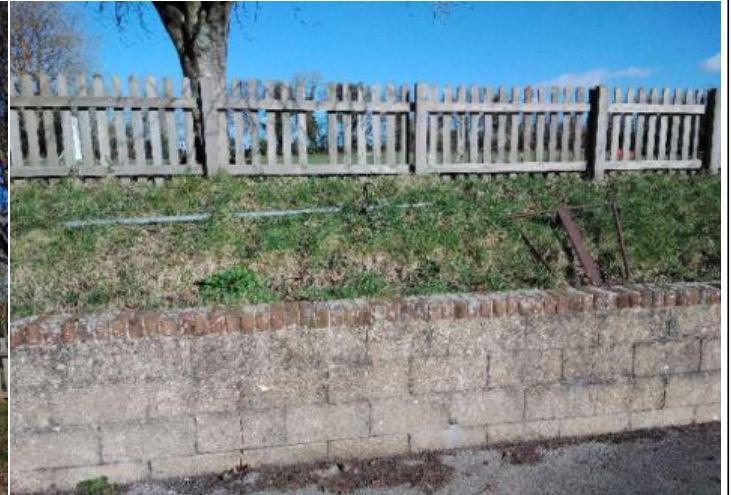
Item: Multi Use Games Area - Basketball Post
Manufacturer: Not Identified

Finding: There are unsecured netball posts in the area

Action: Remove from site

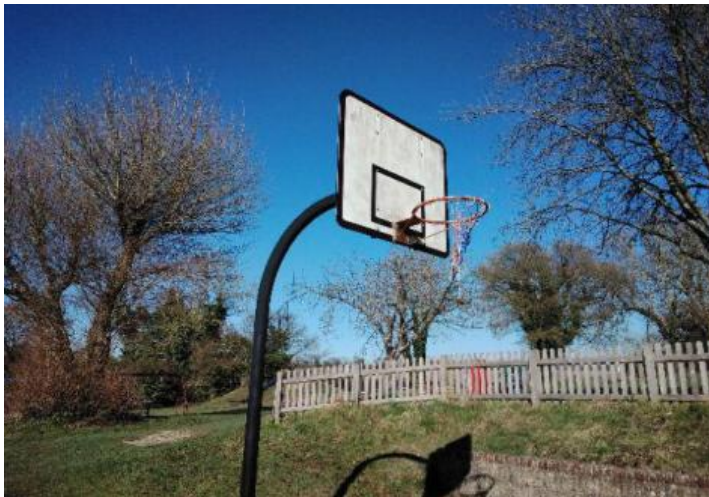
Item: Multi Use Games Area - Basketball Post
Manufacturer: Not Identified

Finding: There are a number of loose posts around the fence

Action: Monitor for any further deterioration and reset as required

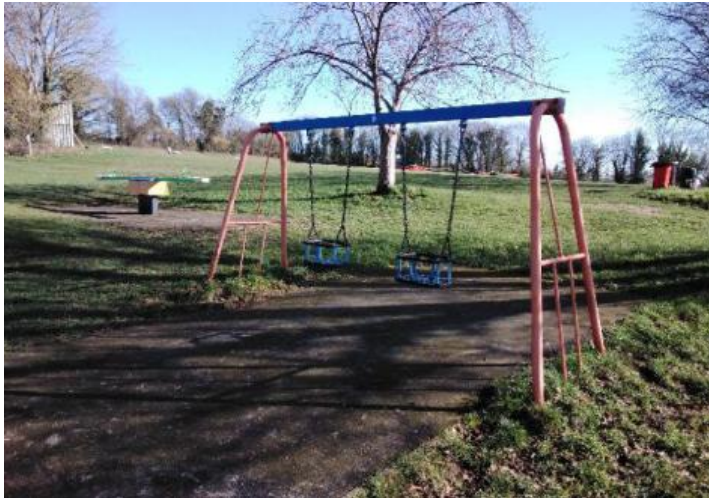
Item: Swings - 1 Bay 2 Seat (Cradle)
Manufacturer: Wicksteed Playgrounds

Finding: There are trip hazards at the edges of the surface

Action: Reinststate surrounding surface levels to remove the trip points

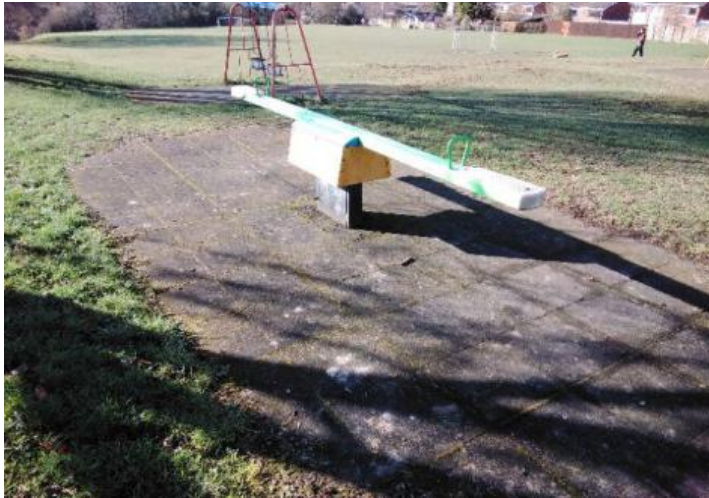
Item: Rocking Equipment - See Saw
Manufacturer: Wicksteed Playgrounds

Finding: There are gaps opening in between the tiles

Action: Monitor for any further deterioration and repair as required

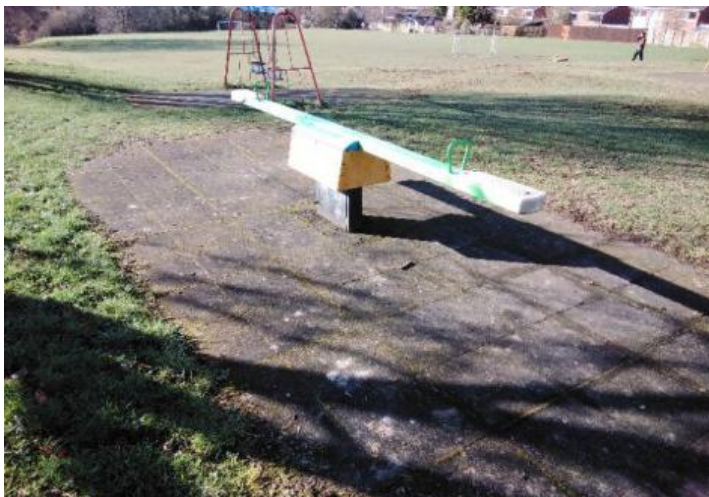
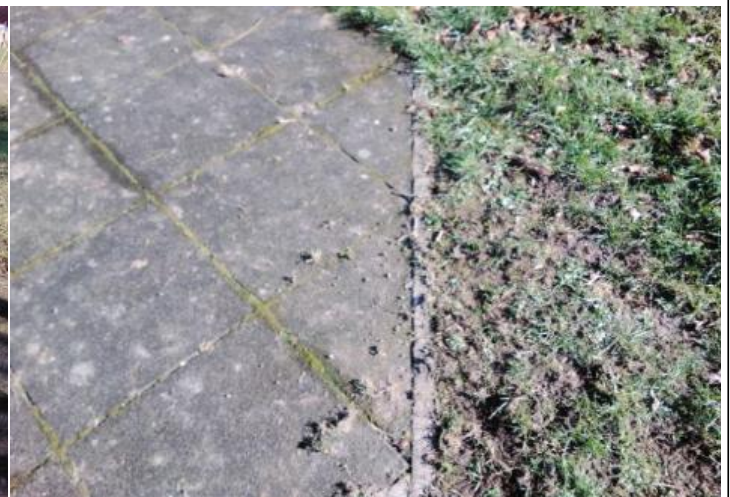
Item: Rocking Equipment - See Saw
Manufacturer: Wicksteed Playgrounds

Finding: There are gaps opening between the surfacing and the edging surround or between the joints in the surfacing

Action: Monitor for any further deterioration and repair as required

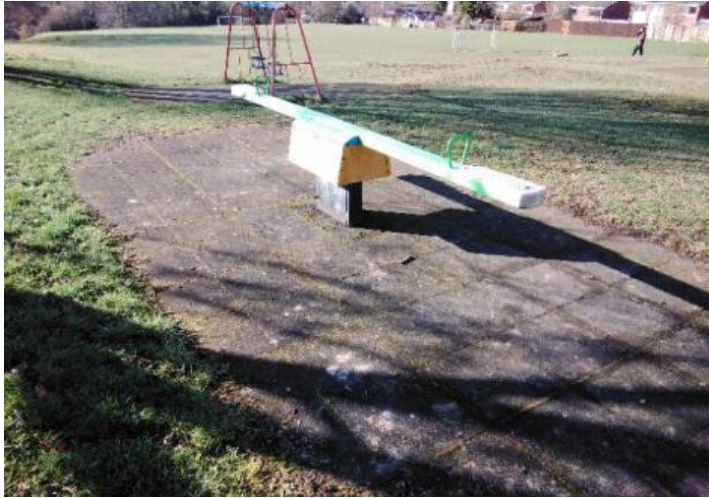
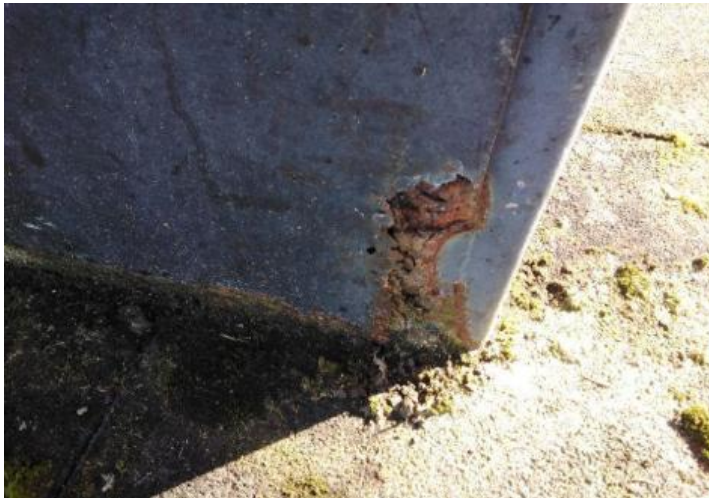
Item: Rocking Equipment - See Saw
Manufacturer: Wicksteed Playgrounds

Finding: Parts of the steel on this item have corroded excessively and the metal has perforated in places

Action: Ensure all affected areas are treated and repaired

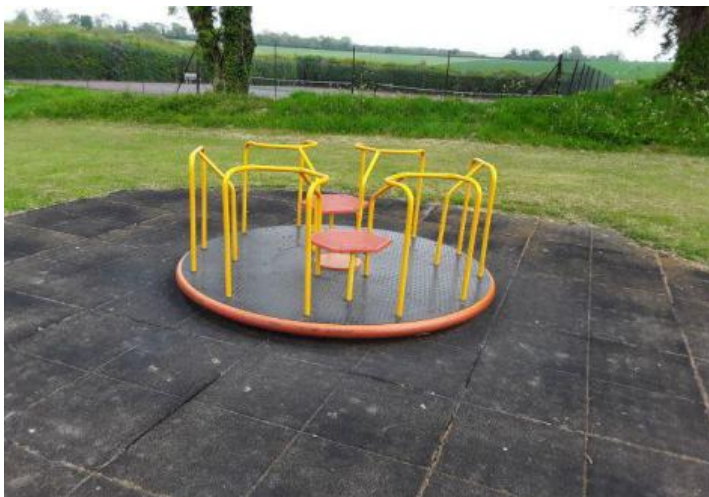
Item: Rotor Play - Roundabout
Manufacturer: Wicksteed Playgrounds

Finding: The safety surface around the area is beginning to wear

Action: Monitor for any further deterioration and repair as required

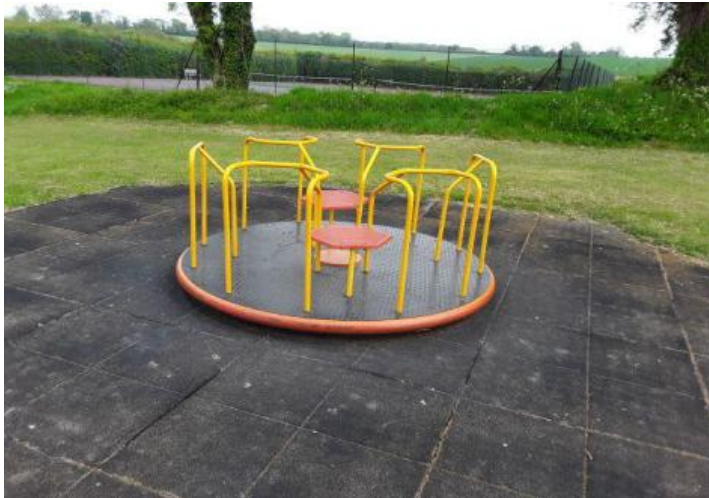
Item: Rotor Play - Roundabout
Manufacturer: Wicksteed Playgrounds

Finding: There are gaps opening in between the tiles

Action: Monitor for any further deterioration and repair as required

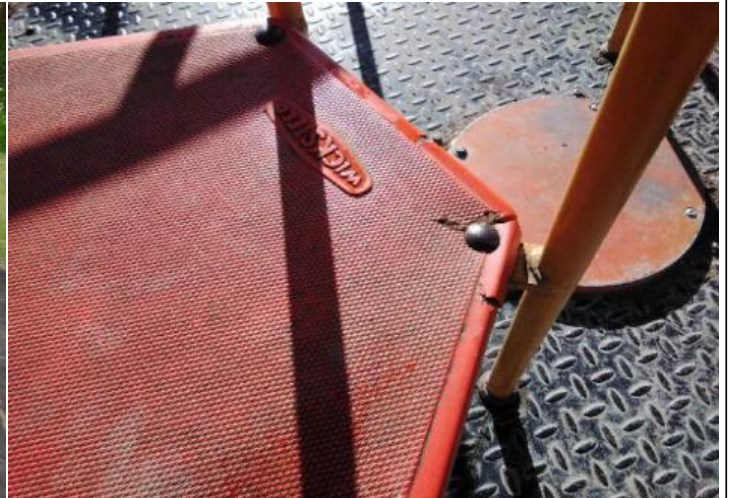
Item: Rotor Play - Roundabout
Manufacturer: Wicksteed Playgrounds

Finding: The item has been damaged

Action: Monitor for any further deterioration and replace as required

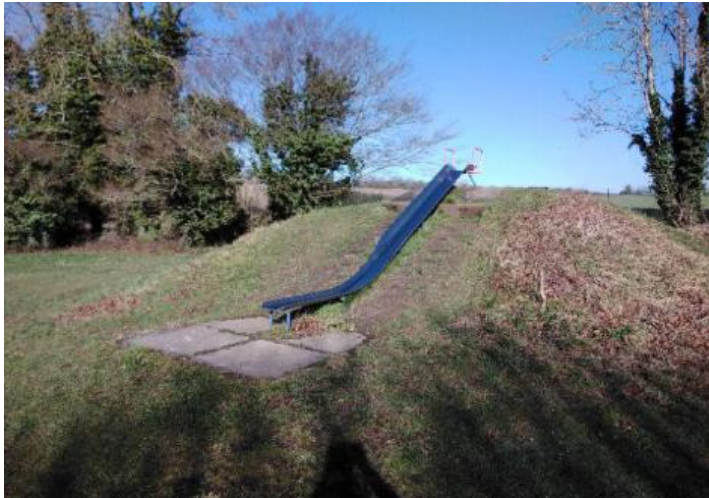
Item: Other - Embankment Slide
Manufacturer: Not Identified

Finding: The surface is lifting at the edges and creating trip points
Action: Repair perimeter of surfacing to remove trip points

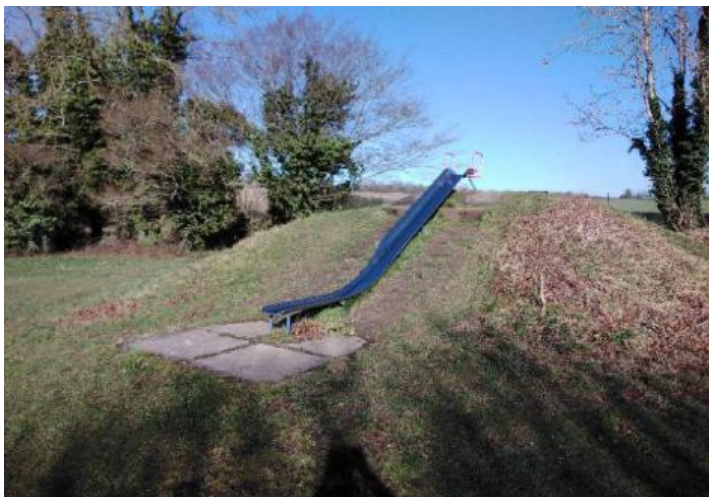
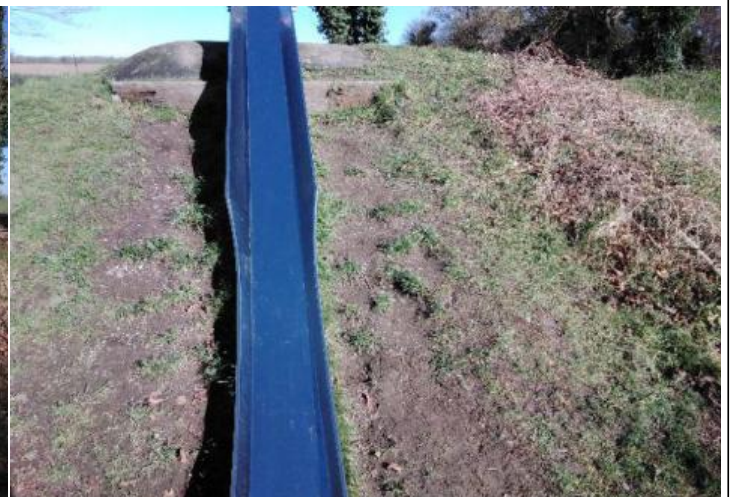
Item: Other - Embankment Slide
Manufacturer: Not Identified

Finding: The area around the item has eroded and may become slippery

Action: Reinstate eroded area

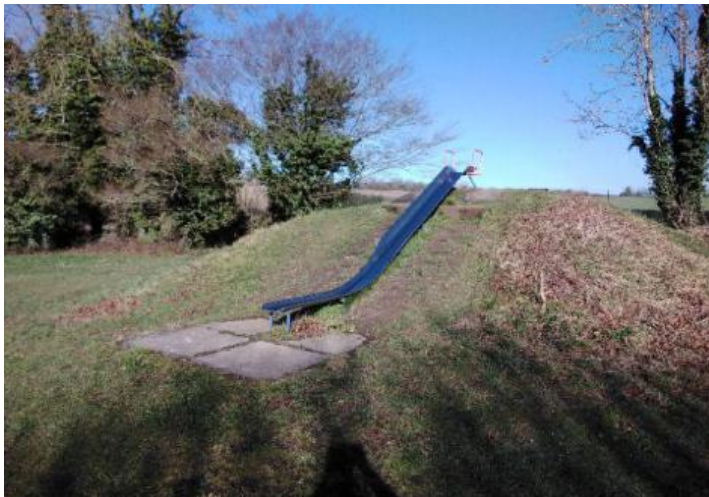
Item: Other - Embankment Slide
Manufacturer: Not Identified

There is some evidence of rot in the timber sleeper - Monitor for any further deterioration and replace as required

Finding: There is some evidence of rot in the timber sleeper

Action: Monitor for any further deterioration and replace as required

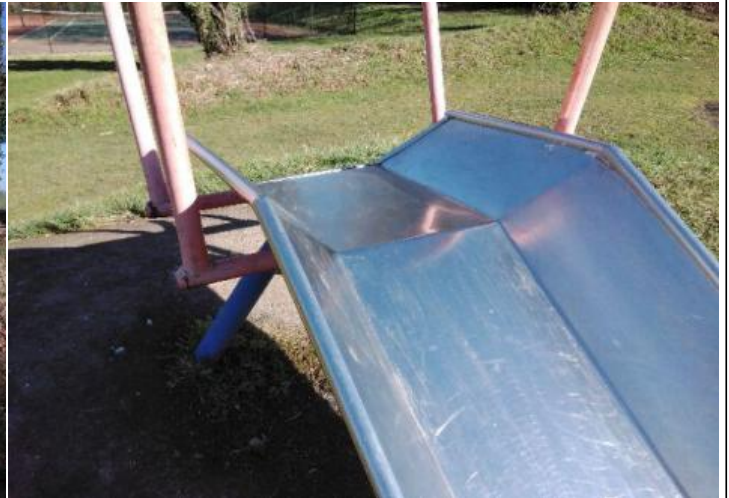
Item: Other - Embankment Slide
Manufacturer: Not Identified

Finding: The slide start section incline is not in the direction of travel; it should slope towards the direction of the sliding surface to meet the requirements of BS EN 1176 Part 3

Action: Monitor - No remedial work recommended

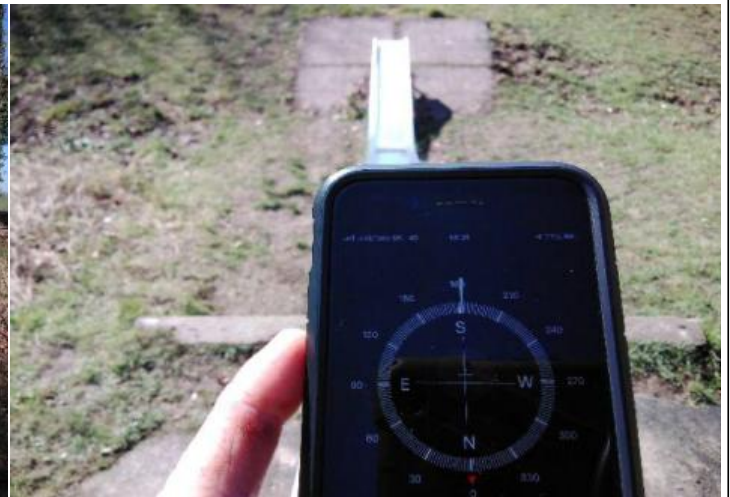
Item: Other - Embankment Slide
Manufacturer: Not Identified

The slide is predominately south facing and will catch the majority of the sun's heat during the day. Slide surfaces can become very warm during periods of sustained sunny weather - Monitor - No remedial work recommended

Finding: The slide is predominately south facing and will catch the majority of the sun's heat during the day. Slide surfaces can become very warm during periods of sustained sunny weather

Action: Monitor - No remedial work recommended

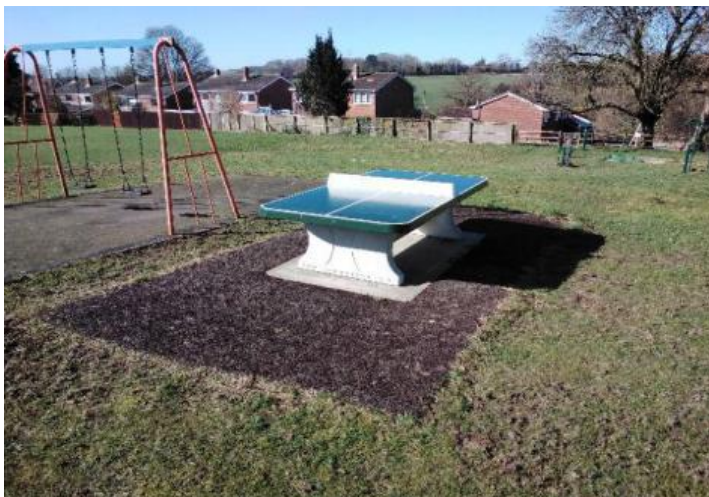
Item: Other - Table Tennis
Manufacturer: HeBlad

Finding: The item has been damaged

Action: Monitor for any further deterioration and replace as required

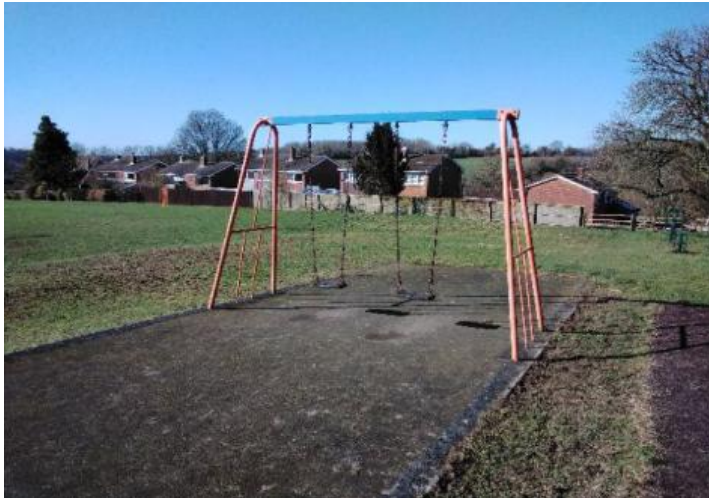
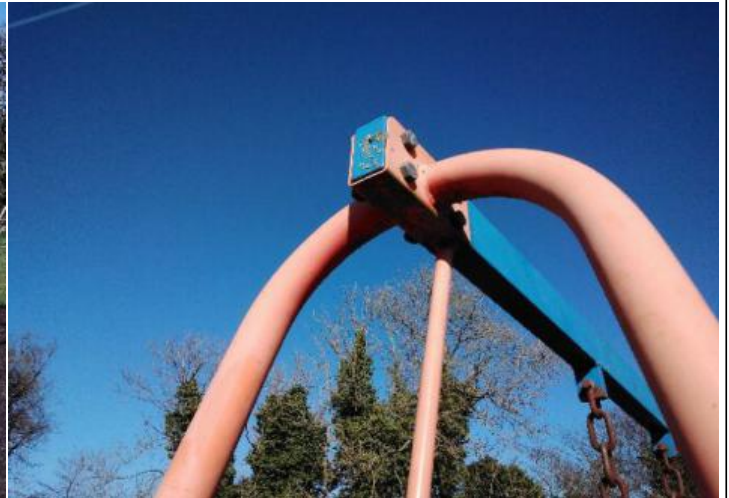
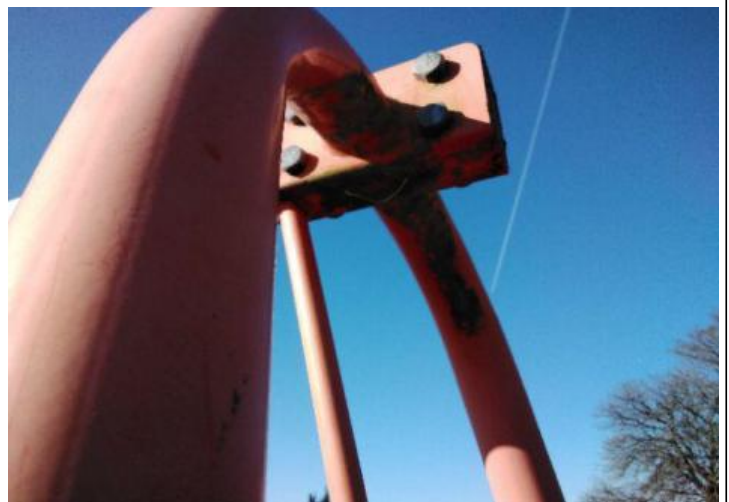
Item: Swings - 1 Bay 2 Seat (Flat)
Manufacturer: Wicksteed Playgrounds

Finding: There is algae or moss on the surface of the equipment

Action: Clean and treat appropriately

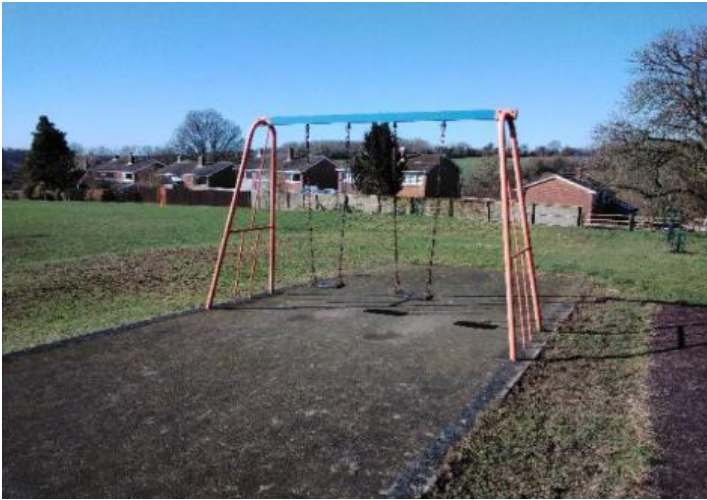
Item: Swings - 1 Bay 2 Seat (Flat)
Manufacturer: Wicksteed Playgrounds

Finding: The safety surface around the area is beginning to wear

Action: Monitor for any further deterioration and repair as required

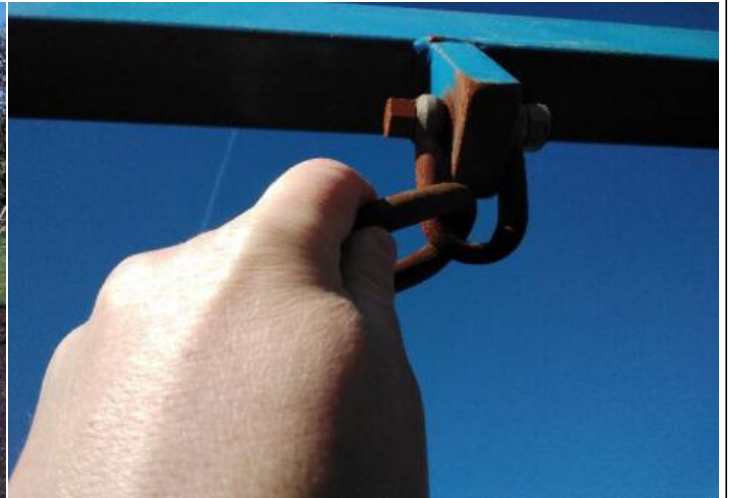
Item: Swings - 1 Bay 2 Seat (Flat)
Manufacturer: Wicksteed Playgrounds

There is some wear to the shackles. - Monitor for any further deterioration and replace when 40% worn

Finding: There is some wear to the shackles.

Action: Monitor for any further deterioration and replace when 40% worn

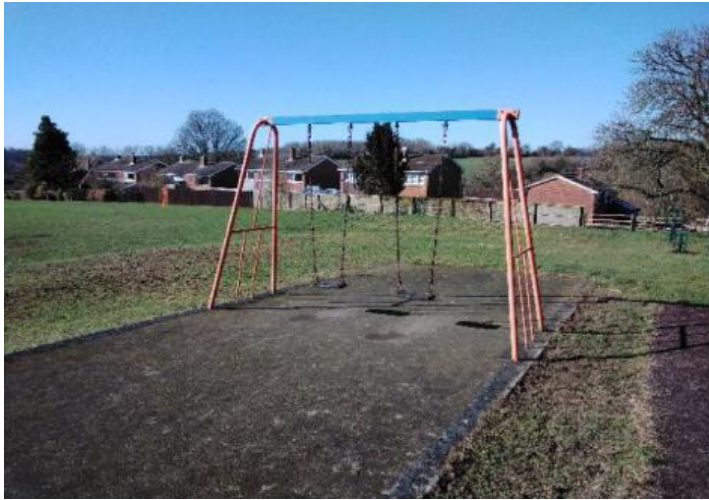
Item: Swings - 1 Bay 2 Seat (Flat)
Manufacturer: Wicksteed Playgrounds

The chain openings are in excess of the 8.6mm as recommended by BS EN 1176 - Monitor - No remedial work recommended

Finding: The chain openings are in excess of the 8.6mm as recommended by BS EN 1176 **Action:** Monitor - No remedial work recommended

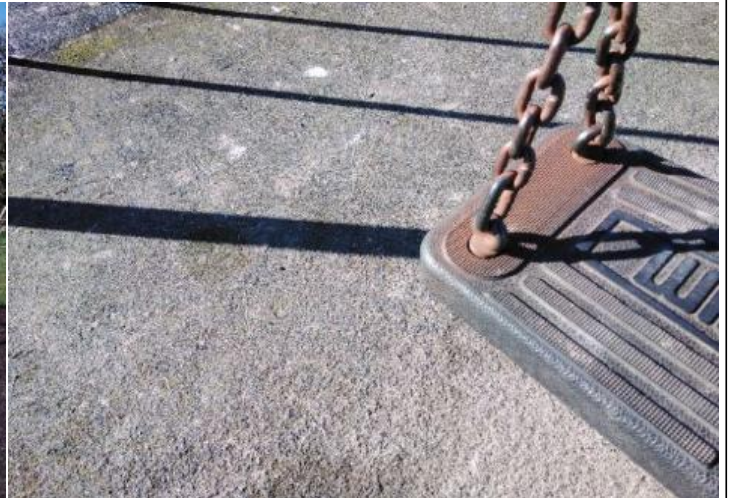
Item: Swings - 1 Bay 2 Seat (Flat)
Manufacturer: Wicksteed Playgrounds

The swing seat connectors are loose - Tighten to secure

Finding: The swing seat connectors are loose

Action: Tighten to secure

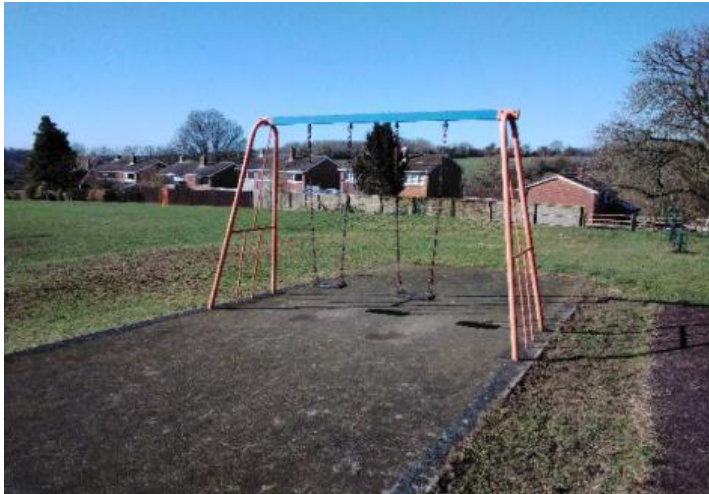
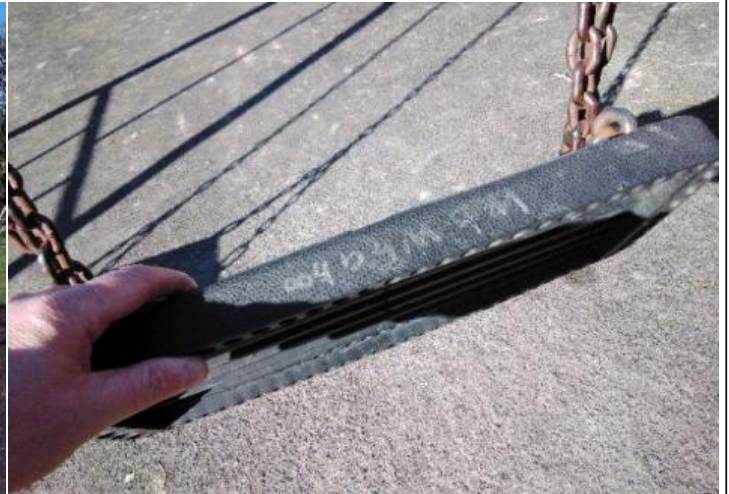
Item: Swings - 1 Bay 2 Seat (Flat)
Manufacturer: Wicksteed Playgrounds

Finding: There is some graffiti present

Action: Remove the graffiti

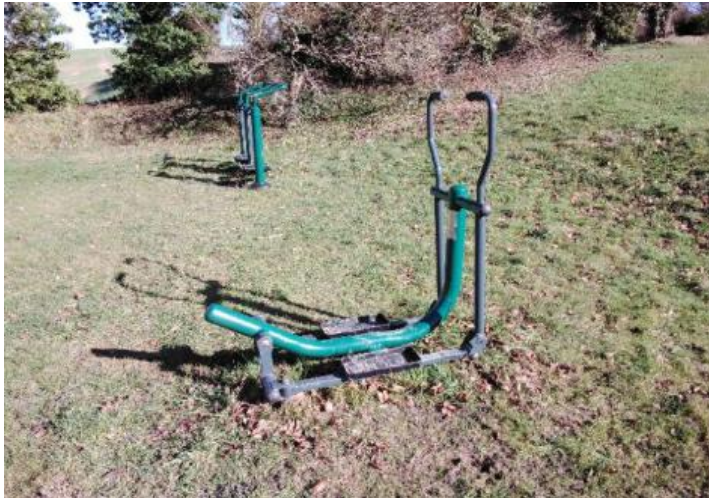
Item: Outdoor Fitness Equipment - Skier
Manufacturer: Sunshine Gym

The bearing is not operating correctly - Replace the bearing as required

Finding: The bearing is not operating correctly

Action: Replace the bearing as required
