the **play inspection** company

Annual Inspection

West Meon Village Hall RG (West Meon PC)

Headon View, West Meon, Hampshire, GU32 1LH

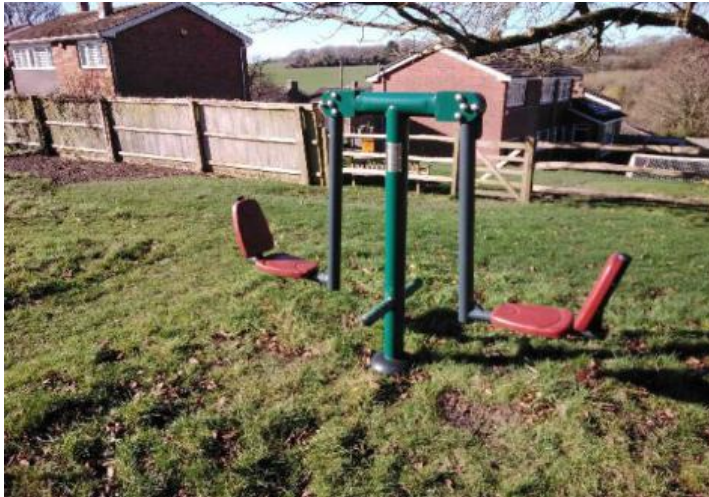
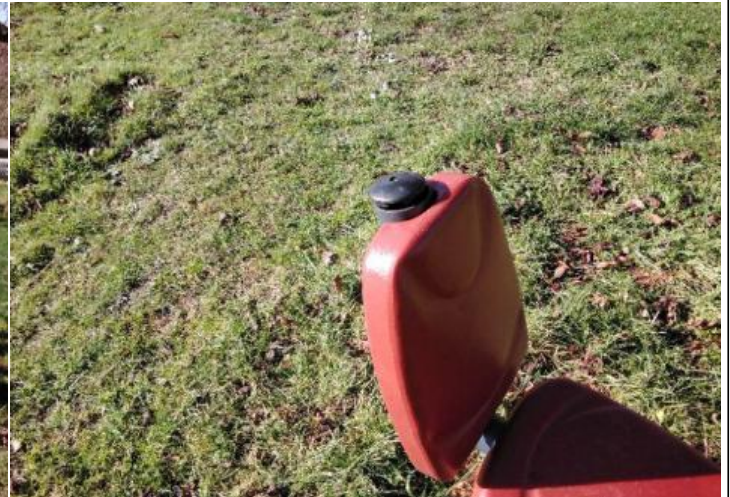
Item: Outdoor Fitness Equipment - Leg Press
Manufacturer: Sunshine Gym

There are post end caps damaged on this item - Replace damaged post caps

Finding: There are post end caps damaged on this item

Action: Replace damaged post caps

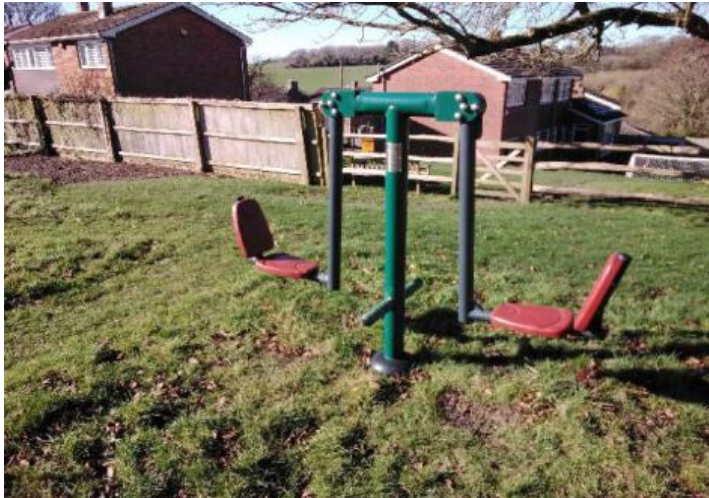
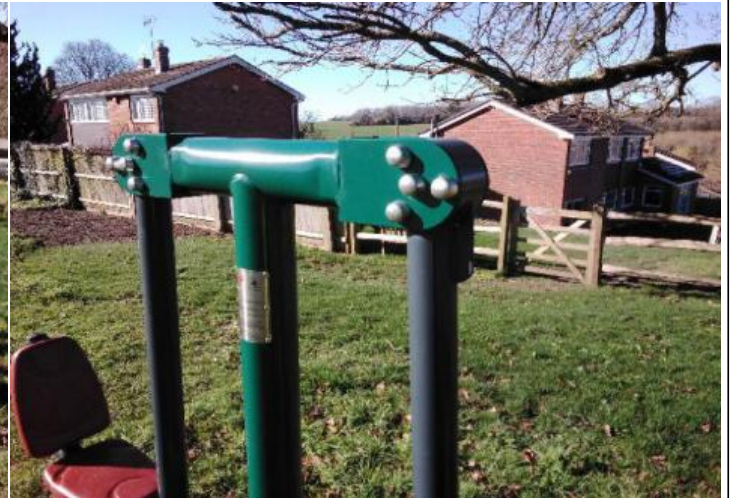
Item: Outdoor Fitness Equipment - Leg Press
Manufacturer: Sunshine Gym

Finding: The item is noisy in operation

Action: Service the item

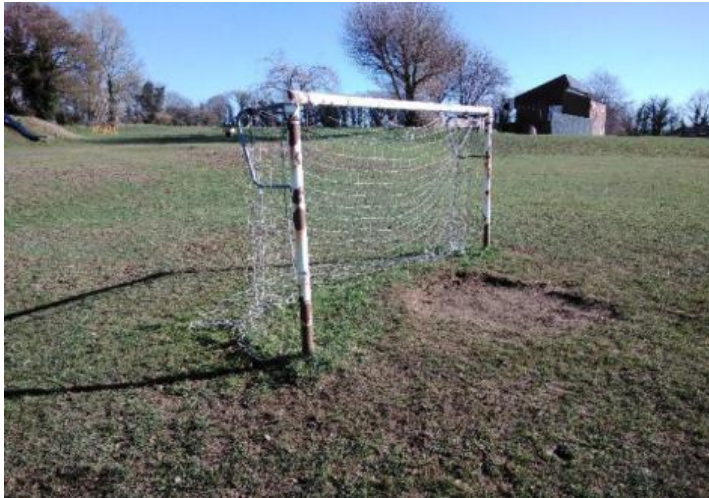
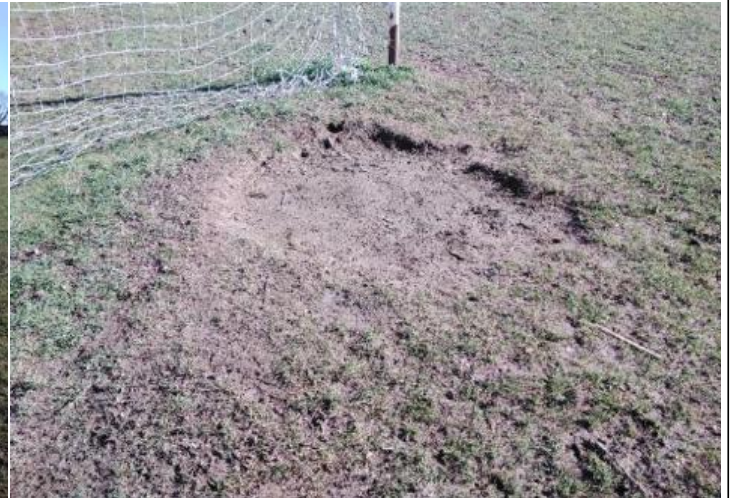
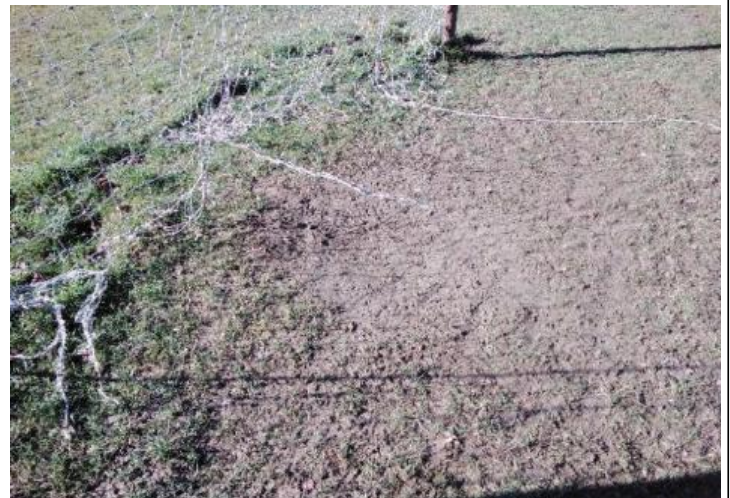
Item: Multi Use Games Area - Football Goal
Manufacturer: Not Identified

Finding: The area around the item has eroded and may become slippery

Action: Reinststate eroded area

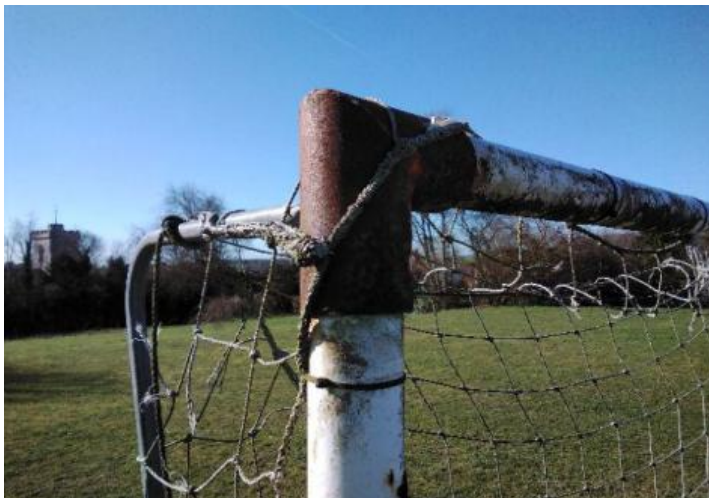
Item: Multi Use Games Area - Football Goal
Manufacturer: Not Identified

Finding: The paintwork on this item has been damaged or worn exposing the metal underneath which is rusting

Action: Treat any rusting components and repaint

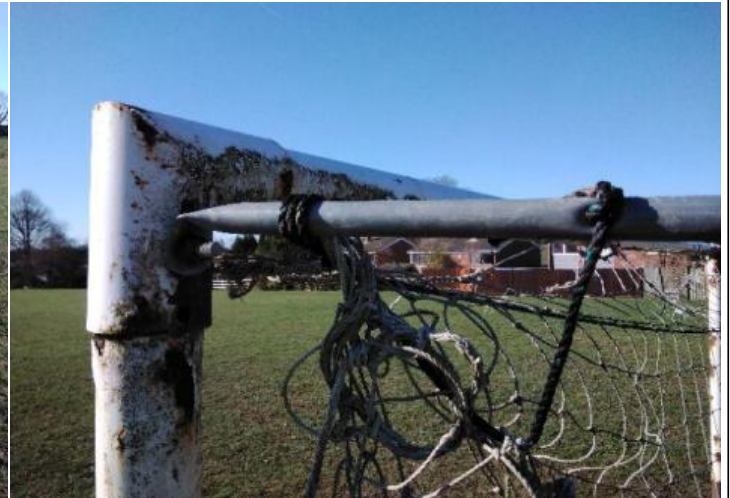
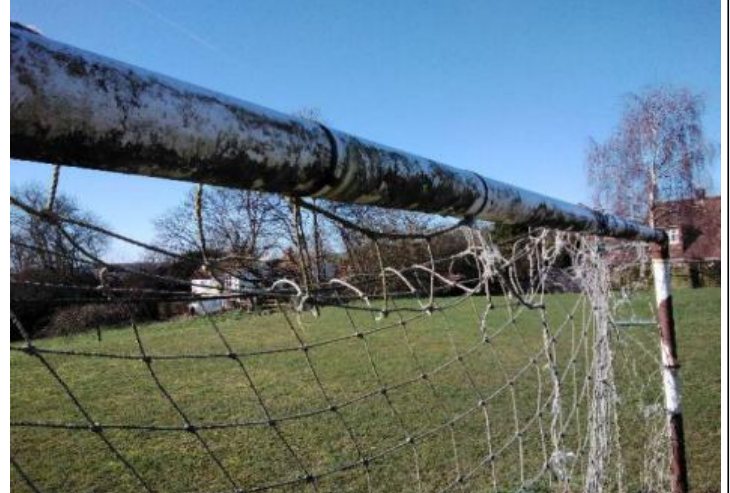
Item: Multi Use Games Area - Football Goal
Manufacturer: Not Identified

Risk Level: L - Low Risk
Surface: Grass

Finding: There is algae or moss on the surface of the equipment

Action: Clean and treat appropriately

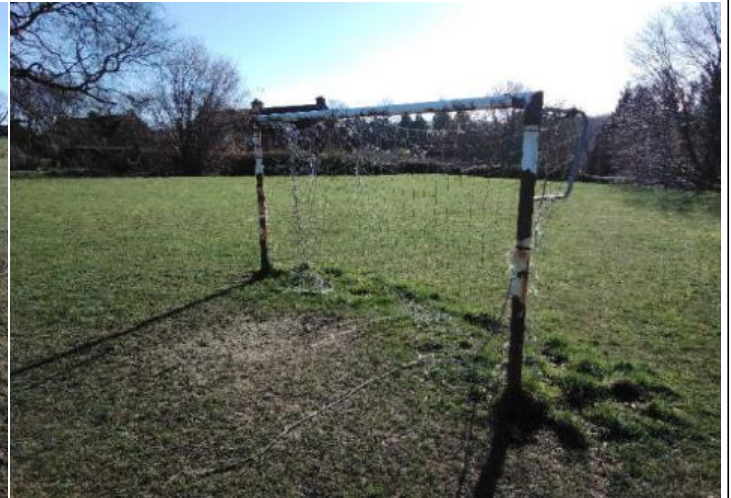
i 4 - Very Low Risk (Finding 6)

Item: Multi Use Games Area - Football Goal
Manufacturer: Not Identified
Risk Level: V - Very Low Risk
Surface: Grass

Finding: NB: We have undertaken a maintenance inspection only of the football goal(s); full load testing falls outside the scope of our inspection.

Action: Implement load testing as required

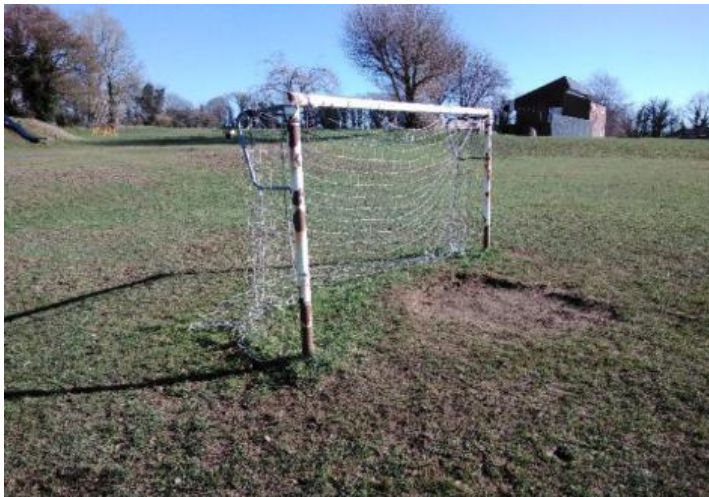
i 8 - Low Risk (Finding 7)

Item: Multi Use Games Area - Football Goal
Manufacturer: Not Identified
Risk Level: L - Low Risk
Surface: Grass

Finding: The goals are not secured in position

Action: Refer to manufacturer recommendations and secure as required
