Annual Inspection

Winchester City Council

Meonwara PA (West Meon PC)

Inspection Ref: 1300377

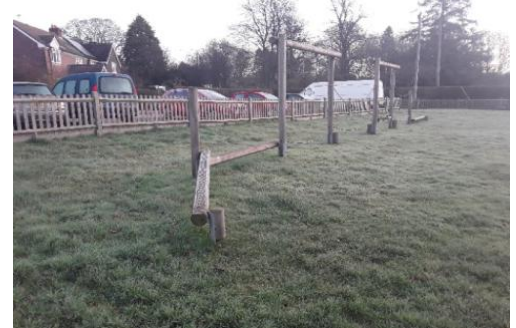
i 6 - Low Risk

Item: Site General
Manufacturer: Owner/Operator
Surface Type: N/A
Item Quantity: 1
Equipment Compliance: N/A
Surface Area Compliance: N/A

Total Findings: 3

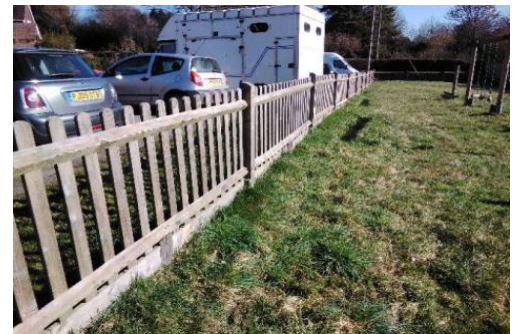
i 6 - Low Risk

Item: Fencing - Timber
Manufacturer: Owner/Operator
Surface Type: Grass
Item Quantity: 1
Equipment Compliance: N/A
Surface Area Compliance: N/A

Total Findings: 2

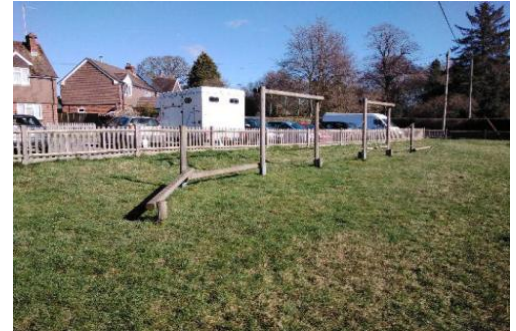
i 10 - Low Risk

Item: Activity Trail
Manufacturer: Playdale Playgrounds Ltd
Surface Type: Grass
Item Quantity: 1
Equipment Compliance: No
Surface Area Compliance: Yes

Total Findings: 7
